# Charlotte County Utilities Department

**2019 Annual Report**  
**March 2020**

## **2019 ANNUAL REPORT**

Jones Edmunds Project No.: 03405-029-03

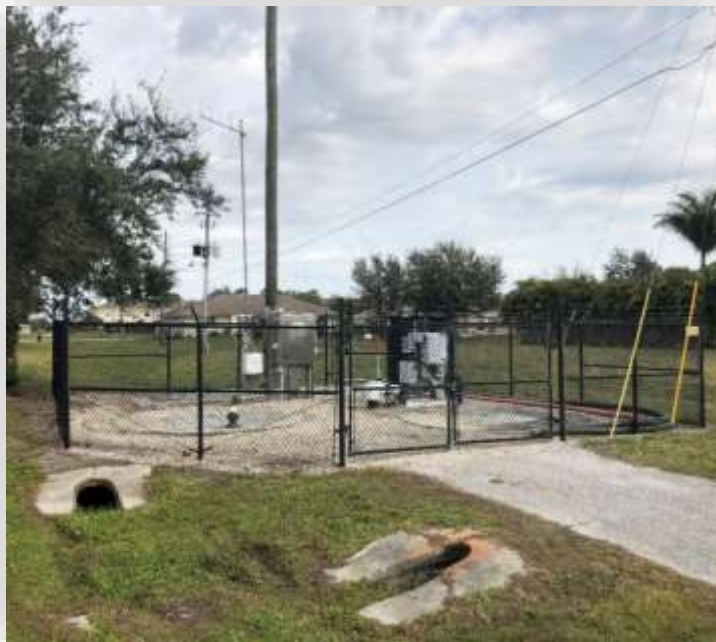
Wastewater flows through the 10-foot diameter manhole directly to the wetwell containing the pumps. The wetwell hatches are in good condition and provide adequate access to remove

the pumps on the rail retrieval system. The discharge isolation valves and the emergency pump discharge connection are in an underground concrete vault. The pump discharge pipes in the wetwell were replaced with HDPE pipe in 2010. The pump discharge check valves were also rebuilt at the same time, but have recent wear and sticking and require additional repair and replacement. The wetwell was last coated in the 1980s.

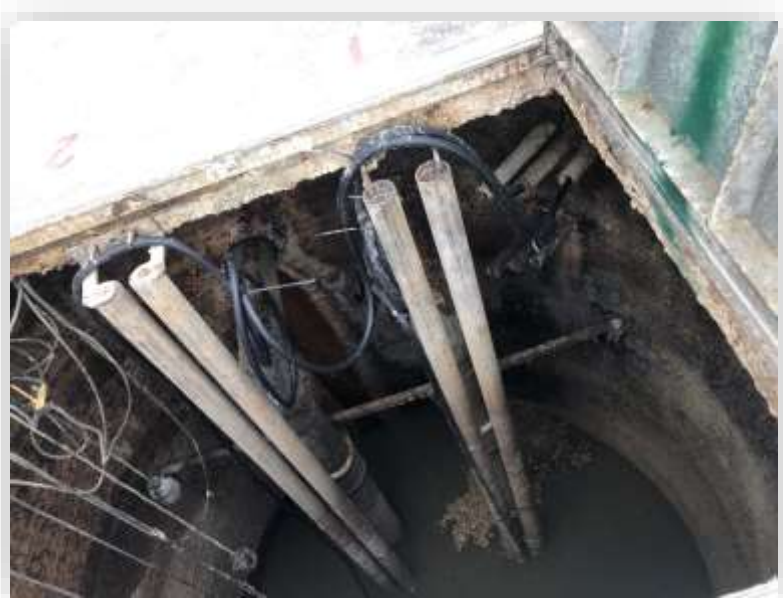
LS 309 currently experiences frequent infiltration during the wet season that requires manual trucking of the excessive flows. During the site visit, the lag float was triggering due to high inflow with no recent rainfall.

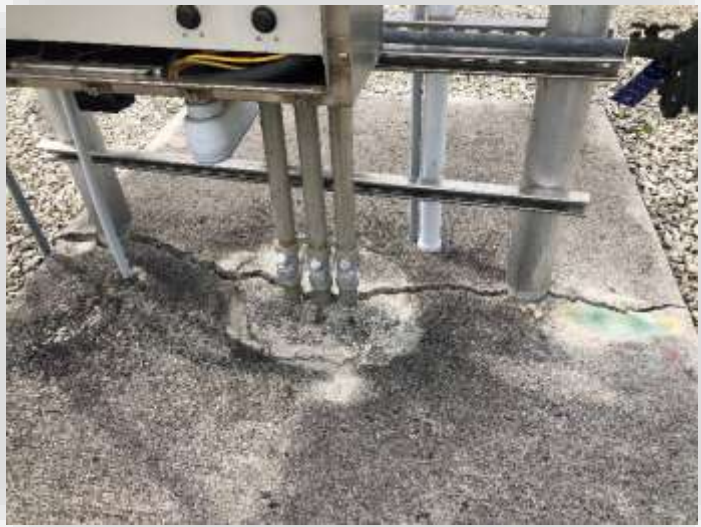
In a previous report, staff had observed severe settling. During the recent site visit, Operations staff noted that site work on this station had been completed. The site work included digging around the station and compacting the layers to prevent additional settling from occurring.

During FY 2019, elevations were taken to ascertain if settling was still occurring at the site. No settling has occurred since this work was completed.

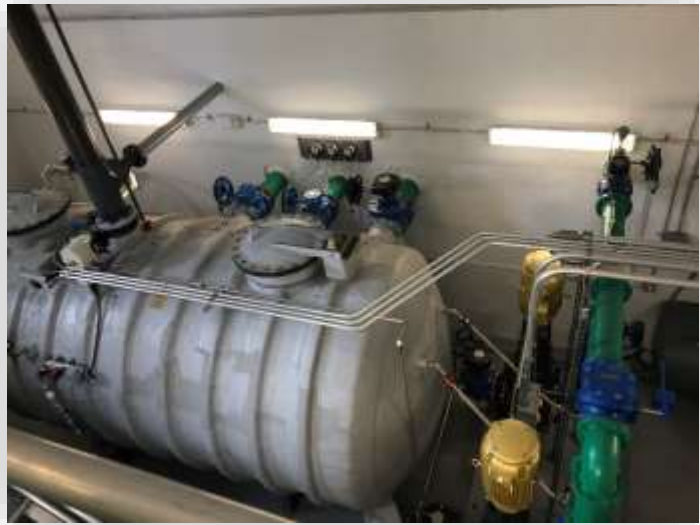
- The generator controls were above 6 feet.
- The crane pump on site is not aligned with the pump or the valves.
- The valves are vertically below the common discharge line and meter, making them difficult to access with the crane.
- The access for tank maintenance is at the top of the tank without a dedicated access point.
- The overhead door to pull the vacuum pumps is relatively short and has a low ceiling.
