Charlotte County Utilities Department

2022 Annual Report
March 2023

Prepared by
JonesEdmunds

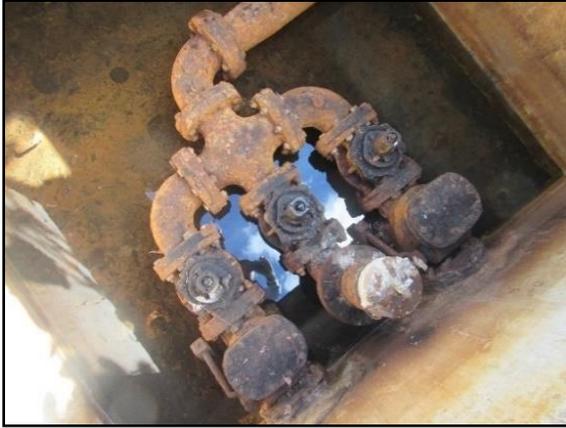
The 4-inch discharge Dezurik plug valves and 4-inch Kennedy check valves are in an underground vault southeast of the station. The valve vault interior has corrosion from standing water. The plug valves, check valves, dedicated discharge connection, and discharge piping are in fair condition with signs of heavy rust and need to be replaced.

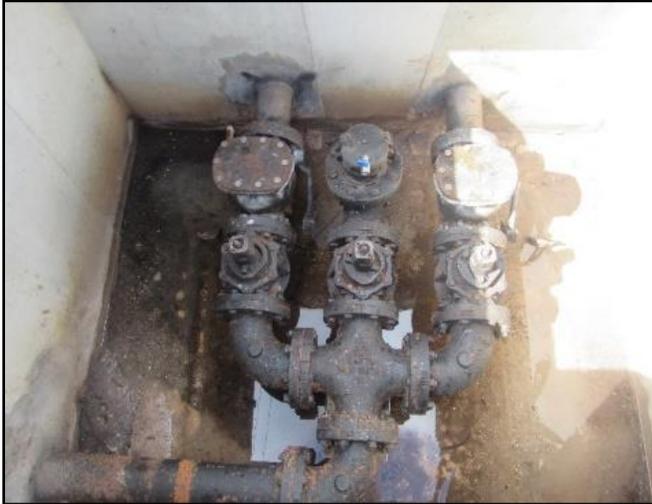
The concrete wetwell interior is in great condition and is vented. The wetwell hatch is in good condition and provides adequate access to remove the pumps on the 2-inch cylindrical-rail retrieval system. The 4-inch Dezurik plug valves, 4-inch Kennedy check valves, and dedicated discharge connections are in an underground vault, east of the wetwell. The plug valves, check valves, and discharge piping show minimal signs of rust. The valve vault has standing water and sediment at the bottom, indicating inflow of stormwater and a clogged drain.

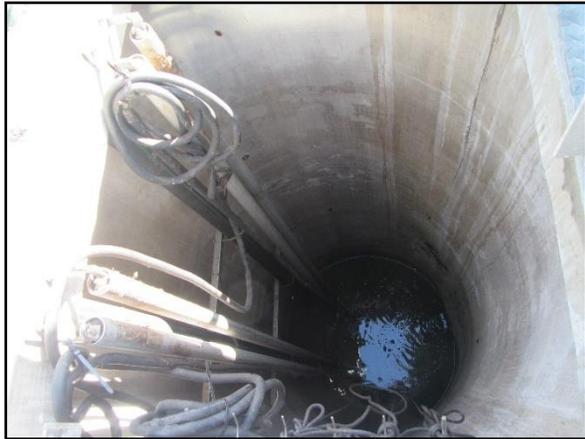
The wetwell is vented and no odor was present. The wetwell exterior and electrical equipment are in relatively great condition. The wetwell interior is in great condition with no signs of deterioration. The wetwell hatch is in great condition and provides adequate access to remove the pumps along the 2-inch cylindrical-rail retrieval system. The discharge 4-inch Dezurik plug valves, 4-inch Kennedy check valves, air-release valves, and dedicated discharge connection are above ground near the wetwell. They are all in great condition and do not require repair or replacement at this time.

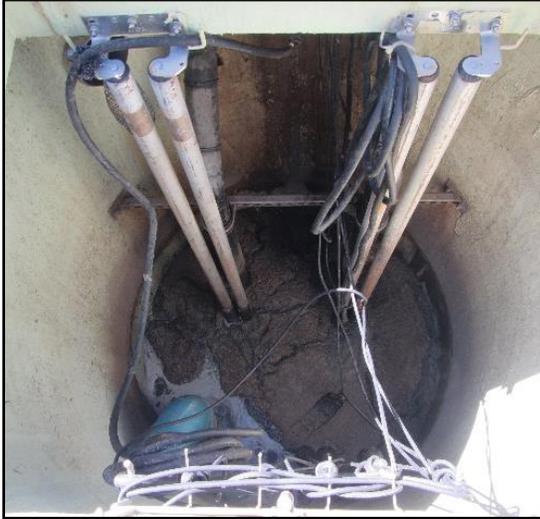
The wetwell hatch is in good condition and provides adequate access to remove the pumps on the 2-inch cylindrical-rail retrieval system. The wetwell interior has solids built up at the bottom near the submersible pumps. The wastewater technicians break down the solids once a week with potable water from a hose bibb. The discharge 4-inch Dezurik plug valves, 4-inch Kennedy check valves, air-release valves, and dedicated discharge connection are above ground southwest of the wetwell. They are all in great condition and do not require repair or replacement at this time. A Bay Products Inc. biological odor-control unit with a fan draws air from the wetwell and reduces the hydrogen sulfide odor generated. The air

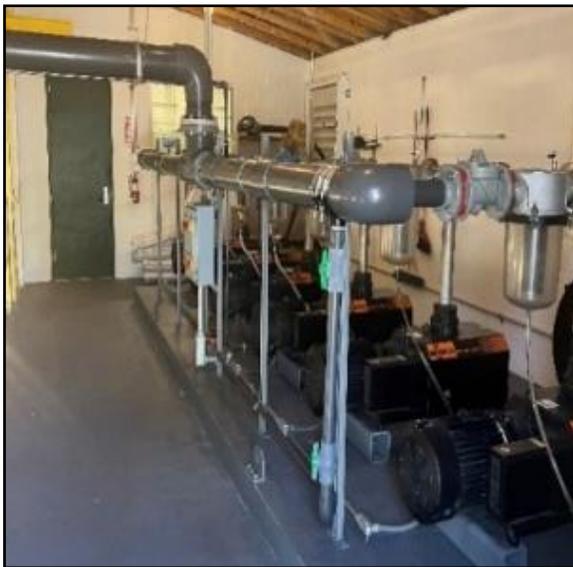
The station contains two 50-HP Cornell centrifugal Model 4514T-VC18DB pumps inside the building. Each pump has a design capacity of 725 gpm at 137.5 feet of head, but the pumps recently had their impellers trimmed to 34-foot TDH @725 gpm and their VFDs modified to account for the improvements made to the system curve after the RTS and GMLS construction. The plastic covers for both pump motor components are missing or broken and need to be replaced. The 8-inch check valve after the discharge of the Cornell pumps is sticking and needs to be replaced.

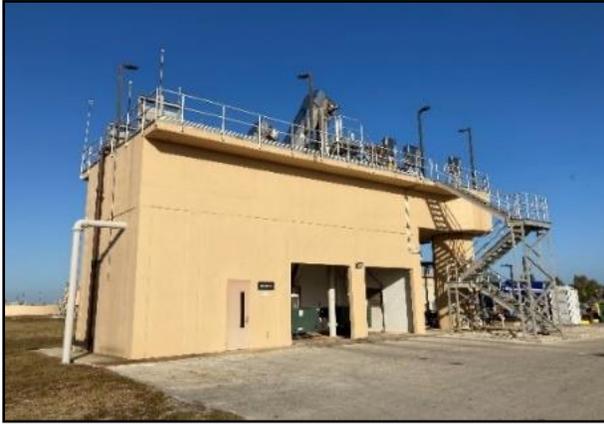
The two septicage-receiving stations require constant maintenance due to the high number of septicage haulers that use the facilities and the nature of the waste. The septicage-receiving units are reaching their useful life and are included in the 9.0-MGD WRF upgrade.

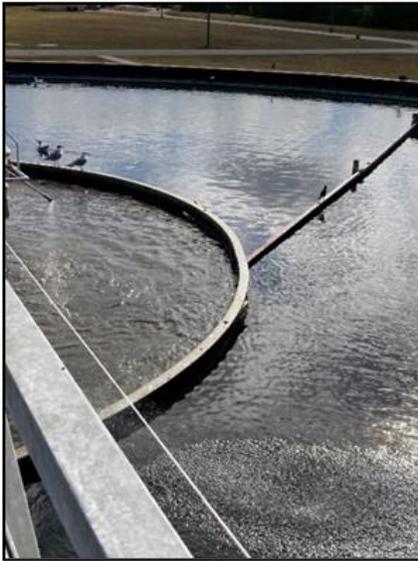
In 2016, the two clarifiers were rehabilitated as part of the Stage 1 and 2 upgrades, which included replacing the clarifier scraper mechanisms. The overall condition of the sedimentation process is well maintained and clean, and the clarifiers are producing a high-quality effluent. The light pole on the walkway between the two clarifiers is completely blown off at the base by Hurricane Ian and needs to be replaced. The five RAS pumps are VFD controlled. The two WAS pumps are controlled by operators' settings in the SCADA system. Both pumping systems are well maintained and in good working order.

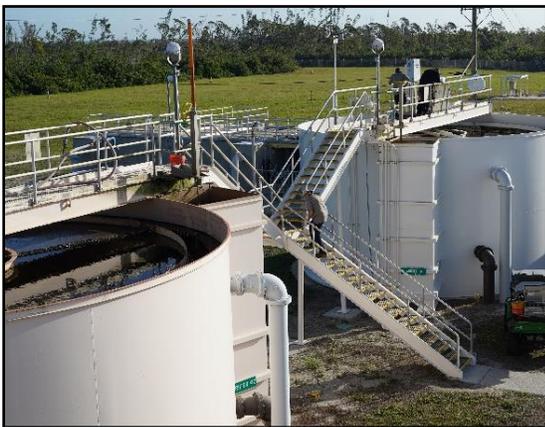
Although most of the unit process tanks are made of concrete or Type 304 stainless steel, the four secondary clarifiers consist of carbon steel and require constant paint maintenance every 2 years. The overall condition of the clarification process is fair. High sudden increases in influent flows can cause further issues with the clarifier performance when one of the four clarifiers are out of service. Installing submerged stamford baffling in the clarifiers could aid with sludge settlement and prevent solids from billowing up the walls and potentially entering the effluent launder.

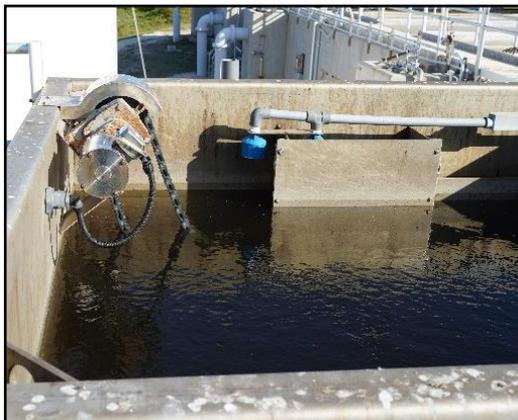
Three filters were in operation at the time of the site visit and were working properly. All three filters were using the same filter cloths that were replaced in 2021. The Chief Operator stated that a higher-quality effluent is obtained when all three filters are operating in parallel.

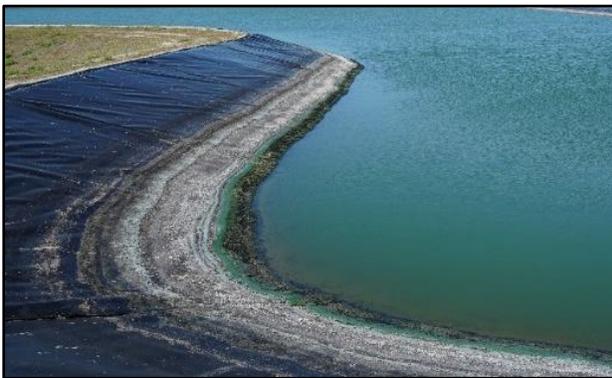
The on-site reclaimed water ponds provide up to 20 MG for wet-weather storage of reclaimed water. At the time of the site visit, the pond linings appeared to be in good condition. The ponds had some algae growth at the time of inspection. The Chief Operator reported in the last annual report update that they plan to add some fine-bubble diffusers to the pond in the future.

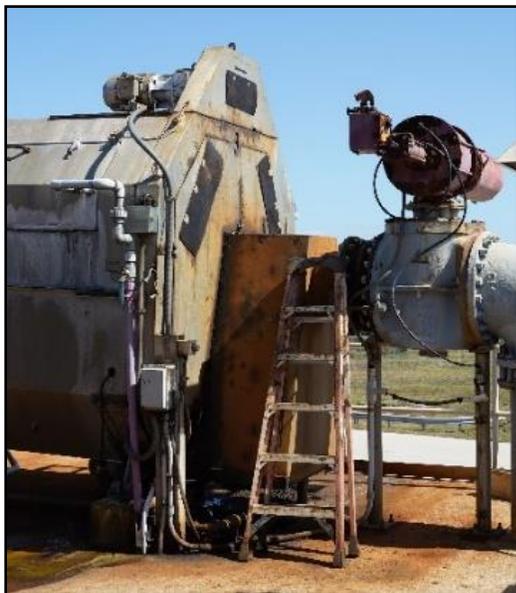
The overall condition of the headworks is fair to poor. The headworks is undergoing an improvement and rehabilitation/replacement project that will include new piping and fine screens as well other improvements to the headworks.

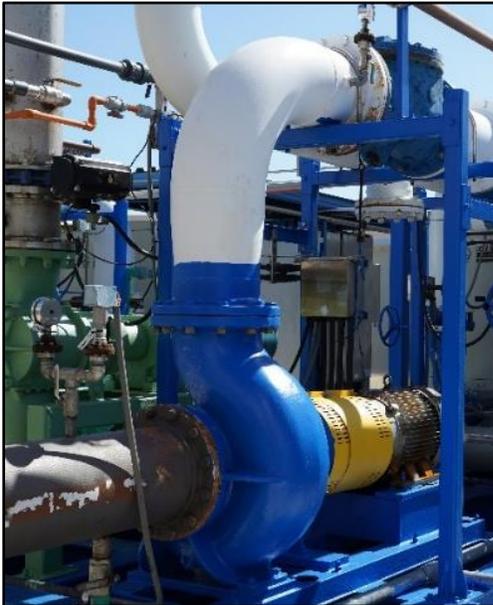
The MBR system continues to produce a high-quality effluent. The system contains four trains with three membrane cassettes each. The MBRs are cleaned once every other day with a weak solution of bleach to maintain their treatment efficiency and remove organics. The cassettes are periodically cleaned in place with concentrated chlorine bleach twice a year and are removed once a year for citrus cleaning to remove inorganics. The MBR system is in fair condition, but MBR No. 3 was not in use during the site visit. Permeate pump No. 3 cavitates and affects the flow meter for MBR No. 3. MBR No. 3 cannot be placed in service as a result.

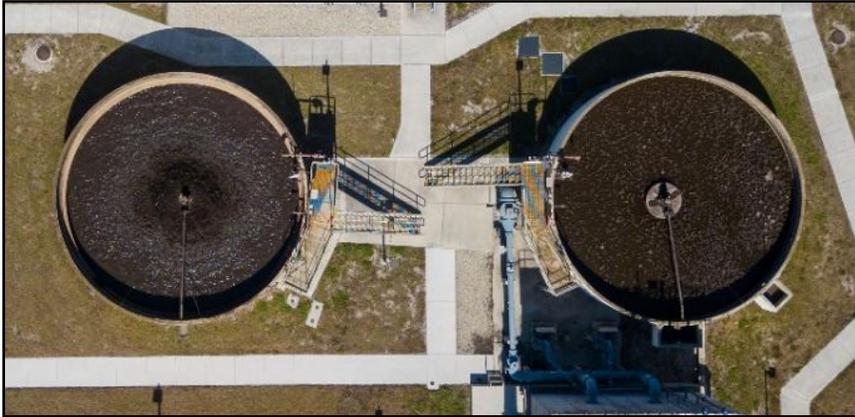
The overall condition of the solids-handling facilities is good. The decant mechanism for the sludge-holding tanks was designed as telescoping valves, but the telescoping valves can only be lowered to one-half the depth of the tank. Currently, decanting is done daily for 10 to 12 hours per day to

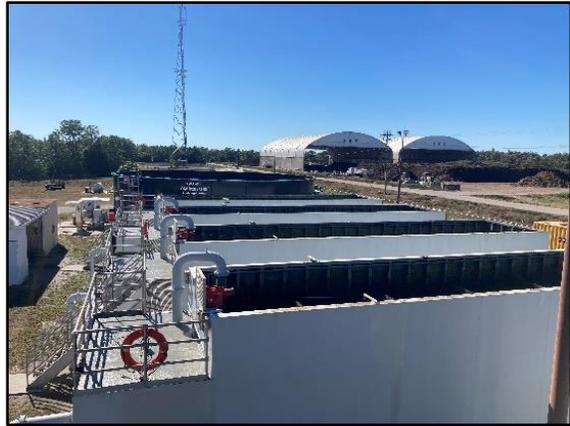
The three PACT units are in good-to-poor condition. The tanks' exteriors and interiors are in good condition since they were partially painted in FY 2017 and completed in FY 2018. Surfaces were pressure washed and rust and lost paint were removed and primed before painting was completed. The polymer feed systems and blower air intakes for the treatment trains should be replaced.
