Charlotte County Utilities Department

2020 Annual Report
March 2021

Prepared by
JonesEdmunds

2020 ANNUAL REPORT

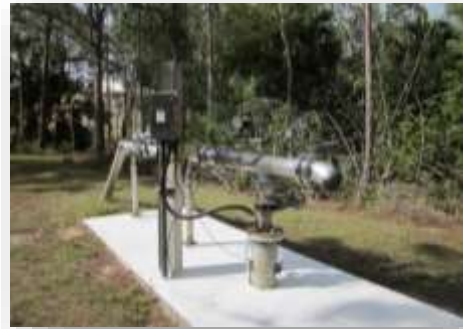
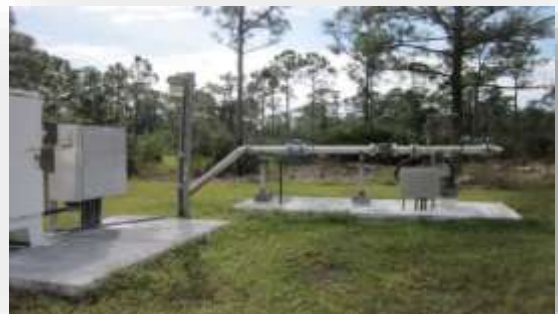
- Well No. 15 is at the rear of the site. The well pump and piping are in excellent condition. However, Well No. 15 is currently not in service due to suspected intrusion of lower quality water from this well's terminal strata. The 2013-issued WUP required this well be abandoned and capped. A study was completed in 2017 to evaluate an alternative way to bring this well back into service.

- Well No. 16 is a 12-inch-diameter well on the east side of the site. The well pump is in excellent condition.

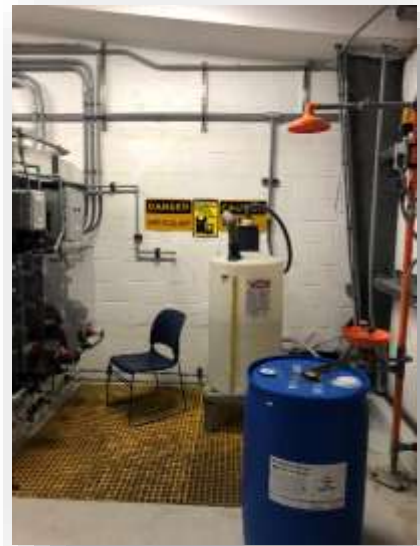
Sulfuric acid is used to decrease the pH of the raw water and prevent calcium carbonate precipitation. The 1,000-gallon bulk sulfuric acid storage tank is outside in the covered bulk storage area. The 100-gallon sulfuric acid storage tank is indoors near the chemical feed skid. The sulfuric acid skid contains two metering pumps. The metering pumps are in good working condition. The concrete in the secondary containment in the bulk chemical storage area was painted in 2018, and the 100-gallon tank inside the process room was replaced.

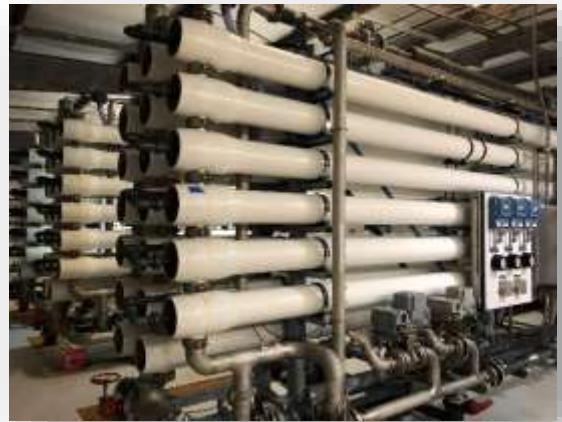
The Burnt Store RO WTP has five two-stage RO process trains, A through E. Trains A and B were installed in 2007, and Trains C, D, and E were installed in 2009. Trains A and B are served by two horizontal split-case pumps, and Trains C, D, and E are fed by vertical turbine pumps. Each RO feed pump is painted and in good condition.

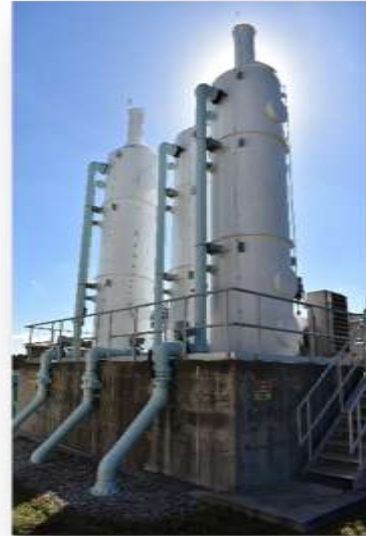
Hydrogen sulfide is removed from the RO permeate via packed-tower degasification. Three packed-tower degasification units are on top of the concrete clearwell and can be operated automatically or manually. One of the degasifier blowers was repaired in February 2017. The degasifier media is expected to be in good condition but should be inspected and potentially cleaned or replaced pending the inspection. In 2014, the clearwell was temporarily taken out of service for inspection. The clearwell inspection report noted for staff to paint the clearwell and exercise the isolation valve between the two tanks. The clearwell valve was exercised by staff and found to be operational in 2019. The outside of the clearwell should be painted.

Degasified water is transferred from the clearwells to the GSTs by three horizontal centrifugal pumps. In 2013, two in-line static mixers were installed in the transfer pipe leading to the GSTs to mix sodium hydroxide, corrosion inhibitor, and sodium hypochlorite. It is recommended that these injection points be labeled. In 2015, two additional air-release valves (ARVs) were installed downstream of the pumps. We recommend that the pumps and piping be covered to prevent sun damage and to prolong the equipment life.

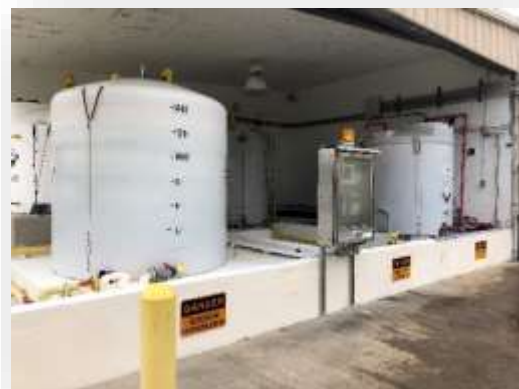
Sodium hydroxide is used to adjust the pH of the finished water before pumping it into the distribution system. The sodium hydroxide system consists of a 1,100-gallon bulk storage tank, a chemical feed skid with two metering pumps, and a 90-gallon chemical feed tank. The skid and smaller storage tank are in the RO process room and are in good condition. The bulk storage tank is outside near the other bulk chemical storage tanks, which poses operational issues during cold weather. When temperatures are less than 45 degrees Fahrenheit (°F), operators install heat lamps to prevent the sodium hydroxide viscosity from increasing. The glass sight gauge on the bottom of the 1,100-gallon bulk storage tank and the ball valve on the transfer line from the bulk tank were replaced in 2018 and are functioning properly.

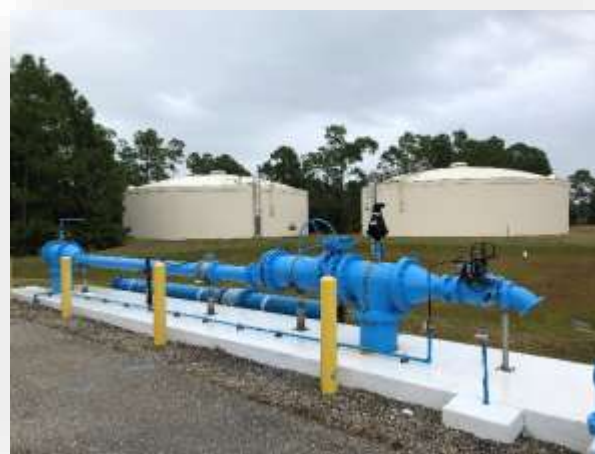
The Burnt Store RO WTP contains three 0.5-MG concrete GSTs housing a total of 1.5 MG of finished water. GSTs A and B were cleaned and inspected in FY 2013, and GST C was inspected in FY 2019. No sedimentation or defects were found in any tank. The outside of GST B was painted in 2019. The outside of GST A was cleaned and painted in 2020.

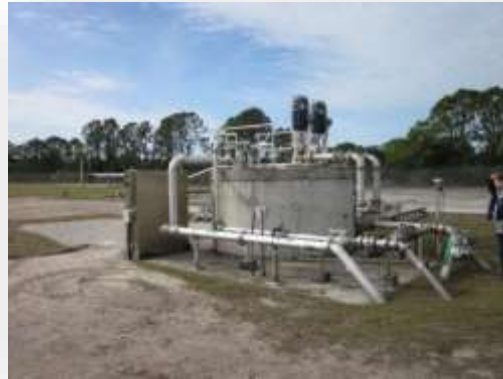
Concentrate from the RO process is disposed of by means of the on-site Deep Injection Wells IW-1 and IW-2. Both wells are permitted to accept concentrate and treated wastewater effluent. Concentrate is transferred to the deep well pumping station clearwell by latent pressure in the RO trains. There it is combined with wastewater effluent and injected into the deep wells. The maximum capacity of IW-1 is 0.564 MGD at a maximum rate of 392 gallons per minute (gpm). The maximum capacity of IW-2 is 2.88 MGD at a maximum rate of 2,000 gpm.

Both injection wells have flow meters and pressure gauges that can be monitored in the control room. Both wells undergo mechanical integrity testing every 5 years. A mechanical integrity test was successfully performed on IW-2 in 2013. A vibration analysis was also conducted for the vertical turbine injection well pumps in 2017. Due to the test results, the pumps were reprogrammed to minimize wear and appear to be functioning properly at the time of the site visit. The pumps at the station were painted in 2018.

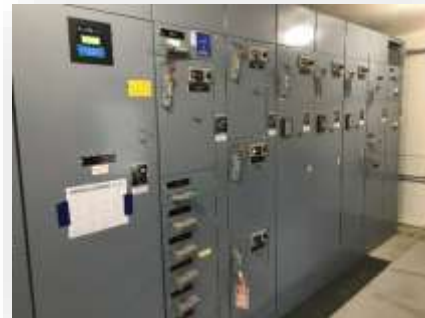
The main electrical components of this facility include the electrical components of the RO process buildings, one 1,250-kW standby generator, and two 80-kW portable generators. The distribution transformer, which provides power to the site, was in good condition with no obvious signs of significant concern. CCU's most recent risk and resilience assessment (RRA) recommended bollards be installed around the influent transformer box.

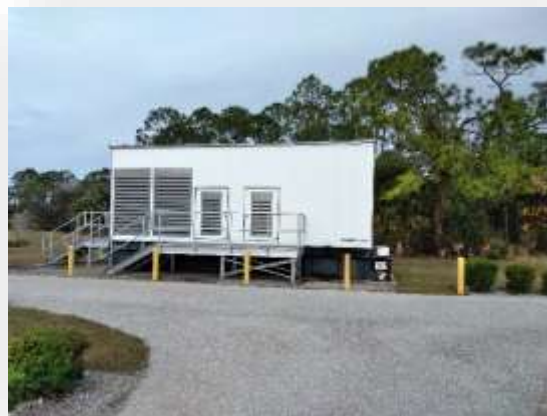
Auxiliary power is adequately sized to run the WTP. The WTP generator and automatic transfer switch were part of the 2009 upgrade of the WTP. The standby generator is operated for 4 hours under load twice per month. An outside contractor performs the maintenance. The generator was cleaned and serviced in 2020. Two generators that were historically attached to Wells No. 15 and 16 were converted to portable trailers. These generators can now be used to power the pumps at Wells No. 11, 12, 15, and 16 through permanently mounted generator connections at each well.

Overall, the electrical equipment is in good functioning condition based on information from the Operations staff.

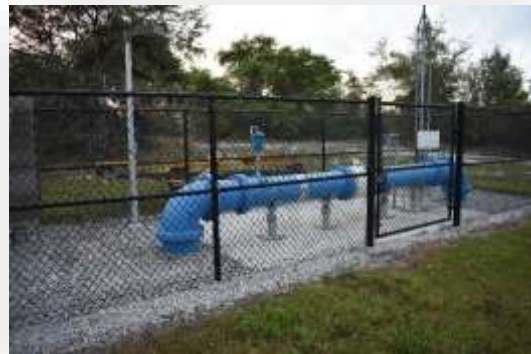
The Phase 1A Punta Gorda pipeline interconnect (Kings Highway/Shell Creek Loop) consists of over 12 miles of pipeline with a minimum design capacity of 6.0 MGD, aboveground storage, high-service pumping, disinfection facilities, and tie-in points with CCU. The geographical end points of the interconnect are the PRMRWSA's 24-inch Regional Transmission System (RTS) on Kings Highway at the Charlotte/DeSoto County line and the City of Punta Gorda's Shell Creek WTP on South Washington Loop Road in Charlotte County. The interconnect, which is on Discovery Drive, is used to supply water to the City of Punta Gorda during the dry-season and receive water from the Punta Gorda system during the wet season. The interconnect is owned and operated by the PRMRWSA, and the flow meter at the interconnect is used to calculate the County's water usage. In FY 2020, Punta Gorda supplied 156.5 MG of water to Charlotte County, and Charlotte County supplied 156.1 MG to Punta Gorda through this interconnect.

Overall, the interconnect is in good condition, and no deficiencies were reported.

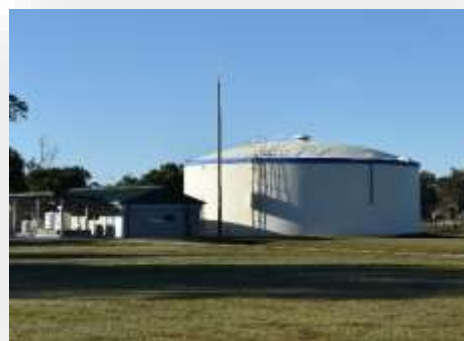
The Port Charlotte Golf Course Booster Station is at 22339 Gleneagle Terrace, Port Charlotte, FL 33952. The station provides local storage and pressure and disinfectant boosting capability for the Mid County service area east of Tamiami Trail. The station was built in 1966 and rehabilitated in 2010. The station contains a climate-controlled laboratory and electrical room, a ventilated pump and chemical feed room, and a 1-MG GST. The station is fenced and has one automatic access gate. The station contains two chemical-injection systems for sodium hypochlorite and ammonium sulfate addition. Each

system contains three metering pumps and two chemical storage tanks. The two 300-gallon ammonium sulfate storage tanks and two 800-gallon sodium hypochlorite tanks are under a covered shed adjacent to the pump room. The County operates the station to maintain a 4.0-mg/L disinfectant residual. The station has a detached diesel generator for backup power supply.

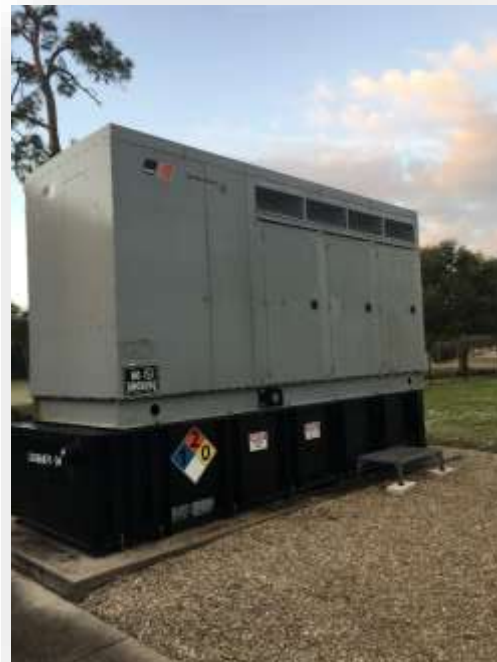
The incoming switchgear and distribution transformer appear in good condition with no obvious signs of significant concern. The generator and enclosure are mounted outside on an elevated sub-base fuel tank. They are in good condition. Overall, the electrical equipment is in good functioning condition based on information from the Operations staff.

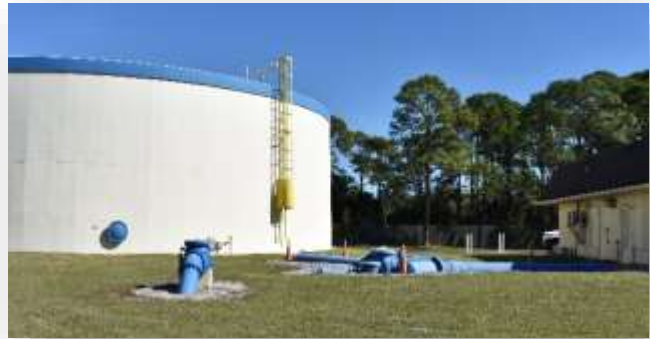
The Gulf Cove Booster Station was built in 1980 and is at 12050 Van Lenten, Port Charlotte, FL 33981. The station receives flow through an aging 12-inch ductile-iron pipe that spans under the Myakka River and feeds the 2-MG GST. The station has four HSPs, rated at 50, 60, 75, and 100 horsepower (HP). The pumps and electrical components of the station are in a ventilated building. The station is fenced and contains two entrances with automatic gates.

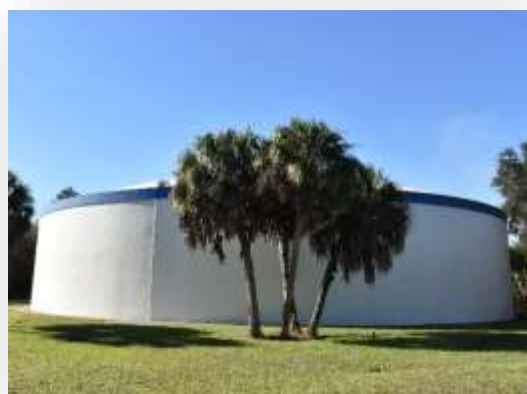
The Walenda Booster Station is at 17177 Walenda Avenue, Port Charlotte, FL 33953. The property contains potable water and reclaimed water infrastructure including reclaimed and potable water GSTs. The potable water GST has a capacity of 2 MG. The potable water station was built in 1994 and has two 100-HP and three 75-HP pumps. The larger pumps were replaced in 2010, and the smaller pumps are being investigated as part of the potable water master plan. The pumps and electrical components are in a ventilated room. The laboratory and office are in a climate-controlled room. The station is fenced

and has two entrances with automatic gates. The station contains two liquid-handling systems for sodium hypochlorite and ammonium sulfate injection. The sodium hypochlorite system contains two 1,000-gallon bulk storage tanks and a chemical injection skid. The ammonium sulfate system consists of two 300-gallon bulk storage tanks and a chemical skid. The chemical skids for sodium hypochlorite and ammonium sulfate each contain two metering

pumps and are in ventilated rooms. The bulk storage tanks are outside under covered sheds within secondary containment structures. The County operates the station to maintain a 4.0-mg/L disinfectant residual using a Hach APA 6000 ammonia/monochloramine analyzer and a Wallace & Tiernan DEPOLOX 3 plus total chlorine analyzer. A diesel generator is in the pump room to provide backup power to the station.

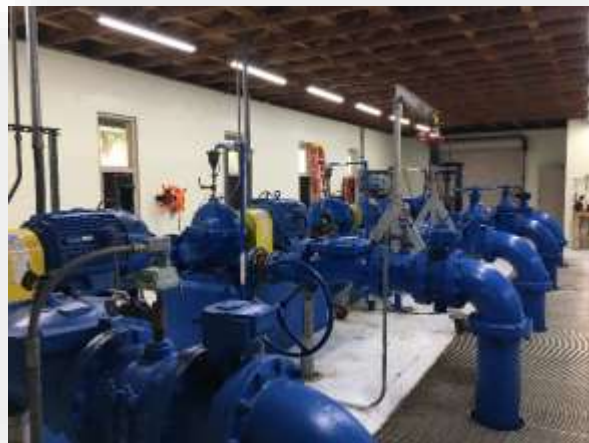
The incoming switchgear and distribution transformer appear in good condition with no obvious signs of significant concern. CCU staff reported that the existing on-site standby generating system is slightly undersized for a full load of the facility. The generator is inside the building that also contains the electrical switchgear. Overall, the electrical equipment is in good functioning condition based on information from the Operations staff.

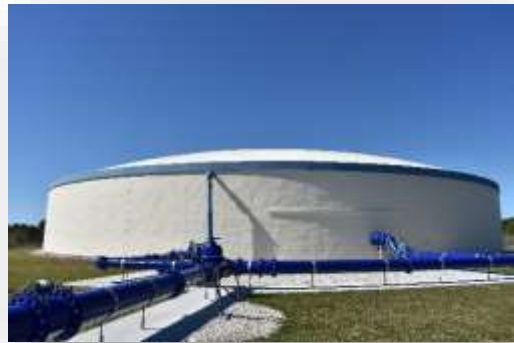
The Rotonda Booster Station is at 46 Parade Circle, Rotonda, FL 33947. Built in 1973, the station has two 100-HP pumps, two 65-HP pumps, and a 5-MG GST. The pumps and electrical components of the station are in a ventilated building. The station also contains a separate climate-controlled building with an office and laboratory. The station is fenced and contains one gated entrance.

The station has two chemical feed systems for injecting ammonium sulfate and sodium hypochlorite. The ammonium sulfate skids are in a ventilated shed, and each skid contains two metering pumps for injection before and after the GST. The sodium hypochlorite skids are in a chemical room attached to the main pumping room, and each skid contains two metering pumps for injection before and after the GST. Ammonium sulfate is stored in two 300-gallon bulk storage tanks, and sodium hypochlorite is in two 1,000-gallon bulk storage tanks. The chemical storage tanks are housed within a covered structure with secondary containment chambers for safety.

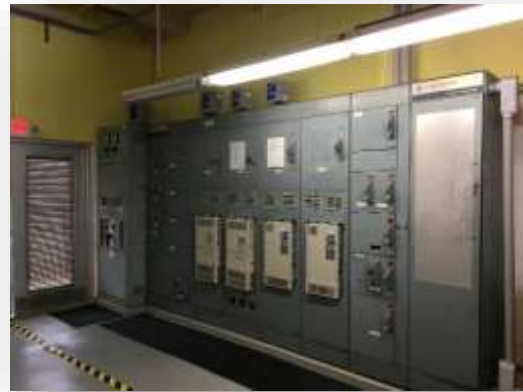
The incoming switchgear and distribution transformer appear in fair to poor condition. Components were identified as possibly being at the end of their service life because of their age. The standby generator and incoming power appear in fair condition as well. Interviews with County staff reported an unresolved issue. During the last maintenance cycle, the incoming main breaker for the facility would not re-close. After several attempts, maintenance personnel were able to get the breaker to close and maintain position. However, this is an indication that the breaker has an issue and likely may fail soon. A review of the site by the electrical engineer found an unresolved issue from the last annual report. Several of the drives have been updated to Yaskawa VFDs and were retrofitted into the existing MCC cabinets. However, the spaces provided did not match the drives, and there is now a gap between the drive and the enclosure (see photo at right) which may be problematic.

Although no live parts appear to be exposed, this does raise a maintenance concern and the possibility of exposed parts. Staff has indicated that the CIP contains a project to replace all of the main switchgear in this facility either this fiscal year or next.

- Much of the switchgear appears to be in fair-poor condition and is possibly reaching the end of its service life. Many components may no longer be manufactured, making long-term maintenance an issue.
- An exterior-mounted automatic transfer switch (ATS) appears to be in fair condition and degraded due to exposure to weather.
- The switchgear contains no warning labels identifying parts and components as being energized.
- Gaps exist between the updated VFD drives and the enclosure.

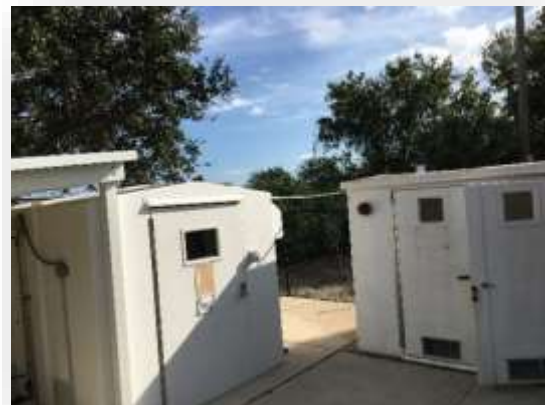
The general condition of the station is fair. The buildings are weathered but in operational condition. The landscaping is maintained. The electrical components at the Ingraham Disinfection Station are in good condition. Interviews with County staff reported no unresolved issues. A review of the site by the electrical engineer found no issues.

- The doorstep to the water-quality testing and storage shed needs repair.

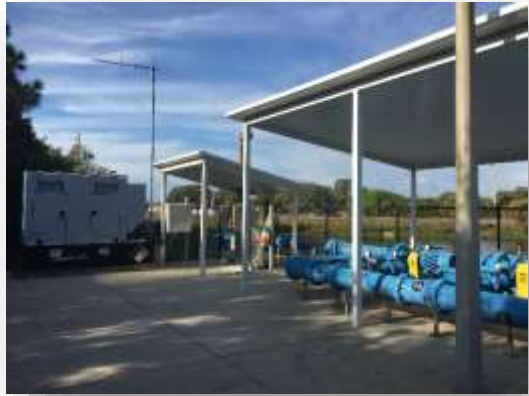
The EWD interconnect not only provides redundancy for EWD and CCU in the event of an emergency, but also acts as a water-pressure booster station. The EWD WBS includes two 40-HP booster pumps with a diesel generator for backup power supply. Monitoring at the interconnect facility includes total chlorine residual, pressure, and flow. No storage or chemical dosing is provided at this facility at this time. By opening or closing valves, the EWD interconnect pumping station can pump water in either direction, i.e., to or from EWD. However, EWD and CCU must both get permission from and will be billed by the PRMRWSA to receive excess water as stipulated by the PRMRWSA contract.

Overall, the interconnect is in good condition, but the lighting fixtures should be lowered so the cover does not block the illumination of the pumps and equipment.

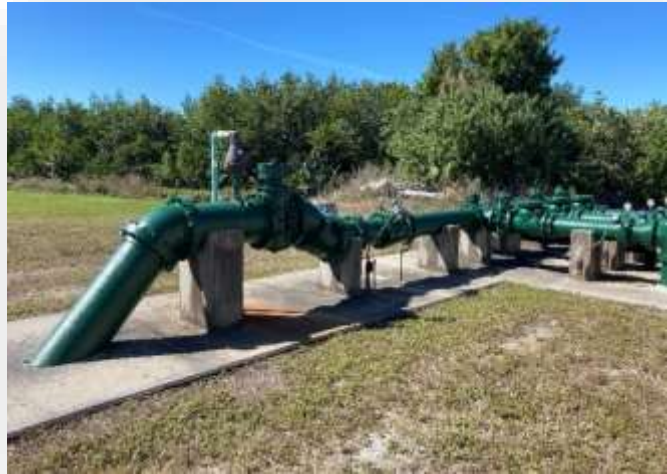
South Port Master Lift Station is centrally located just south of US 41 and southwest of the building at 4157 S Tamiami Trail in Port Charlotte. LS 65 currently receives flow from over 23 different lift stations, surrounding gravity lines, and LPS lines. The station discharges through a 16-inch force main. The flow is then conveyed to the East Port WRF.

The station contains three submersible Flygt model CP3300 88-HP submersible pumps with 454-millimeter (mm) impellers in a 12-foot-diameter, 19-foot-deep, lined concrete wetwell.

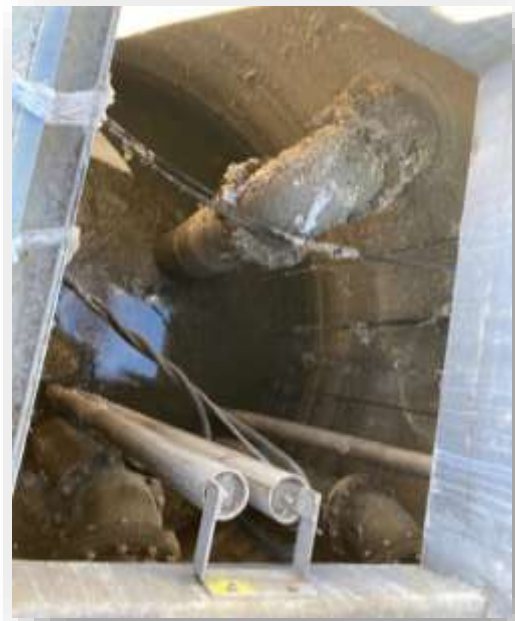
The station is not fenced other than the odor-control unit, but the building and all access hatches are locked. The site has no significant lighting other than building lights, but the building housing the generator and panels has indoor lighting. The odor-control system at the station is a carbon adsorption, forced-air system, which has kept hydrogen sulfide levels in the wetwell low. This has contributed to the relatively good condition of the wetwell even though the station has been in service for over 20 years. The carbon adsorption unit is within a locked, fenced area that has barbed wire. Power service to the station is 480-volt, three-phase with a pad-mounted transformer east of the station. A 300-kW Cummins generator, rated at 375 kilovolt-amperes (kVA), with an ATS is inside the control building. The generator is operated once a week each Monday to ensure it is ready for standby power. The electrical and control panels are in good condition and are enclosed inside the building. The station has a SCADA system with a telemetry transmitter/receiver. The station has a water hose bibb for washdown.

Due to the high inflow of this station and the relatively shallow wetwell, the system capacity is extremely limited. The time between a high-water alarm and sewage spill is estimated at less than 10 minutes.

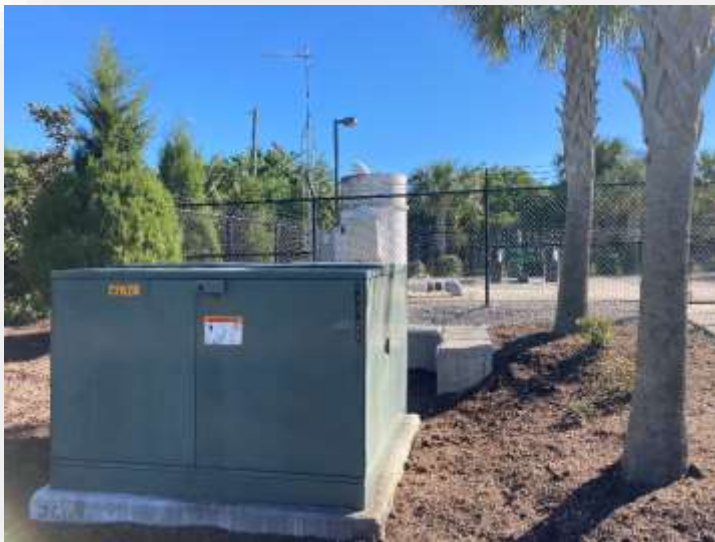
The station is fenced, and access hatches are locked. The station has no dedicated sight lighting. An odor-control system is on site adjacent to the wetwell. The power service to the station is 480-volt, three-phase, with a pad-mounted transformer northeast of the station outside the fence. The station has a SCADA system with a telemetry transmitter/receiver. The control panel has seal-offs as well as a portable generator receptacle with mechanical interlock between the main breaker and generator. The station has a potable water hose bibb for washdown.

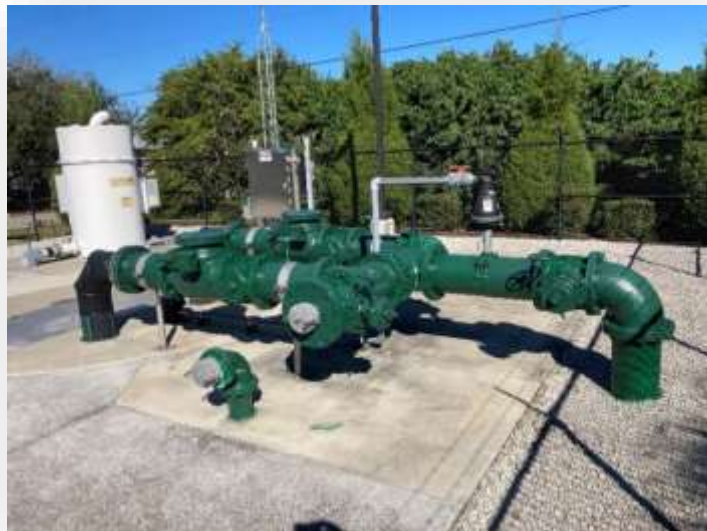
The station is fenced, has site lighting, and has a bio-trickling tower odor-control system. The power service to the station is 480-volt, three-phase with a pole-mounted transformer east of the station outside of the fence. The station has a SCADA system with a telemetry transmitter/receiver as well as a Telemetry Control Unit inside the panel. The control panel has seal-offs as well as a portable generator receptacle with a mechanical interlock between the main breaker and generator breaker. The station has a potable water hose bibb for washdown.

The odor-control blower motor was replaced since the last site visit. The Operations staff noted that the unit had been running as designed since.

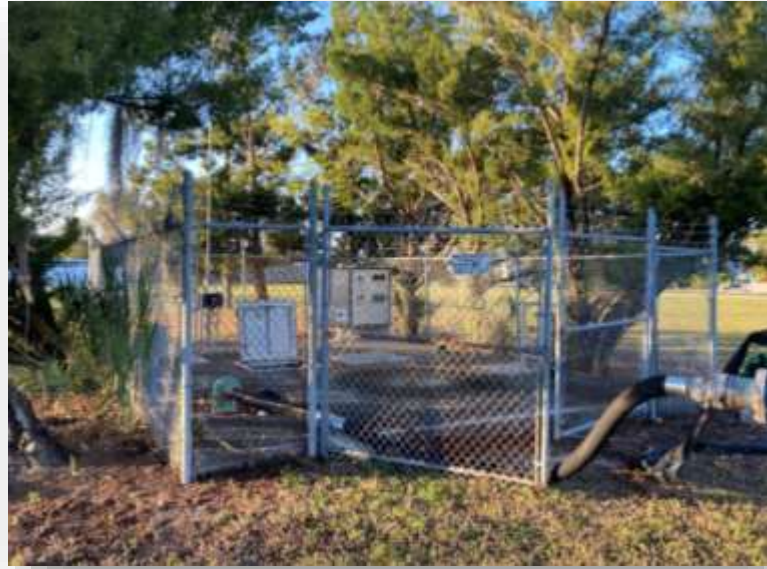
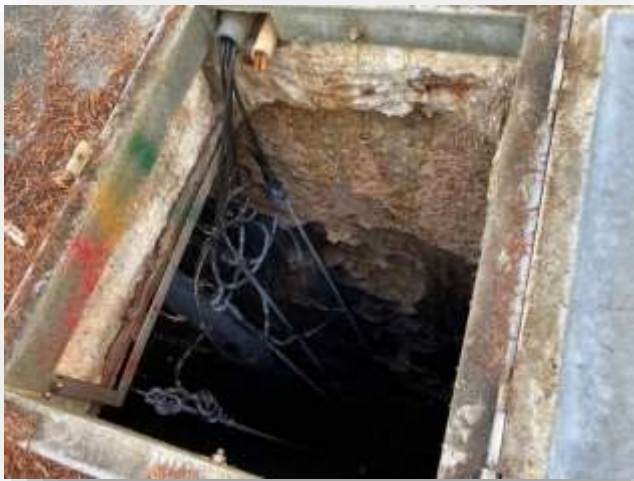
The station contains two 20-HP Flygt model 3152 dry-pit installation pumps with 434-mm impellers. The wetwell is 21 feet 7 inches deep. Each pump has a design capacity of 758 gpm at 50 feet of head. The concrete wetwell is corroded by years of hydrogen sulfide exposure, and metal reinforcement is exposed near the access hatch. The emergency dedicated pump suction and the emergency discharge connection are above grade north of the wetwell. The site's dedicated suction and discharge connections were being used by an on-site bypass pump at the time of the site visit.

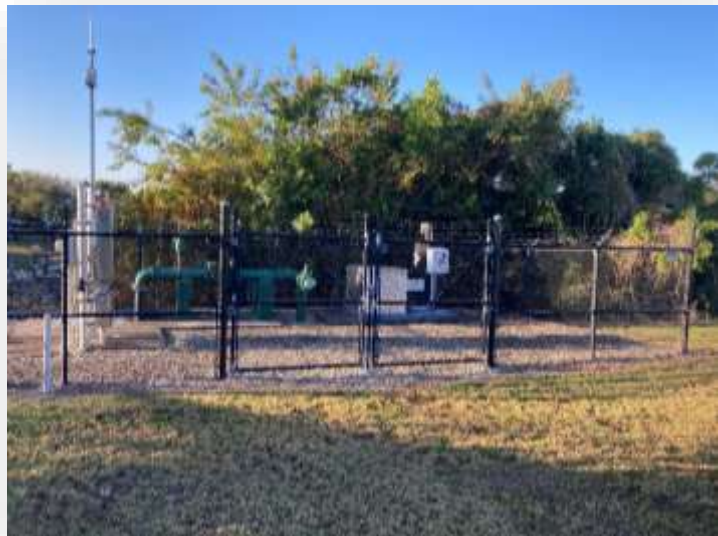
The station contains two 10-HP Flygt Model 3127 submersible pumps with 484-mm impellers in a 6-foot-diameter, 19-foot-11-inch-deep, lined concrete wetwell. Each pump has an estimated capacity of 369 gpm at approximately 46 feet of head (based on the County's latest drawdown reports that Operations staff had available at the time of the site visit). The wetwell lining is in good condition and appears to be largely unaffected by hydrogen sulfide. The wetwell hatches are in good condition and provide adequate access to remove the pumps from the rail retrieval system. The discharge isolation valves and the emergency dedicated pump discharge connection are above grade adjacent to the wetwell.

The station is fenced, and access hatches are locked. The station does not have dedicated lighting. The station has a Siemens Carbon Adsorber odor-control system. The power service to the station is 240-volt, three-phase with a pole-mounted transformer northeast of the station outside of the fence. The control panel has seal-offs and is equipped with a portable generator receptacle with a mechanical interlock between the main breaker and generator breaker. The station has a SCADA system with a telemetry transmitter/receiver. The station has a potable water hose bibb for washdown.

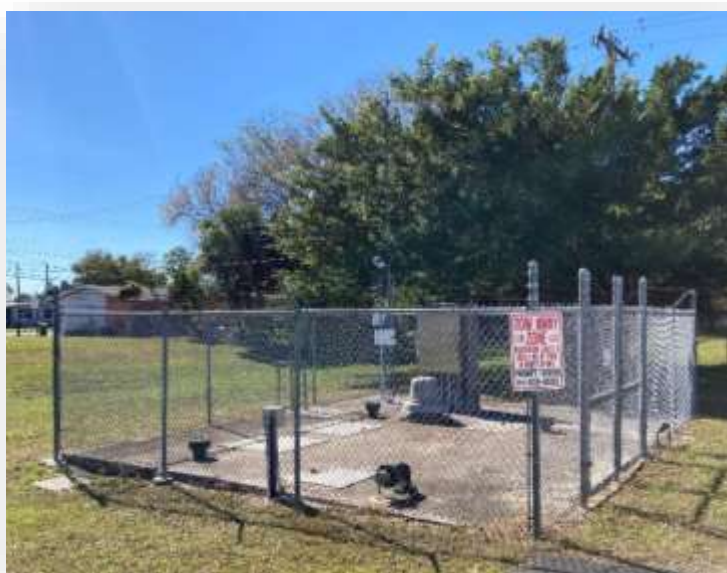
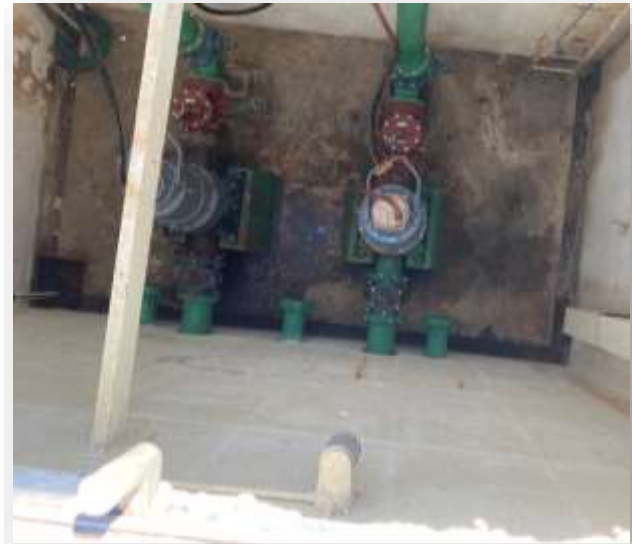
The station contains two 29-HP Flygt model CP3201 dry-pit installation pumps with 454-mm impellers. The concrete wetwell is 16-foot by 9-foot and 16 feet 10 inches deep. The pumps have an estimated capacity range between 1,464 gpm and 1,487 gpm at approximately 67 to 77 feet

of head (based on the County's latest drawdown reports that Operations staff had available at the time of the site visit). The access hatches are in fair condition with some signs of corrosion, metal, and exposure between the hatch and concrete. The emergency dedicated pump suction and the emergency discharge connection are above grade adjacent to the wetwell.

- Concrete corrosion in the wetwell and concrete separation around the wetwell access hatch.
- Installed pumps will be running off their performance curve after the RTS and GMLS construction.
- Dry-pit design requires confined space entry, resulting in delays to the pump repair and replacement.
- Operations staff noted issues with force main flows fighting against each other during heavy rain events.

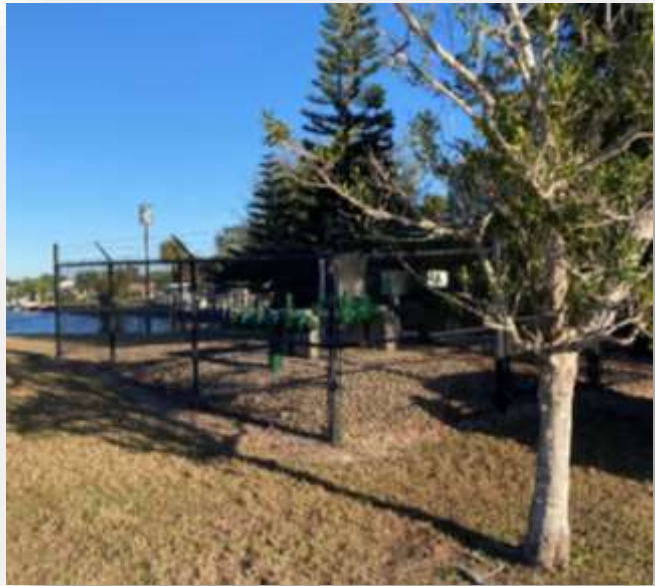
The wetwell lining is largely unaffected by hydrogen sulfide. The wetwell hatches are in fair condition with signs of rust and wear, but provide adequate access to remove the pumps from the installed rail retrieval system. The discharge isolation valves, dedicated pump suction, and dedicated discharge connection are all above grade to the southwest of the wetwell.

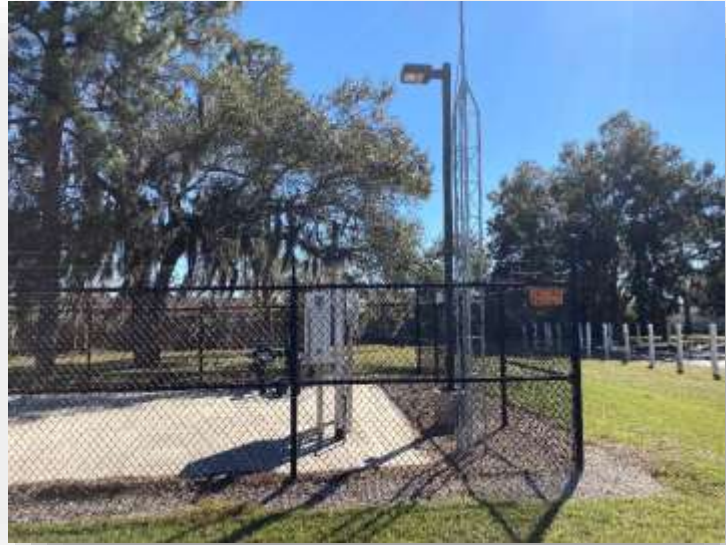
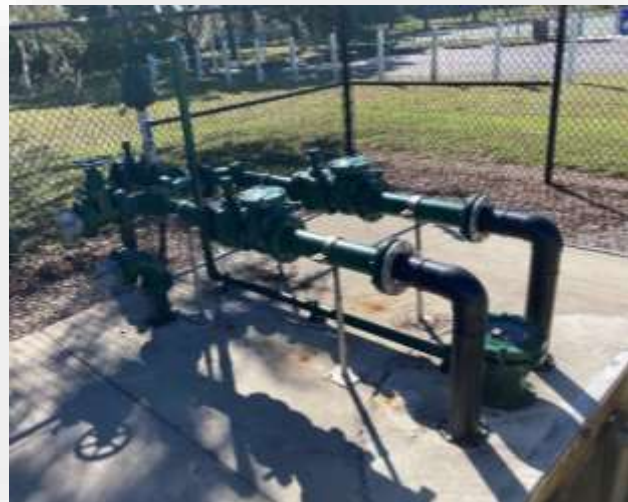
estimated capacity range between 423 and 617 gpm at approximately 29 to 30 feet of head (based on the County's latest drawdown reports that Operations staff had available at the time of the site visit). The wetwell hatches are in good condition and provide adequate access to remove the pumps along the lift station rail retrieval system. The wetwell lining is largely unaffected by hydrogen sulfide. The discharge isolation valves, dedicated pump suction, and emergency discharge connection are all above grade to the south of the wetwell.

- Installed pumps will be running off their performance curve after the RTS and GMLS construction.

- Evaluate updating the pumps to a lower-head pump selection to avoid future run-out conditions.

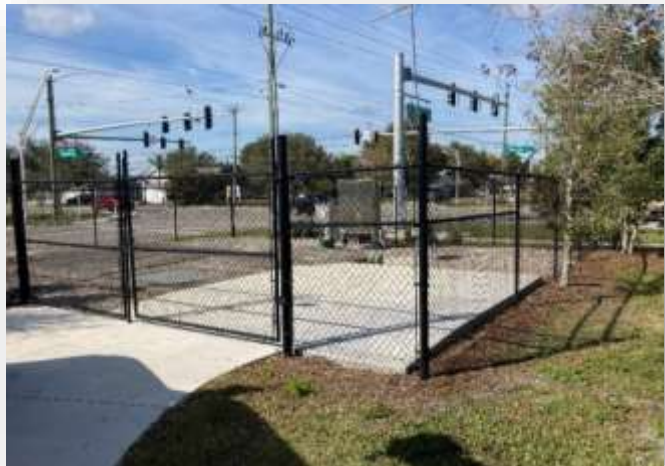
The station contains two 29-HP Flygt Model CP3201 submersible pumps with 454-mm impellers in a 10-foot-diameter, lined concrete wetwell. Each pump has an estimated capacity of 950 gpm at approximately 70 feet of head. The wetwell hatches are in good condition and provide adequate access to remove the pumps on the rail retrieval system. The rails stop a short distance from the top of the wetwell and are composed of two rails welded together that appear to be buckling at the connection point and causing some difficulty when reinstalling the pumps into the wetwell once maintenance or inspection is complete. The wetwell lining is somewhat unaffected by hydrogen sulfide; however, the seams all have signs of seepage and wear including those in the liner and the pipe penetrations. The discharge isolation valves and dedicated-pump discharge connections are below ground in an adjacent valve vault that is locked with a padlock.

- Minor wear of the concrete meter and disconnect switch posts.
- Rusting of the structural metal supporting the disconnect switch posts.
- Installed pumps will be running off their performance curve after the RTS and GMLS construction.
- The pump rails are not continuously even and end before the top of access hatch.
- Some seepage and lining wear around seams and pipe penetrations within the wetwell are apparent.

- Replace concrete control panel posts with County aluminum standard.
- Evaluate updating the pumps to a lower-head pump selection to avoid future run-out conditions.
- Evaluate replacing pump rails with single, continuous rails that reach the access hatch when pumps replaced.
- Evaluate re-lining the wetwell or specifically address the exposed penetrations and seams.

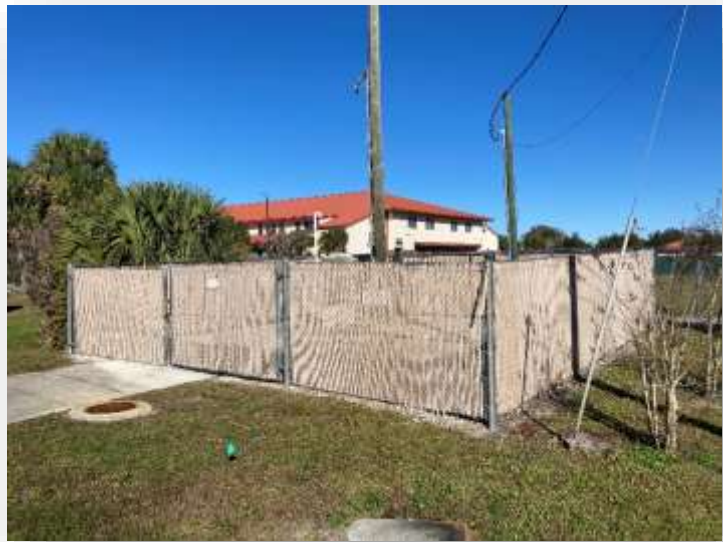
The station contains two 20-HP Flygt Model 3152 submersible pumps with 454-mm impellers in a 6-foot-diameter, 17-foot-8-inch-deep, lined concrete wetwell. The pumps have an estimated capacity range between 264 and 81 gpm at approximately 95 to 100 feet of head (based on the County's latest drawdown reports that Operations staff had available at the time of the site visit). The wetwell lining is largely unaffected by hydrogen sulfide; however, signs of grease and significant odor were noticed at the time of the site visit. The odor had an oil smell to it, and the operators questioned whether it was resulting from the school or a pump seal issue. The wetwell hatches are in good condition and provide adequate access to remove the pumps on the rail retrieval system. The discharge isolation valves and dedicated-pump discharge connections are below ground in an adjacent valve vault that is locked with a padlock.

- Strong odor noticed on site.
- Odor on site had an oil smell to it.
- No surge-protection device appeared to be present.
- No mechanical interlock is present.
- Staff noted that the County plans to reroute this station to the force main feeding LS 139.

- Evaluate odor control or simplistic HIVENT system for the lift station site.
- Evaluate the odor whether it is a pump issue, including if a pump seal might have blown.
- Evaluate implementing a surge-protection device on the main breaker.
- Install a mechanical interlock between the generator breaker and main breaker to return to code conformance.

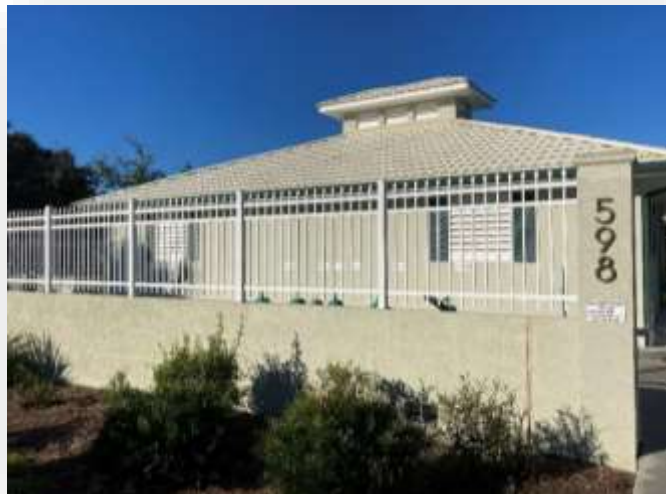
The station contains two 50-HP Cornell centrifugal Model 4514T-VC18DB pumps inside the building. Each pump has a design capacity of 725 gpm at 137.4 feet of head.

A 5,000-gallon Augusta Fiberglass Vacuum Tank in the lower level of the building has a design pressure of 5 psi. Six 15-HP Busch Mink model MM 1502 A VA6 vacuum pumps, each rated at 200 hectopascal (hPa) with a max rate of 600 cubic meters per hour, force flow into the vacuum tank.

- The crane pump on site is not aligned with the valves.
- Some of the valves are vertically below the common discharge line and meter, making them difficult to access with the crane.
- The access for tank maintenance is at the top of the tank without a dedicated access point.
- The overhead door to pull the vacuum pumps is relatively short and has a low ceiling.
- The installed pumps will be running off their performance curve after the RTS and GMLS construction.

- Evaluate modifying the overhead crane with a trolley for lateral movement.
- Evaluate a catwalk or dedicated ladder for accessing the top of the tank for maintenance.
- Evaluate a portable hoist or dedicated overhead crane for easier access to the vacuum pumps.
- Verify the vacuum station site is in accordance with Occupational Safety and Health Administration (OSHA) and County safety and confined-space requirements.
- Evaluate updating the pumps to a lower-head pump selection to avoid future run-out conditions.

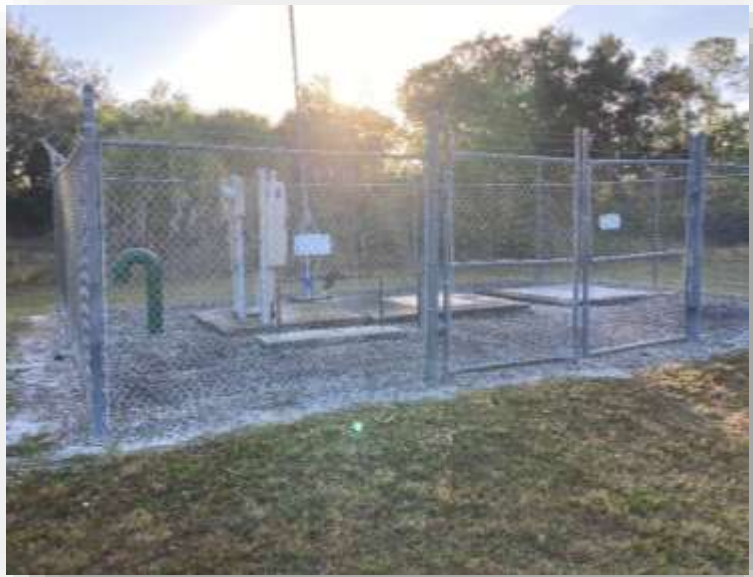
The station contains two 7.5-HP Flygt Model 3127 submersible pumps with 212-mm impellers in a 6-foot-diameter lined concrete wetwell. The pumps have an estimated capacity range between 142 and 178 gpm at approximately 38 to 41 feet of head (based on the County's latest drawdown reports that Operations staff had available at the time of the site visit). The wetwell lining is largely unaffected by hydrogen sulfide; however, significant grease was noticed during the site visit. The wetwell hatches are in good condition and provide adequate access to remove the pumps from the lift station rail retrieval system. The discharge isolation valves and the emergency dedicated pump discharge connections are below ground in an adjacent valve vault. The vault valve vault appeared to be significantly deep.

- Installed pumps will run off their performance curve after the RTS and GMLS construction.
- A small driveway apron is near the road but no driveway connects the station and the lift station, resulting in a grassy area that could become muddy and cause vehicles to get stuck.
- The station experiences short pump run times as current flows are limited due to sparse population in the area.

- Evaluate updating the pumps to a lower-head pump selection to avoid future run-out conditions.
- Evaluate installing additional driveway between the apron at the road and the lift station.
- Evaluate whether a smaller impeller diameter might be worth considering while the flow demands are still low.

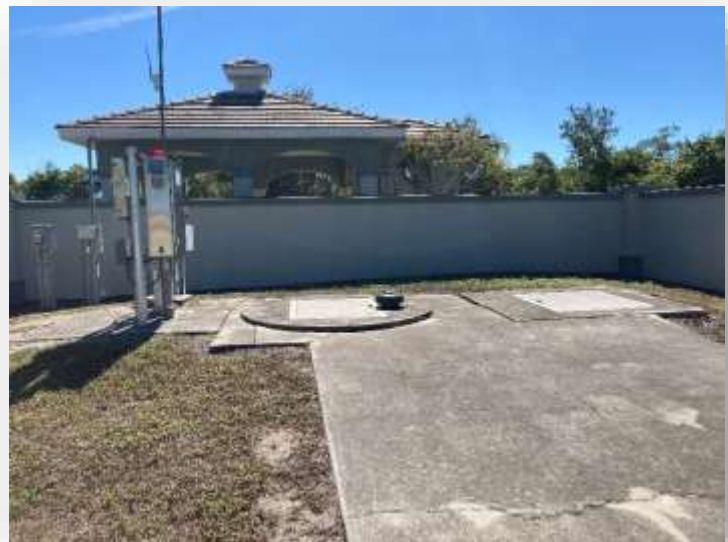
LS 77 contains two 7.5-HP Flygt Model 3127 submersible pumps with 485-mm impellers operated on variable frequency drives in an 6-foot-diameter, 20-foot-deep, lined concrete wetwell. The pumps

have an estimated capacity range between 422 and 493 gpm at approximately 43 to 49 feet of head (based on the County's latest drawdown reports that Operations staff had available at the time of the site visit). The wetwell lining is largely unaffected by hydrogen sulfide, though noticeable grease buildup was apparent, and the wetwell hatches are in good condition and provide adequate access to remove the pumps on the rail retrieval system. The discharge

- Evaluate updating the pumps to higher-head pumps to avoid deadheading after the RTS and GMLS construction.

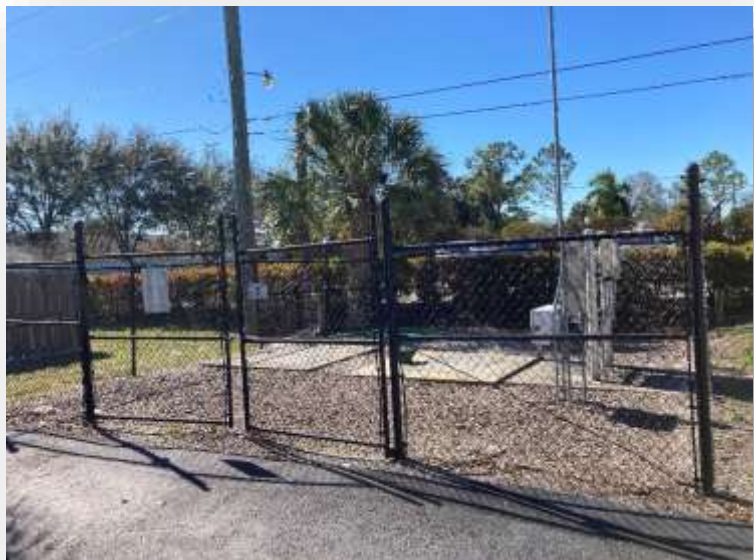
The lift station contains a 5-HP Liberty Pumps Model LGH05 submersible pump with a 6.6-mm impeller and a 12.1-HP ABS Model XFP100E submersible pump with a CB1 impeller in a

6-foot-diameter, 19-foot-3-inch-deep, polymer/plastic wetwell. The pumps have an estimated capacity range between 185 and 211 gpm at approximately 49 to 51 feet of head (based on the County's latest drawdown reports that Operations staff had available at the time of the site visit). The wetwell lining is largely unaffected by hydrogen sulfide. The wetwell hatches

and valve vault hatches are in good condition. The discharge isolation valves are below ground in an adjacent valve vault that is locked with a padlock. The emergency discharge connection is above grade southwest of the wetwell.

- Evaluate updating the pumps to a lower-head pump selection to avoid future run-out conditions.

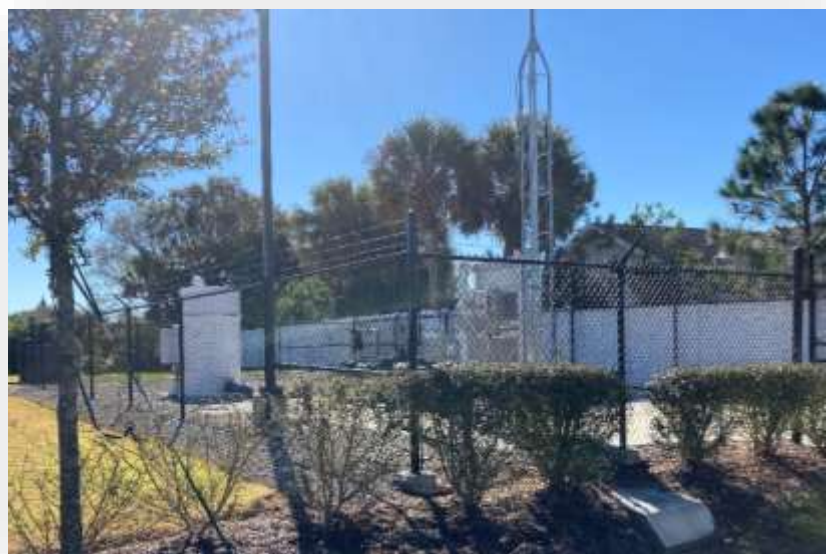
The station contains two 23-HP Flygt Model 3153 submersible pumps with 274-mm impellers in a 10-foot-diameter, 13-foot-3-inch-deep, lined concrete wetwell. The wetwell lining is largely unaffected by hydrogen sulfide. The wetwell hatches are in good condition and provide adequate access to remove the pumps from the lift

station's rail retrieval system. The discharge isolation valves, the emergency dedicated pump suction, and the emergency discharge connection are all above grade southeast of the wetwell.

- Evaluate updating the pumps to a lower-head pump selection to avoid future run-out conditions.

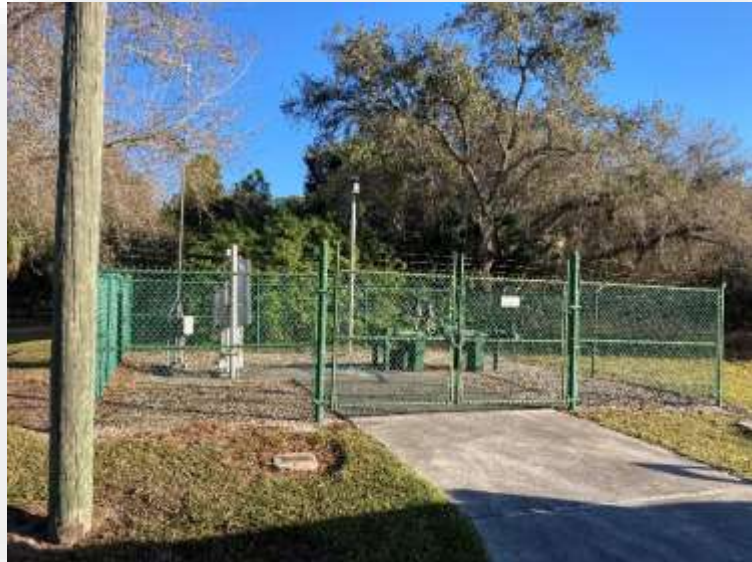
The lift station contains two 23-HP Flygt Model 3152 submersible pumps with 267-mm impellers in a 6-foot-diameter, 11-foot-9-inch-deep, lined concrete wetwell. The pumps have an estimated capacity range of between 212 and 247 gpm at approximately 80 to 84 feet of head (based on the County's latest drawdown reports that Operations staff had available at the time of the site visit). The wetwell lining is largely unaffected by hydrogen sulfide. The wetwell hatches are in good condition and provide adequate access to remove the pumps from the lift station's rail retrieval system. The discharge isolation valves, dedicated pump suction, and the emergency discharge connection are above grade to the east of the wetwell.

- Evaluate updating the pumps to a lower head pump selection to avoid future run-out conditions.

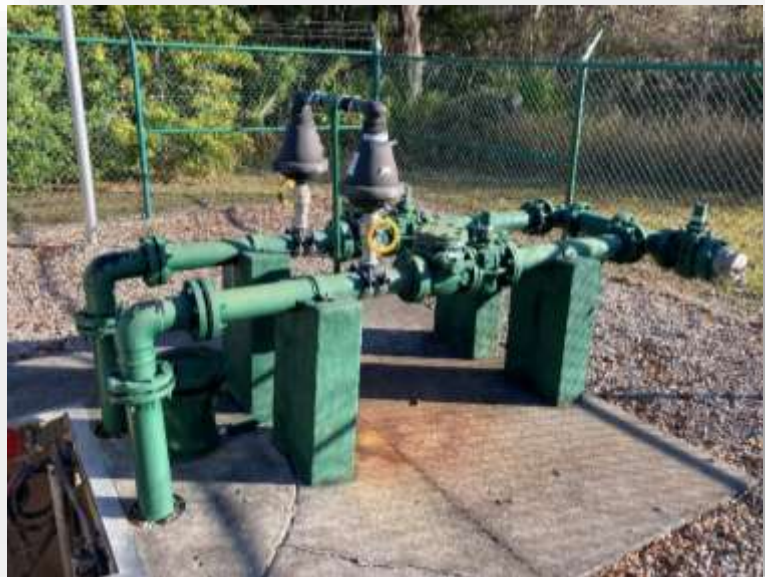
The station is fenced and does not have dedicated site lighting. No odor control is provided on site, but the wetwell has a screened vent. The power service to the station is 240-volt, three-phase. Neither a transformer nor meter were visible in the vicinity; operators suspect that power may come from the adjacent fire station. The station has a SCADA system with a telemetry transmitter/receiver. The control panel has seal-offs and is equipped with a portable generator receptacle with a mechanical interlock between the main breaker and generator breaker.
