Charlotte County Utilities Department

2020 Annual Report
March 2021

Prepared by
JonesEdmunds

2020 ANNUAL REPORT

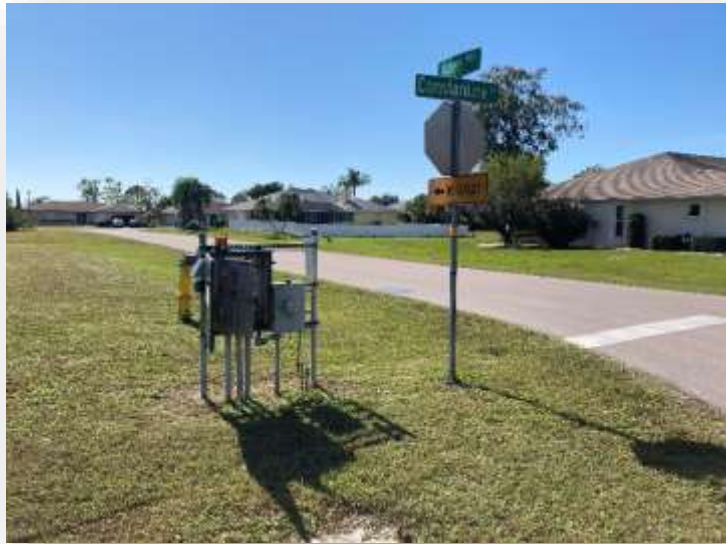
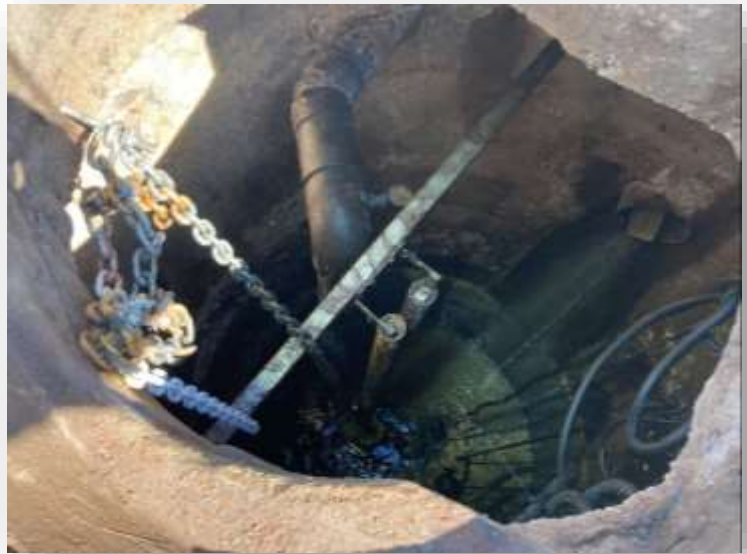
LS 303 contains a single 3-HP Flygt Model 3085 submersible pump with a 436-mm cutter impeller. The pump is installed in a 6-foot-diameter, lined concrete wetwell.

The wetwell lining is largely unaffected by hydrogen sulfide but does show some signs of corrosion. The wetwell has an older conical lid design that can obstruct access during maintenance events. The wetwell manhole opening is in good condition. Although guiderails appear to have been included in this station, they end some distance below the manholed conical lid, which may present some difficulty removing and resetting the pumps. The station does not have discharge isolation valves, an emergency dedicated pump suction connection, nor an emergency discharge connection.

The site is not fenced, does not have dedicated site lighting, and has no odor-control or wetwell venting. The power service to the station is 240-volt, single-phase and is serviced through underground electric. The station has an Omni-Beacon telemetry system. The control panel does not have seal offs, but is equipped with a portable generator receptacle. No mechanical interlock is provided between the main breaker and generator breaker. The control panel uses an inverter to allow a three-phase generator hookup for the portable generator quick connection. No hose bibb is provided on site for washdown.

The wetwell is in the center of the road intersection, which requires Operations staff to manage traffic during routine maintenance and any pump removal. The County owns the adjacent lot southeast of the intersection. The design to move the lift station into the lot and the existing wetwell converted to a master manhole has been completed. The new design includes isolation valves and bypass piping, which currently do not exist at this simplex station.

- No interlock between the generator breaker and the main breaker.
- Missing seal-offs from the control panel conduit.
- Difficult-to-access wetwell.
- No isolation valves.

- Install seal-offs and interlocks on electrical equipment and perform a detailed electrical code review to return to conformance with code.
- Evaluate the installation of a secondary standby pump.
- Prepare for construction of improved design noted by Operations staff.

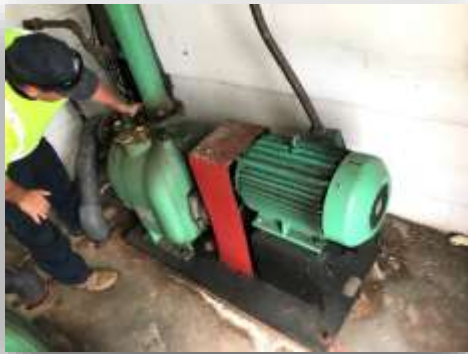
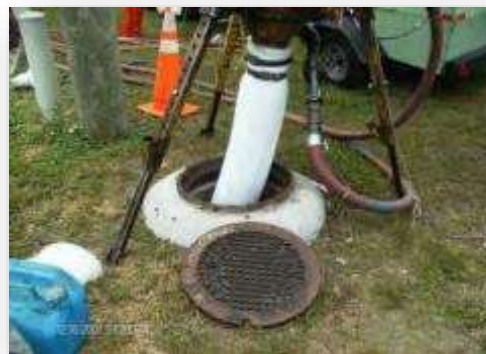
The average age of the CCU gravity system is nearly 50 years. Older sewers were typically installed in swales, which made them more prone to I/I. Also, design and construction standards were not as stringent as the current practices. Pipe material and joints were constructed with material that deteriorates with time. The older gravity sewer pipes are vitrified clay with frequent joints that are sources of infiltration. Vitrified clay pipe is resistant

to corrosion but is more brittle than PVC and HDPE pipe. After many years of service, cracks develop and pieces of the clay pipe protrude into the flow stream. Although CCU has relatively few plugged sewers, the broken clay pipe will cause blockage and must be repaired.

CCU Wastewater Collections staff performs in-place pipe repairs to fix most of the broken pipes in the system. Most of these repairs involve a cast-in-place lining, fold-and-form lining, or PVC lining. These repair methods restore the integrity of the sewer system without requiring excavation.

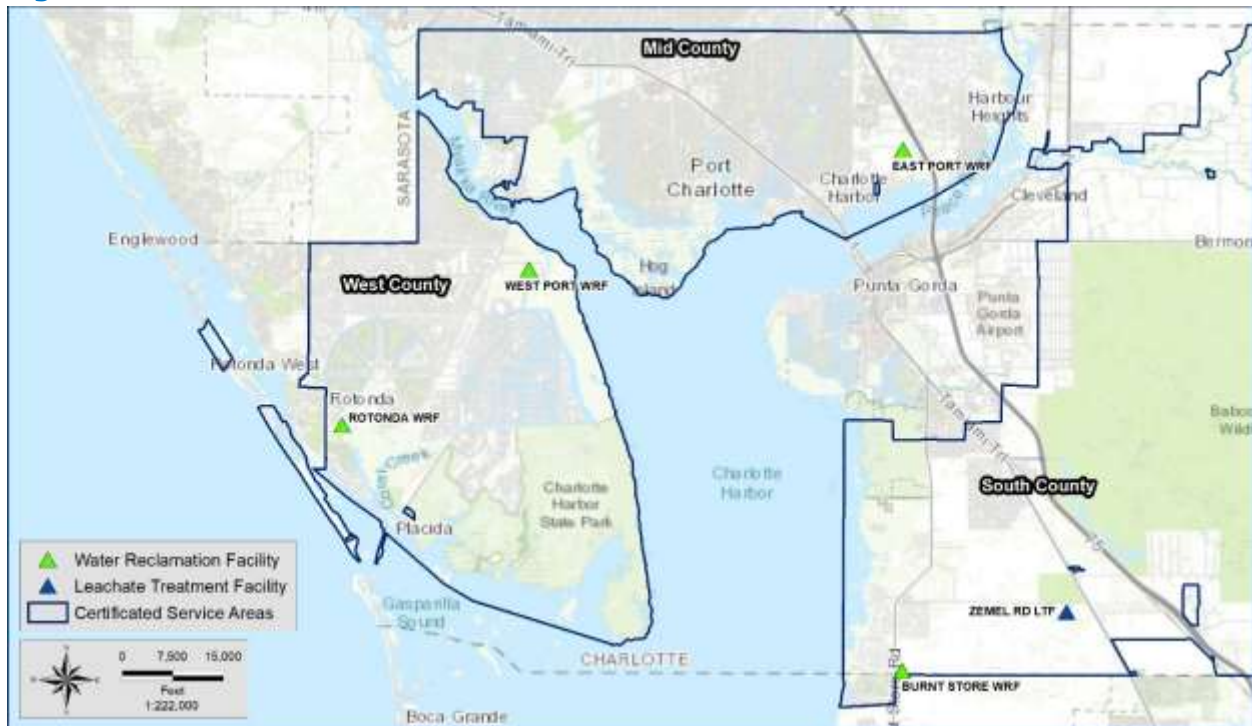
Figure 6-1 CCU Wastewater Treatment Facilities

CCU owns and operates four WRFs throughout Charlotte County and one leachate treatment facility (LTF) for the County landfill as shown in Figure 6-1. The East Port WRF serves Mid County, the West Port and Rotonda WRFs serve the West County service area, and the Burnt Store WRF serves the South County service area. Each WRF is unique in its design and treatment approach, so each facility needs to be evaluated independently. Table 6-1 shows that the WRFs are designed and permitted to treat a specific volume of wastewater expressed on an AADF basis.

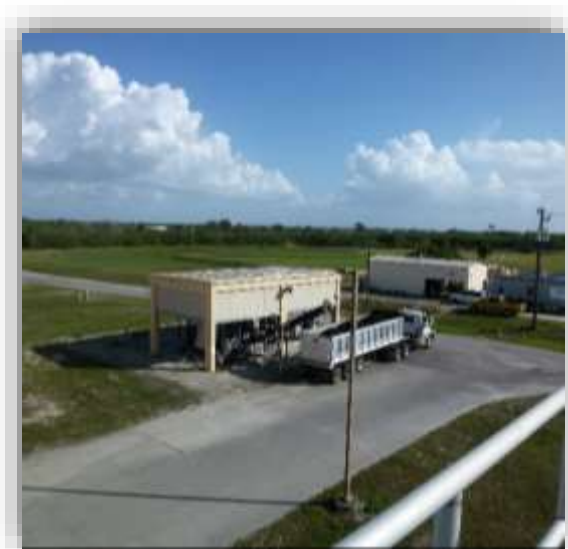
CCU is proud of the Waste Receiving Program, which provides an environmentally safe disposal option for septic waste, reducing land application and environmental impacts. Located at the East Port WRF, the septage receiving station (SRS) combines the hauled waste with plant influent to achieve reclaimed water-quality effluent and beneficial reuse of biosolids. Once on site, septage haulers enter a code to activate the SRS and then another code to identify their hauled septage as either In-County or Out-of-County septage for billing purposes.

through Friday, which allows CCU staff to monitor operations. This approach prolongs the life of the equipment by ensuring compliance with disposal requirements and eliminating mixed loads that damage equipment. In FY 2019, the program accepted 7,670,994 gallons from 41 permitted haulers.

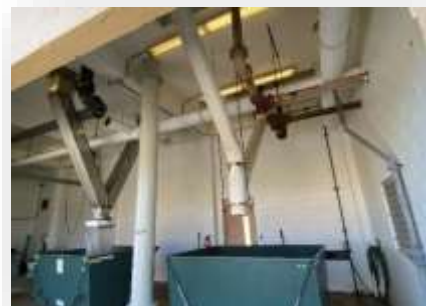
The overall condition of the headworks is good. The adjacent old grease dewatering building is now demolished, and the piping from the new GMLS and Interceptor is ready to be connected to the existing headworks. The screening and grit bagging system that was attached to the chutes that discharge into the dumpsters has significantly reduced the water on the floor, flies, and odors that usually accompany headworks' dumpster areas. The floor is clean and dry.

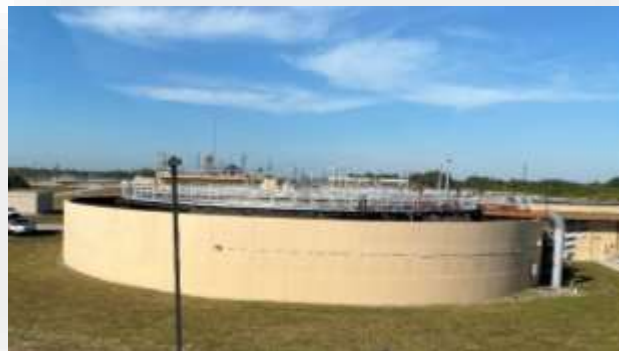
The East Port WRF currently does not have flow EQ storage for peak-hour influent flows and loads. However, the 1.48-MG cast-in-place concrete tank that was the old aerobic digester is being modified and retrofitted to provide an influent EQ Tank for the 9-MGD plant expansion design.

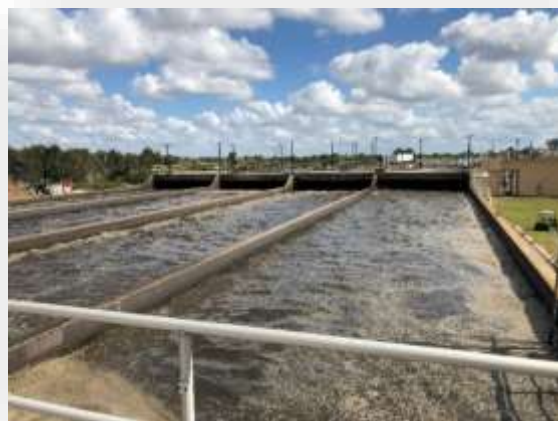
The overall condition and operation of the MLE process is good following the Stage 1 and 2 Improvements in 2016. Four VFD-controlled surface aerators are in operation in the oxidation ditches. The aerator speed is adjusted based on the dissolved oxygen (DO) probe at the end of the ditches. The aerators are well maintained. The DO-control system helps the WRF lower its power consumption and improve the denitrification process by minimizing DO carry-over to the anoxic zone. Six VFD-controlled IR pumps were replaced in the Stage 1 and 2 Improvements. These pumps are controlled by the SCADA based on operators' settings. The IR pumps are well maintained and in good working order.

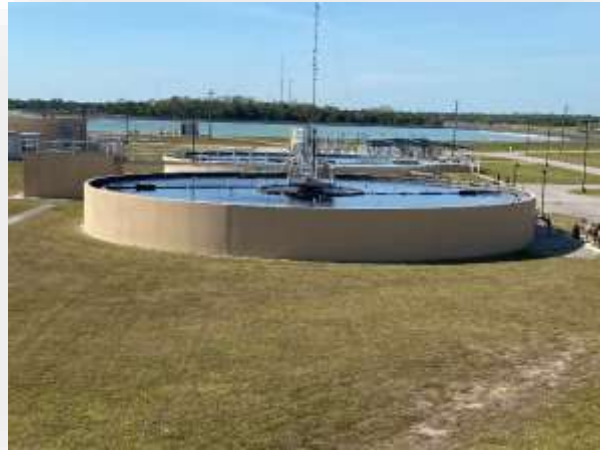
In 2016 the two clarifiers were rehabilitated as part of the Stage 1 and 2 upgrades, which included replacement of the clarifier scraper mechanisms. The overall condition of the sedimentation process is well maintained and clean, and the clarifiers are producing a high-quality effluent. The five RAS pumps are VFD controlled. The two WAS pumps are controlled by operators' settings in the SCADA system. Both pumping systems are well maintained and in good working order.

The existing scum ejectors will be replaced with a cost-effective scum-pumping system as part of future plant expansion to 9 MGD.

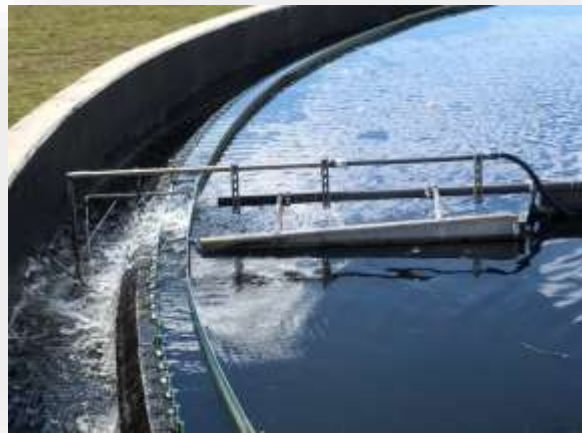
A "weir washer" system was installed on Clarifier No. 1 and Clarifier No. 2 in 2017 and 2018, respectively. The weir washers eliminate the need to have O&M staff enter the clarifier effluent launders to remove algae, eliminating associated safety concerns. The weir washers do an excellent job keeping the clarifier effluent weirs and troughs clean. An excellent-quality effluent is being produced by both clarifiers.

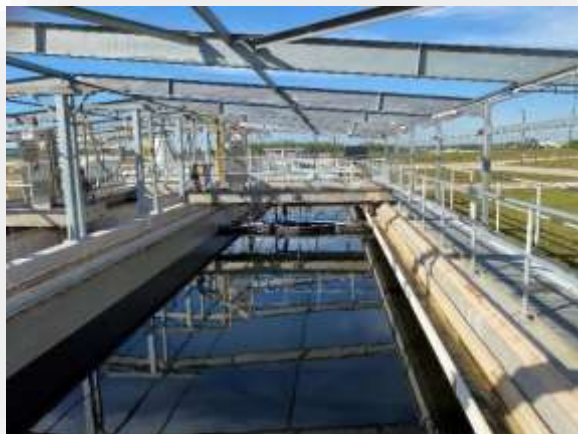
The overall condition of the effluent filtration system is excellent and well maintained. Filters were rehabilitated as part of the Stage 1 and 2 Improvements. The two-traveling bridge sand/anthracite filters were in operation at the time of the site visit. Turbidity results indicate that the filters are producing an excellent effluent for unrestricted public-access reuse water. A galvanized metal frame was installed over the filters in the Stage 1 and 2 Improvements to support a fabric roof constructed of UV shade cloth. However, the cloth rips in the wind and will be replaced with roof panels bolted to the galvanized frame for the 9-MGD expansion.

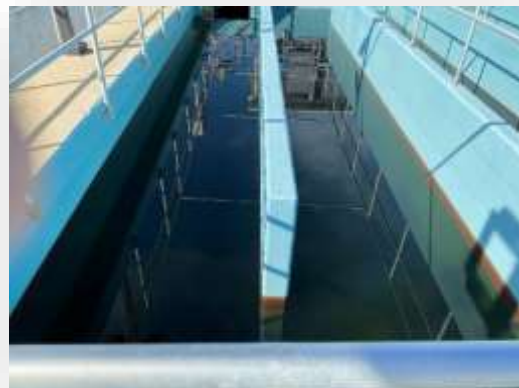
The CCCs are in good condition, well maintained, and operated to produce reclaimed water for unrestricted public-access reuse. CCC No. 1 was recently painted to improve high-level disinfection. Liquid Sodium Hypochlorite (12.5 percent) is stored in a 6,000-gallon dual-containment tank and is used for disinfection to maintain a residual of ≥ 1.0 mg/L to meet unrestricted public-access reuse standards. In 2018, the old liquid reagent chlorine residual analyzer was replaced with a non-reagent analyzer to control chlorine feed rates. Another non-reagent analyzer is used for chlorine residual compliance measurement. The new skid-mounted chlorine feed system is encased in a clear plastic enclosure to control the spray of liquid chlorine for safety purposes. The overall chemical feed systems and instrumentation are well operated and maintained to meet regulatory permit requirements. The effluent flow and monitoring locations (EFA-01 and EFA-02) are clearly marked, and the refrigerated effluent composite samplers are in good operating condition.

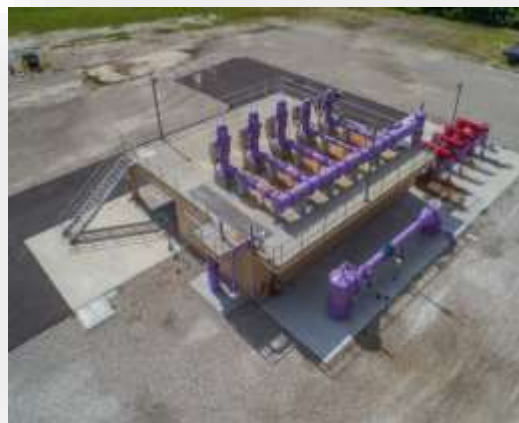
Effluent that meets reclaimed water standards from the East Port WRF is conveyed to CCU's Master Reuse System (discussed in Chapter 7) using the reclaimed water HSPSs. The East Port WRF has two reclaimed water HSPS. The reclaimed water HSPS No. 1 has three VFD-controlled 100-HP vertical turbine pumps that pump reclaimed water from the clearwell adjacent to CCC No. 1 into the WRF plant water system. The reclaimed water service pumps are well maintained and operated. The VFD controls allow the pumps to operate at high speeds to meet distribution system demand and at low speeds to provide non-potable water on site for O&M purposes.

The reclaimed water HSPS No. 2 has five VFD-controlled pumps, can pump 9.0 MGD at 108 psi, and was completed in 2019 as part of the Stage 5 Improvements. The system includes four 120-micron self-cleaning filters manufactured by ORIVAL and was submitted as a value-engineering substitution. The units are currently bypassed due to failure in fall 2020. The bypass around these filters is not impacting reclaimed water quality to end users.

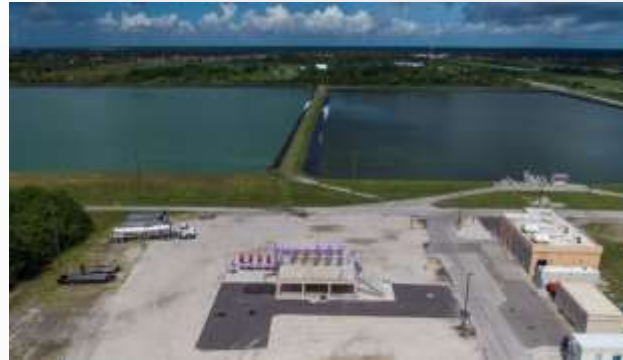
Excess reclaimed water or effluent not meeting reclaimed water standards (reject water) is disposed of through two deep injection wells and a restricted-access, on-site slow-rate irrigation system (on-site sprayfield). Effluent transfer pumps are well maintained but are showing signs that they need to be repainted. CCU also contains a 45-MG lined effluent storage pond which is used to store effluent before injection well and/or sprayfield disposal and also serves as additional wet weather storage. The 45-MG pond liner is in good condition.

The irrigation pump station is on the east bank of the 45-MG pond and pumps water from the pond to the deep injection wells or the sprayfield. Both deep injection wells are well maintained and in good working order. All valves are exercised regularly. All associated meters are calibrated semi-annually and are up to date.

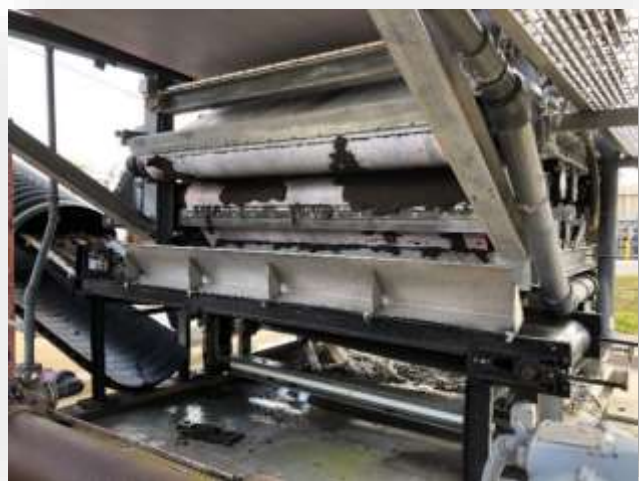
The overall condition of the biosolids storage/digestion tanks, associated piping, truck off-loading facilities, decant supernatant pumping, and BFP feed pumps at the new biosolids handling and storage tanks constructed under the Stage 1 and 2 Improvements are good. The facilities receive waste biosolids from East Port and the three other CCU WRFs and are well maintained and operated. CCU has two tankers used for hauling liquid sludge from the other WRFs and off-loading into the aerobic sludge-holding tanks before dewatering.

The Lead Operator noted the capacity of the aerobic digesters and the BFP to handle biosolids from all four facilities is starting to become an issue where sufficient time to allow tank decanting is limited due to the increased sludge flows. In addition, when a BFP is down for

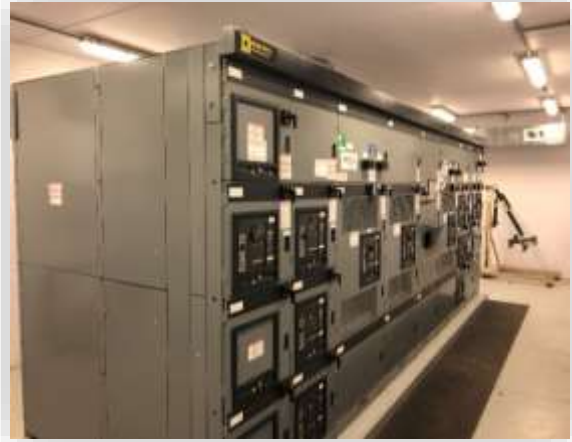
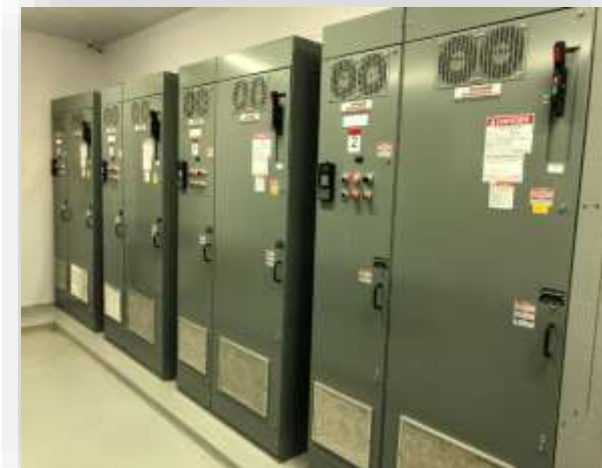
The East Port WRF contains one 1,250-kW generator serving the primary WRF as standby power. An additional 1,500-kW generator was installed as part of the Stage 5 Reclaimed Water Improvements. One standby generator serving the Administration building was relocated from another facility in used condition. The facility has five primary electrical switchgear locations – the Administration building, the generator/MCC building, the new primary incoming switchgear building, the new electrical building #2, and the blower building. The Administration building has a separate service drop from the power company. The rest of the WRF is served through two new parallel transformers serving the incoming switchgear building recently constructed. The Administration building, the incoming switchgear building, and electrical building #2 were all constructed within the last 8 years. The generator/MCC building had upgrades and improvements to existing original equipment and generators. The blower building has been in service for several years.

The incoming service and distribution transformers at the Administration building are relatively new and in excellent condition with no obvious signs of concern. The standby generator functions properly and is in good condition. Since it was relocated from another location, it does show signs of wear and deterioration but with no major issues to interfere with its function. The distribution switchgear of the Administration building was in excellent condition with minor issues (see below). Overall, the electrical equipment is in good functioning condition based on information from Operations staff.

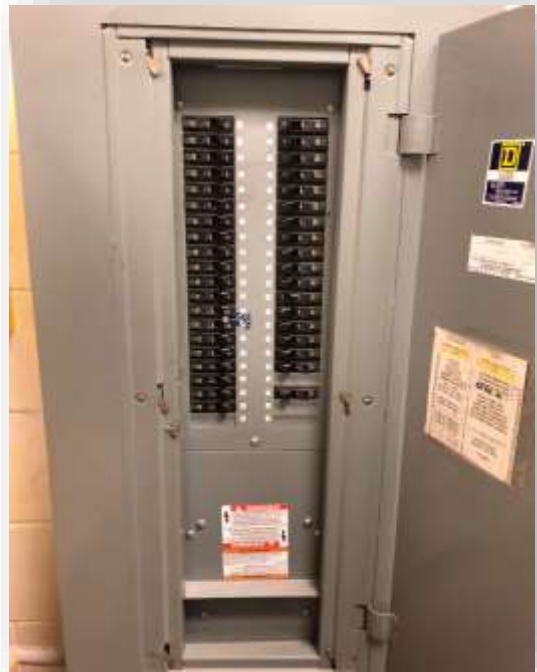
The following briefly lists minor issues at other locations throughout the plant. None of these constitute a significant issue but are documented here for reference and for future action. Most of them do represent minor NEC violations:

- Headworks – Several conduits were broken or damaged and need to be replaced or repaired.
- Blower Building – Most of the equipment is new and not yet in service as part of another ongoing project upgrading the system. However, legacy equipment will need to be removed.

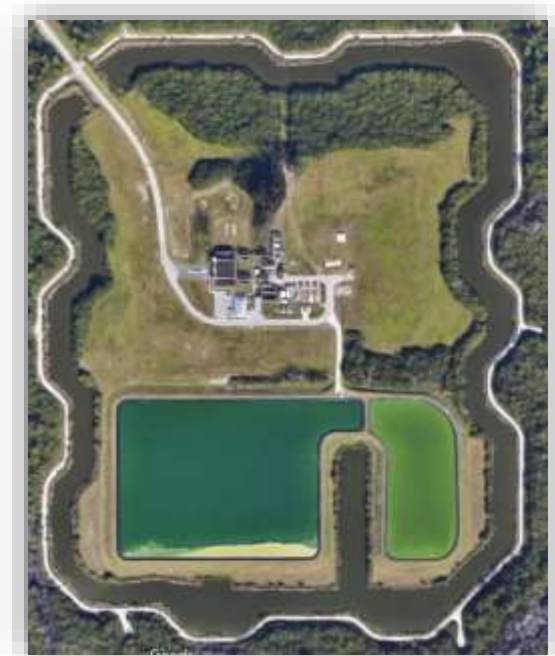
Figure 6-3 West Port WRF Process Flow Diagram

The West Port WRF is in the Gulf Cove area of West Charlotte County at 15005 Cattle Dock Point Road, Port Charlotte, Florida. This WRF was upgraded in 2005 and has a current permitted capacity of 1.20 MGD AADF. The West Port WRF uses an activated sludge process to treat domestic wastewater collected from part of the West County service area. The West Port WRF is permitted to distribute reclaimed-quality water to unrestricted public-access reuse sites and inject into a deep well injection system. Two diesel-powered emergency generators with ATSS provide standby power to the WRF. Figure 6-3 shows the West Port WRF process flow diagram.

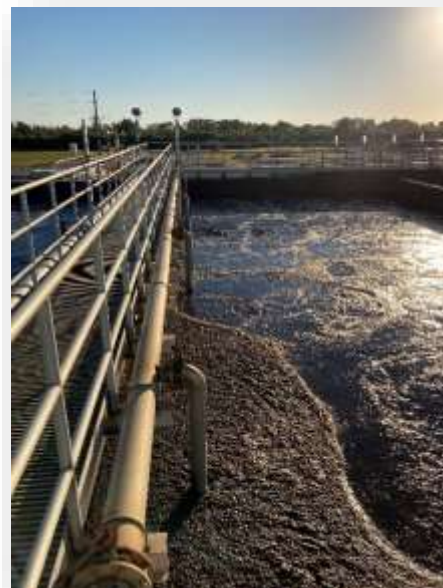
7.0. A timer is used to turn the blower on and off throughout the day. Using pH for operational control is not the most practical method for treating wastewater; an alternate control method including DO and oxygen reduction potential (ORP) should be evaluated. The outlet weirs of the aeration tanks require manual cleaning when debris catches on the weirs. The steel supports of the walkway over the aeration tank effluent splitter box were touched up with paint in FY 2017, and the aeration tanks were repainted in 2018.

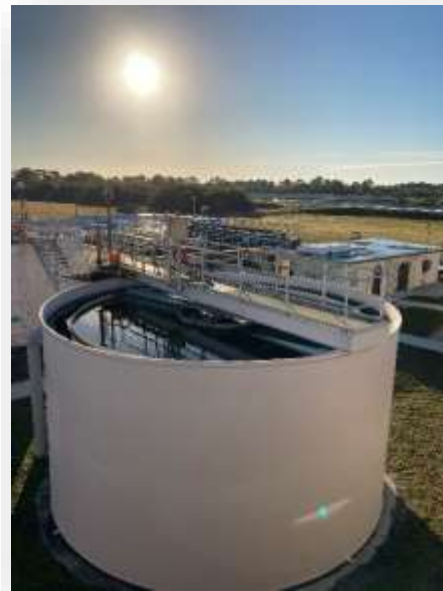
Overflow weirs are hosed daily and brushed weekly to keep them clean. The overflow weirs were leveled in FY 2017. At the time of the site visit, the effluent launder/overflow weir on Clarifier No. 4 appeared unlevelled as the skimmer arm was not contacting the water surface while operating. The Chief Operator stated that the effluent launder/overflow weir will be adjusted and leveled. If the skimmer arm still does not contact the water surface, the rubber on the skimmer can be replaced with longer pieces. New weirs were installed in Clarifier No. 1 and Clarifier No. 2 in 2018. Clarifier No. 3 and Clarifier No. 4 received new weirs in FY 2020 and FY 2021, respectively.

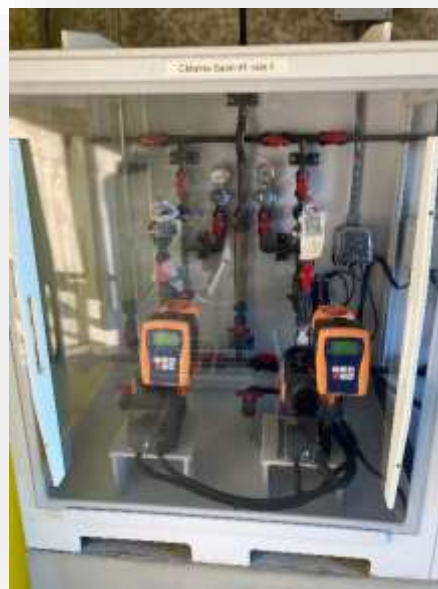
In June 2017, a new chlorine feed system with two chemical feed pumps for each CCC and new storage tanks was installed in a new chlorine storage and feed area between the two CCC structures. This will enable two parallel CCCs to operate when peak hourly flows exceed 955 gpm. The new dosing pumps have double-containment protection.

The CCC effluent is monitored by the effluent composite water quality sampler (EFA-01). The overall condition of the effluent monitoring, storage, and disposal system is good.

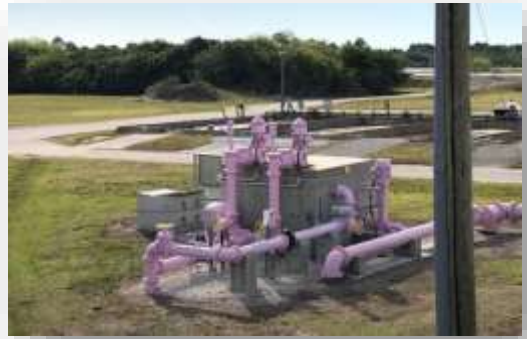
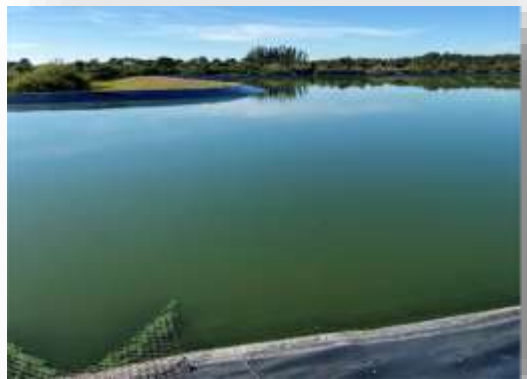
The West Port WRF reclaimed water pump station feeds part of the Master Reuse System that interconnects with the Rotonda WRF and the East Port WRF reclaimed water systems. The station contains two reclaimed water HSPs and one jockey pump. The Chief Operator noted that the pump shafts of this pump station are fairly worn and will need to be rebuilt or replaced by FY 2022. Jones Edmunds recommends an inspection of these pumps by the manufacturer to determine the extent of the work required. This provides flexibility to serve existing and future reclaimed water customers. The main customer for the reclaimed water produced at the West Port WRF is the Coral Creek Golf Club Golf Course, which receives reclaimed water through a 7-mile-long, 10-inch-diameter main constructed by the golf course owners. Chapter 7 provides additional information about the Master Reuse System.

The West Port WRF has two lined reclaimed water storage ponds – one 5 MG and one 15 MG. The stored water can be pumped to the reclaimed water distribution system or the deep injection well. The reclaimed water ponds were full at the time of the inspection, and effluent was diverted for deep well injection disposal. The ponds had some algae growth at the time of inspection. The Chief Operator reported that they plan to add some fine bubble diffusers to the pond in the future.

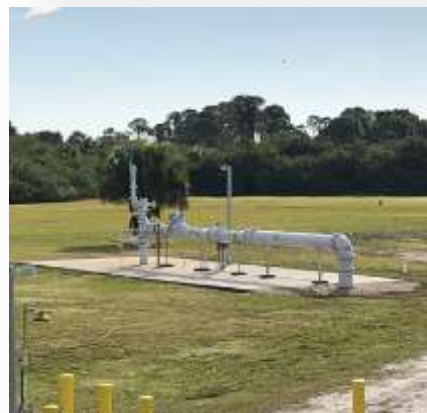
Effluent that does not meet public-access reclaimed water standards is conveyed to a clearwell for disposal via a deep injection well. Three new deep-well pumps are used to convey effluent through a 16-inch manifold pipe into the deep well. All compliance monitoring equipment and pumps were fully functioning and in good condition at the time of the inspection.

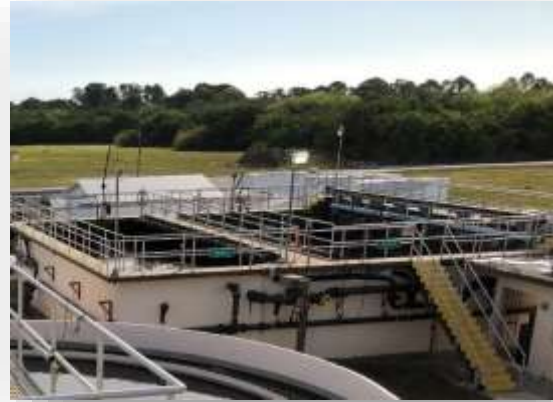
The sludge produced as a byproduct of treatment is pumped to aerobic sludge-holding tanks and then gravity thickened at the West Port WRF before being truck hauled in liquid form to the East Port WRF for sludge dewatering and final disposal at the compost facility. The overall condition of the sludge-holding tanks is good, but the aerobic sludge-holding tank volume is too small and prevents proper decant thickening, resulting in a decant thickened sludge of 1-percent TS or less. Additional sludge-holding tank volume and decant thickening capabilities should be provided to allow a thickened sludge of 1.5- to 2.0-percent TS, which will reduce the sludge-hauling volume by 50 to 100 percent and reduce hauling costs. CCU is evaluating the feasibility of adding more biosolids-handling capacity at the West Port WRF to handle biosolids generated at the West Port and Rotonda WRFs.

Sludge is transferred between tanks and loaded onto tanker trucks by a sludge-transfer pump. Valve changes determine where sludge is directed. The liquid sludge load-out pump was replaced in 2017. The WRF has four emergency sludge-drying beds.

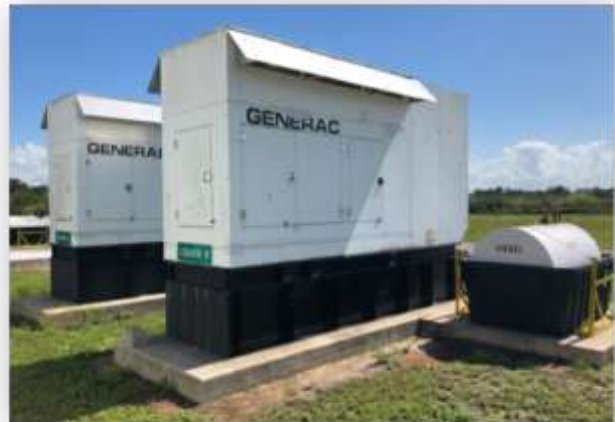
The incoming switchgear and distribution transformer appear in good condition with no obvious signs of significant concern. The incoming power via overhead aerial is new and was installed within the past couple of years. The WRF is served from two 400-kVA generators connected in parallel that are fed from a subbase tank and an auxiliary tank adjacent to them. A new 6,000-gallon fuel tank and pad for the generators was installed in 2020. Overall, the electrical equipment is in good functioning condition based on information from the Operations staff, except for the deficiencies listed below.

Thermography scanning of the equipment showed no anomalies.

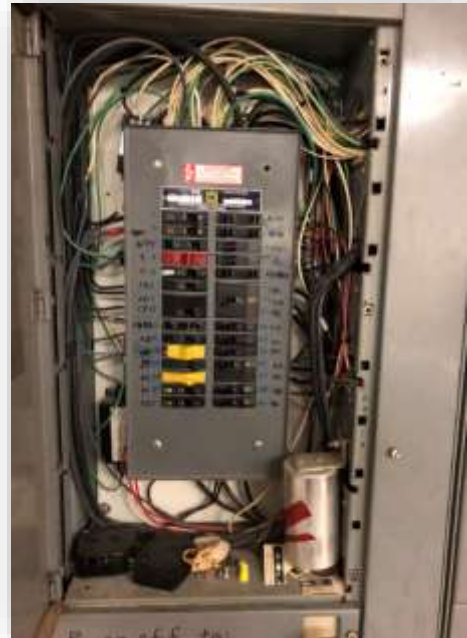
- A power distribution panel within the plant's MCC is missing a protective cover. Access in the panel to activate a breaker could potentially expose personnel to live conductors (see photograph).

- County Staff reported that the existing blowers at the West Port WRF do not operate properly when running under the generator. Staff has been able to successfully operate the blowers using a specific procedure, but this should not be necessary if the electrical equipment were properly functioning as designed.
- Other minor issues include damaged or missing conduit in the headworks and the deep well. Clarifier No. 4 is also missing some conduit components that need to be replaced. A conduit of the pumping building has a hose rack and hose bib attached to it that has pulled the conduit away from the electrical box. These all represent minor NEC violations.

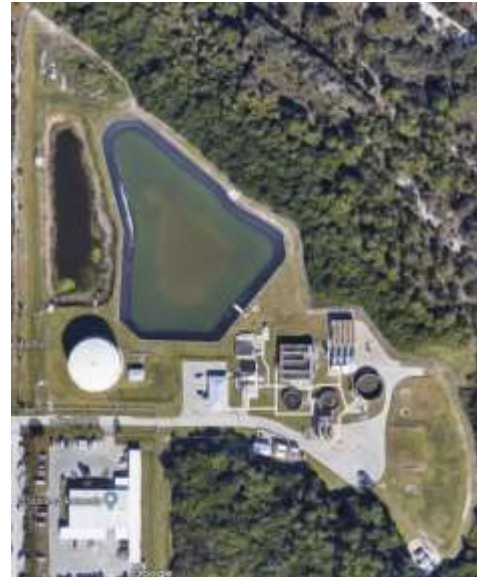
Figure 6-4 Rotonda WRF Process Flow Diagram

Effluent can be distributed as reclaimed water to the unrestricted-public-access master reuse system or transferred to West Port for injection into a deep well injection system. Figure 6-4 shows the Rotonda WRF process flow diagram. Two diesel-powered emergency generators in an on-site building have ATSS for providing emergency power to the WRF.

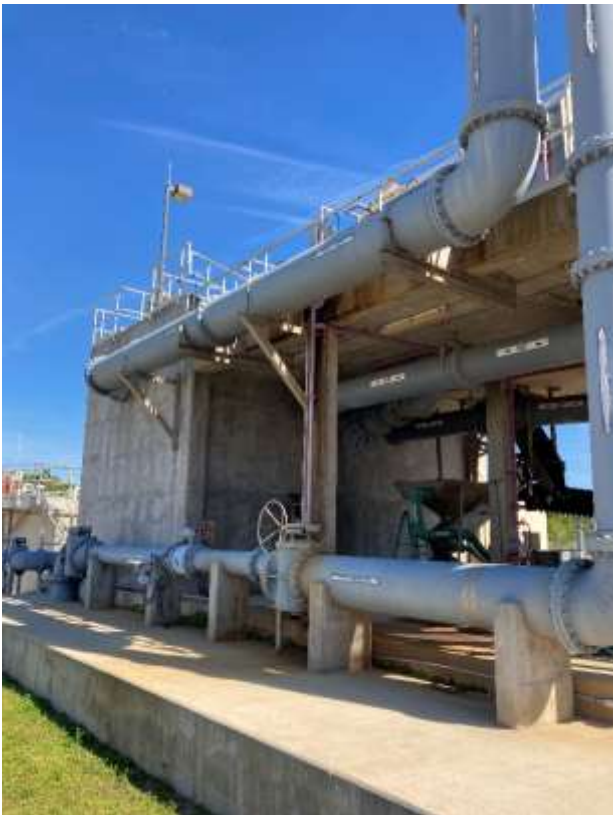
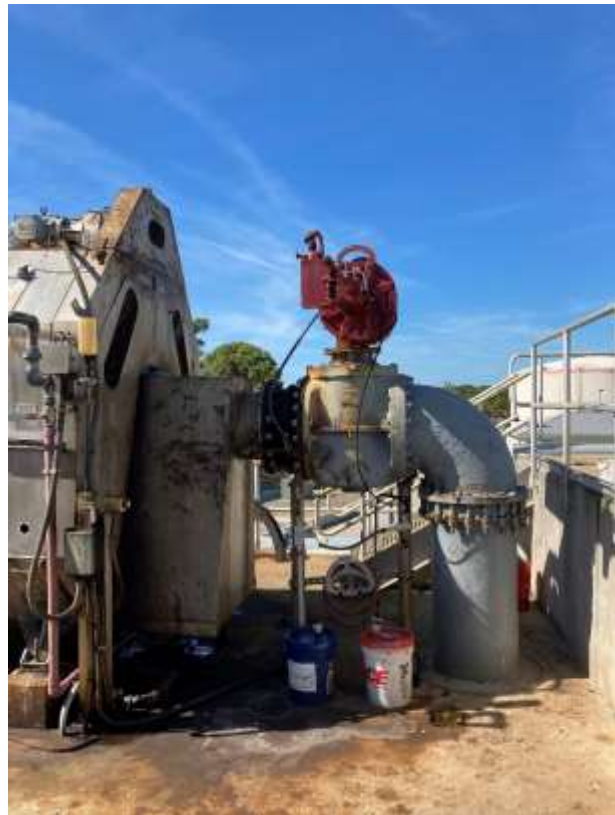
The influent water quality sampling location (INF-01) and flow monitoring (FLW-01) locations are clearly marked, and the refrigerated influent composite sampler and flow meter are in good operating condition. The two main influent valves to the headworks screens are inoperable and were scheduled to be replaced in 2019. However, this was deferred to FY 2021 to allow the facility to procure the equipment necessary to isolate the drum screens. An actuator was added to Screen No. 1 in FY 2019.

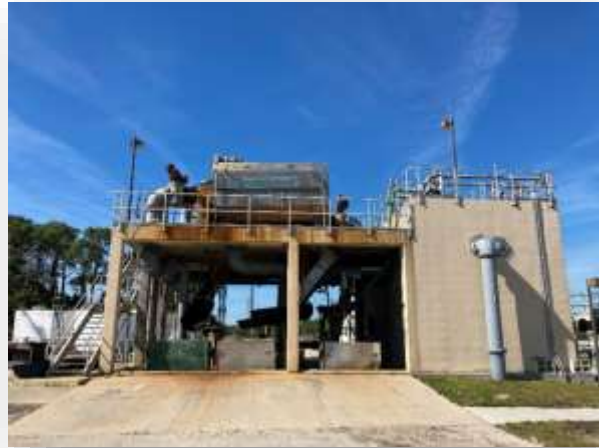
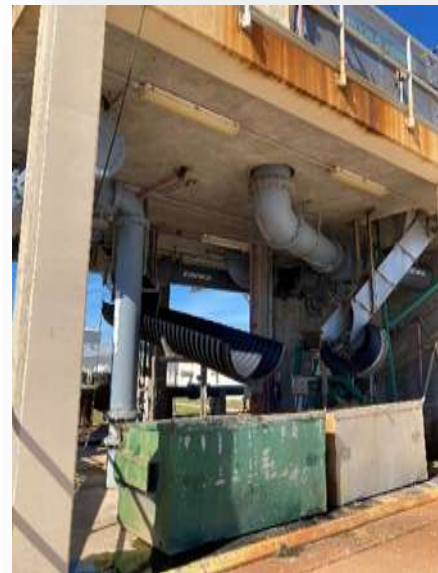
The grit removal process operates as intended. The organic wastewater component of the pumped mixture is returned to the wetwells. The separated grit passes to a grit "snail" washer before being deposited into a dumpster bag. The grit "snail" washer includes a conveyor belt that allows the grit to shed water as it proceeds to the dumpster. The grit "snail" washer produces a dry grit that is deposited into a plastic grit bag. In 2017, Grit Pump No. 2 was replaced, and the cyclones were scheduled for replacement in FY 2020, which was not completed at the time of the inspection so these should be replaced in FY 2021.

The screenings and grit dumpsters are emptied once per week. The dumpster area is clean and free of odors. The screening Screw Conveyor/Compactor No. 1 and grit dewatering units are operating as intended. The screening screw conveyor/compactors have been removed and drop chutes have been installed in their place.

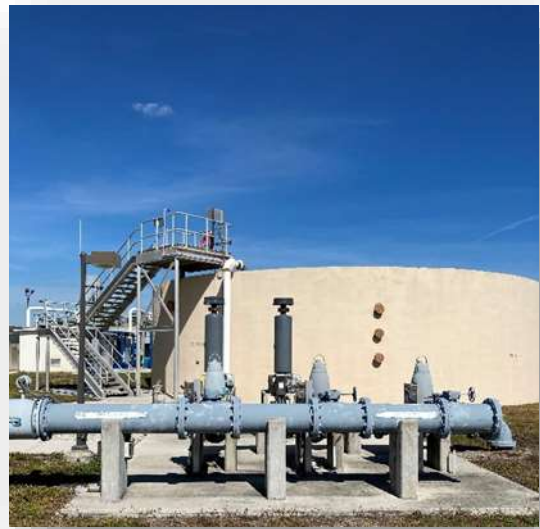
The overall condition of the 0.3-MG EQ tank is good. The EQ tank, which attenuates high hourly flows, is filled through a gravity system initiated by an overflow weir at the headworks structure. The EQ tank contents are returned to the headworks for treatment at a steady flow over 24 hours using VFD pumps. This has proven to be a valuable asset to the operation of the facility. The Chief Operator noted that Lift Station No. 801 sends 1,500 gpm to the Rotonda WRF for about 20 minutes and then turns off for 20 to 30 minutes. The operation of the EQ tank has been adjusted to respond to the intermittent discharge from Lift Station No. 801. Dry-pit submersible pumps are used to return EQ tank contents to the treatment stream. The EQ tank positive displacement blowers are run intermittently to save power. Oil sight glasses and fill ports were added by CCU to improve maintenance. The EQ tank was painted in FY 2019.

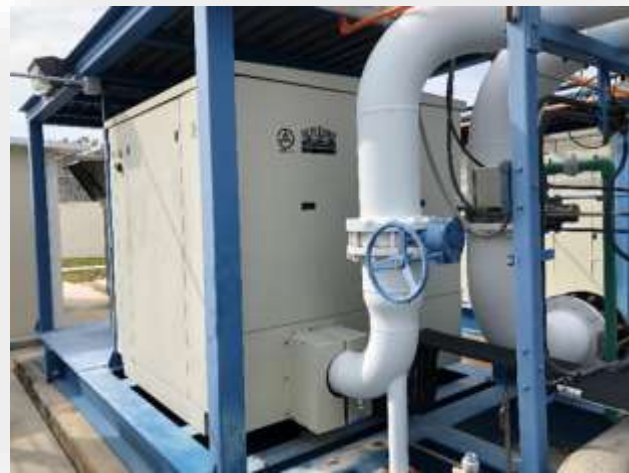
The four MBR blowers and the four permeate pumps were running and in good condition with some of the components requiring repainting.

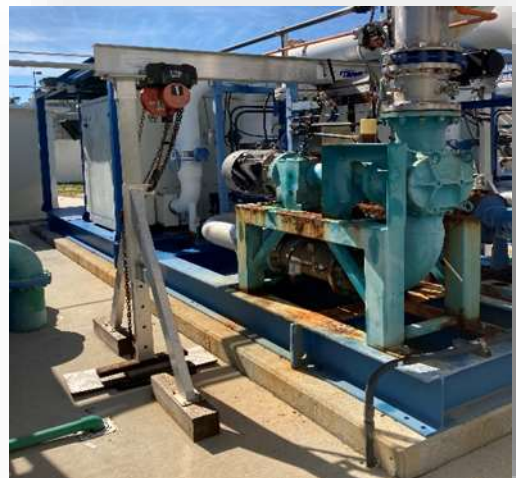
In 2017, three mixed-liquor volatile suspended solids (MLVSS) return/recycle pump motors were replaced and are in good working order. The frame on the MLVSS Return/Recycle Pump No. 2 was being rehabilitated at the time of the visit, and the frame and skid floor will be repainted in FY 2021 when completed.

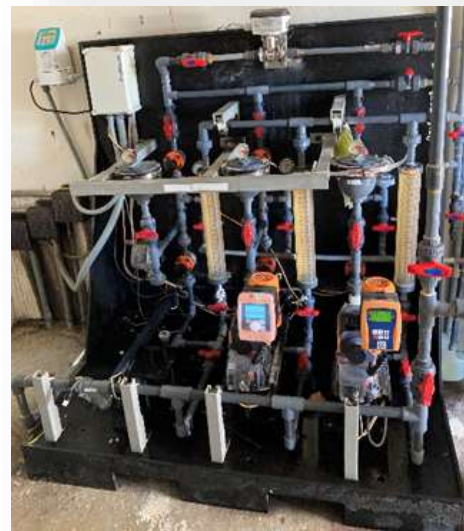
Replacement of Chlorine Storage Tank No. 3 began in 2017 and finished in 2018. Leaks were noted around chlorine pipe fittings due to the continuous exposure to sunlight. The other storage tanks are still in place with two new tanks and secondary containment on site ready for replacement at the time of the inspection.

Progress:	Completed.
Recommendation:	Add an MBR cassette to existing trains as capacity needs dictate.
Progress:	Cassettes are being monitored to determine a replacement schedule.
Recommendation:	Add galvanized metal frame and UV shade cloth to CCC 2.
Progress:	Ongoing.
Recommendation:	Replace hypochlorite Feed Pump No. 3.
Progress:	Completed.
Recommendation:	Add protection to chlorine storage tanks and piping from direct sunlight.
Progress:	Completed.

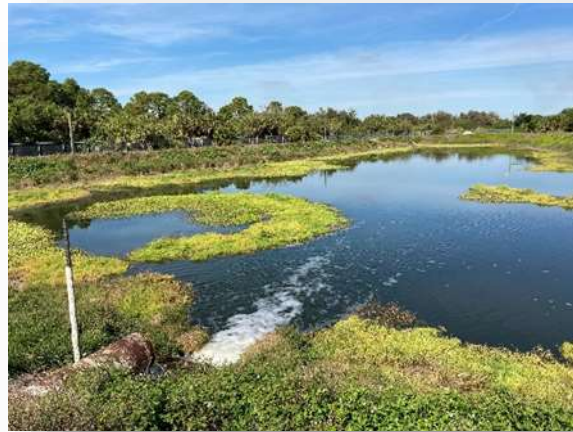
Reclaimed water quality effluent can also be stored in the Rotonda WRF on-site 3.0-MG GST and unlined reclaimed water storage pond. The GST was drained and cleaned in 2017. Reclaimed water from the GST can be pumped to pressurized reuse customers using HSPS No. 2. The unlined reclaimed water storage pond has a reduced capacity of approximately 50 percent due to high percolation into the ground because the pond is unlined. In 2018, the Rotonda WRF Chief Operator expressed concerns about the condition of part of the berm around one of the pond walls. Jones Edmunds is evaluating this pond and will make recommendations as part of the 2021 Reclaimed Water Master Plan.

Recommendation:	Add a small winch to each decant pump in the sludge-holding tanks for better control of the pump level.
Progress:	Ongoing.
Recommendation:	Remove vegetation, clean, reinforce the berm, and evaluate lining the reclaimed water storage pond to increase storage capacity.
Progress:	Ongoing.
Recommendation:	Evaluate different aeration systems for the reclaimed water storage pond.
Progress:	Not Started.
Recommendation:	Clean the reject storage pond.
Progress:	Ongoing.
Recommendation:	Complete installation of reclaimed water pipe to the Cape Haze Golf Course and Placida Corridor.
Progress:	Ongoing.
Recommendation:	Evaluate ASR for additional reclaimed water storage.
Progress:	Not started.
Recommendation:	Improve the operation of the generators, primarily Generator No. 2.
Progress:	Completed.
Recommendation:	Perform a load study to identify any issues related to power quality, quantity, and capacity of the system. The load study would help identify deficiencies in the system, identify reserve capacities, and assess potential anomalies that may affect long-term operation.

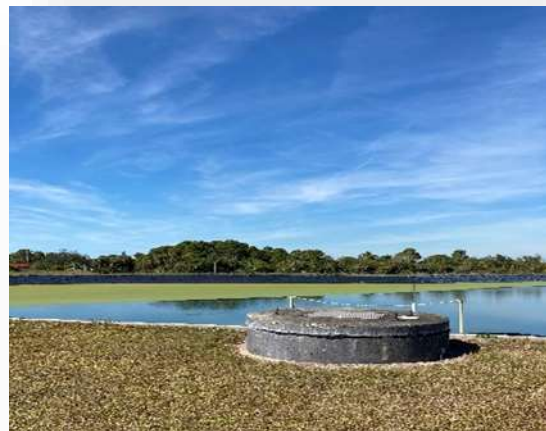
As mentioned previously, the Rotonda WRF provided reclaimed water to the Master Reuse System. This also allows for excess reclaimed-quality effluent to be sent to West Port's reclaimed water storage ponds or deep injection well (capacity 4.75 MGD) for final disposal. The Rotonda WRF also contains an on-site lined reject pond has a storage capacity of 5.182 MG. Water diverted to this pond does not meet reclaimed water standards and must be retreated through the WRF. A small pumping station pumps reject water back to the headworks. The pond is scheduled to be cleaned of algae in FY 2022.

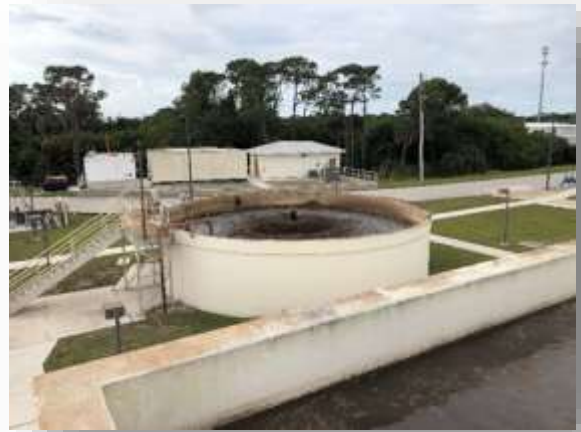
The overall condition of the solids-handling facilities is good. The decant mechanism for the sludge-holding tanks was designed as telescoping valves, but the telescoping valves can only be lowered to one-half the depth of the tank. The operators have replaced the designed method of decanting by using bottom-feed submersible pumps suspended on ropes. A small winch should be added to each pump site for better control of the pump level. The Chief Operator does not see this as a high priority because decanting is done only two or three times per month. Sludge load-out pumps were operating properly. They were repainted in FY 2019.

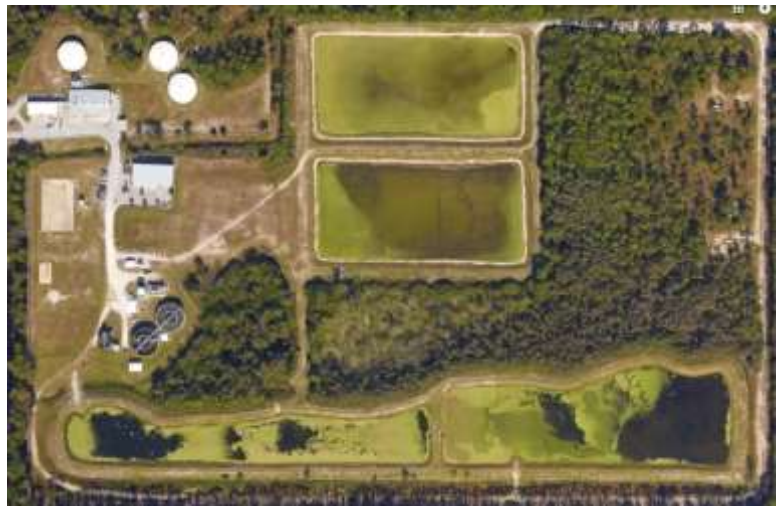
The Burnt Store WRF was acquired December 12, 2003, when CCU purchased Florida Water Services' Burnt Store Division. Located in southwest Charlotte County on Burnt Store Road, the WRF serves south Charlotte County along Burnt Store Road and 2 square miles of residential golf course/marina in Lee County. The WRF shares the site with the Burnt Store RO WTP.

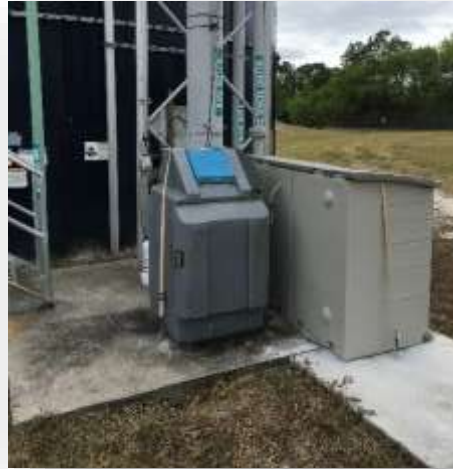
The influent water quality sampling location (INF-01) is clearly marked, and the refrigerated influent composite sampler is in good operating condition. The influent flow monitoring location (FLW-01) is clearly marked, and the flow meter is in good operating condition.

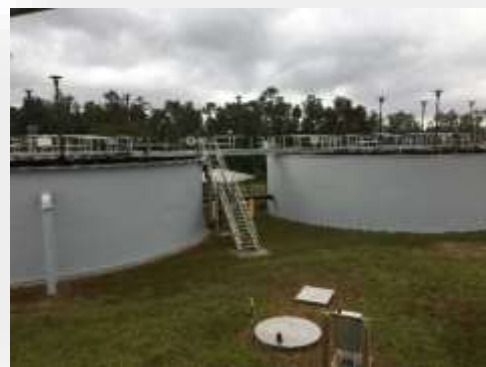
The activated-sludge facilities are steel-ring package plants consisting of two aeration tanks and two secondary clarifiers. At the time of the site visit, the aeration basins appeared to have adequate air distribution throughout the tank. All blowers were rebuilt in 2017. The operation of the blowers is based on timers, but no DO sensors are provided to adjust blower operation. The hinged sluice gates separating the two aeration tanks are not functioning as intended, allowing wastewater to flow to the adjacent tank during maintenance. The tanks have minimum free-board (<1 foot), creating concerns of overflowing during high-flow conditions or if a downstream flow obstruction occurs.

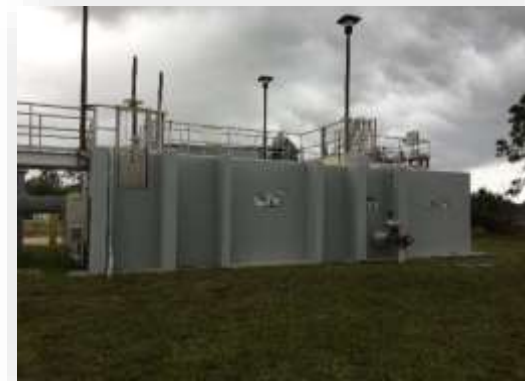
The effluent filtration system is a cloth-media disk filter with 5-micron cloths, housed in a painted carbon-steel tank and controlled by a series of backwash actuators. The backwash actuators were replaced in 2019 and are in excellent condition. The operator indicated that the filter is producing a good-quality effluent but backwashes frequently during periods of high flow, which can cause overflows to the CCC. However, the overall condition of the filtration system is good though it is not sized to meet future flow conditions.

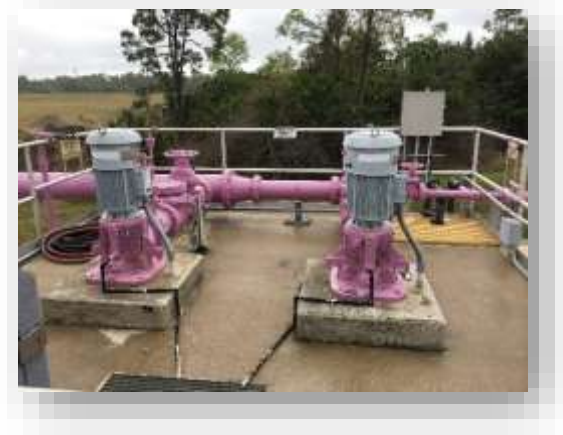
The Burnt Store WRF reuse facilities include a reclaimed water pump station and clearwell, which are in overall good condition. The reclaimed water pump station is located above the clearwell following the CCCs. Two HSPs and two booster pumps are used to convey up to 0.5 MGD AADF of reclaimed water to customers. The booster pumps are currently used to satisfy demand in the reuse system, but the two large HSPs are working properly and are tested regularly. The reclaimed water HSPs and jockey pumps are well maintained and show no signs of deterioration. Flow to the

reclaimed water pump station is monitored by an ultrasonic flow meter and primary weir device, which became obsolete when the WRF began transferring flow to the deep injection well system. A new flow meter is needed to monitor the pump discharge line and measure reclaimed water flow. In addition, no on-site reclaimed water storage is available, which will require future major reclaimed water users to be served through direct distribution to the user's reclaimed water holding facility or require storage to be added on site. These limitations will be addressed in the design of the Burnt Store WRF expansion project. Chapter 7 provides additional information about the Burnt Store Reuse System.

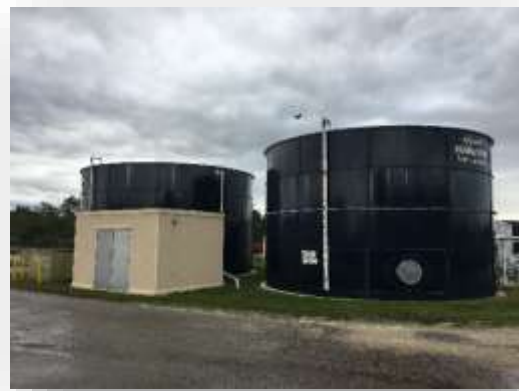
The influent pumps convey leachate into the 125,000-gallon influent holding tank and through the influent plant flow meter to record the daily influent leachate volumes. A high-level sensor automatically shuts-off the pump in the No. 1 Pump Station to prevent overflowing of the raw leachate tanks. At the time of the site visit, the influent holding tank had some panels that need to be replaced and were scheduled for replacement in early 2021.

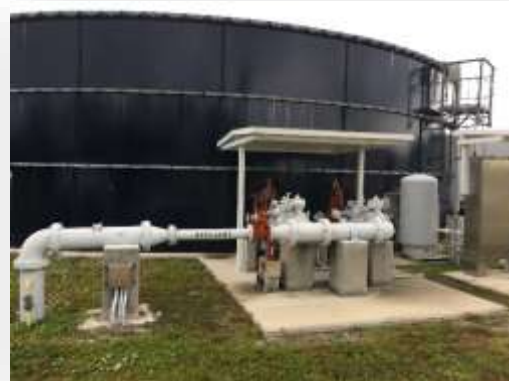
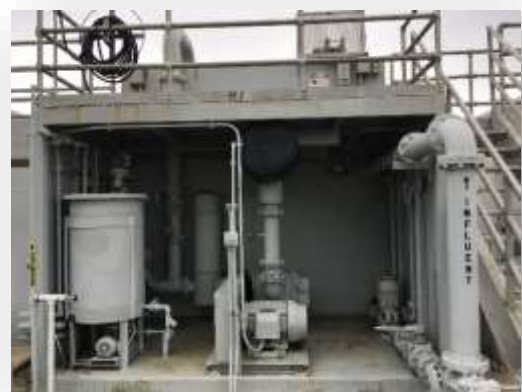
The three PACT units are in good-to-poor condition. The tanks' exteriors and interiors are in good condition since they were partially

painted in FY 2017 and completed in FY 2018. Surfaces were pressure washed and rust and lost paint were removed and primed before painting was completed. The polymer feed systems and blower air intakes for the treatment trains should be replaced.
