Charlotte County Utilities Department

2020 Annual Report
March 2021

Prepared by
JonesEdmunds

2020 ANNUAL REPORT

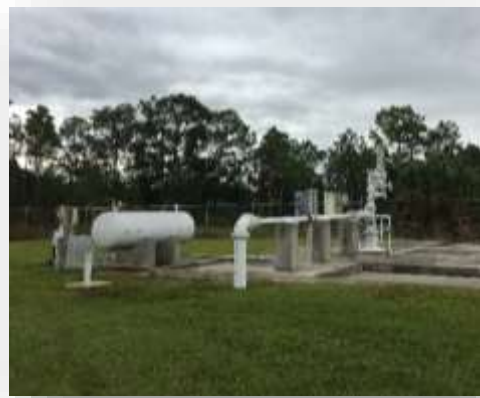
The effluent storage and disposal systems are in fair condition and are properly maintained to meet the facility needs. The effluent storage tank has minor degradation toward the top of the tank that needs to be repaired but remains operable. The existing 12-HP pumps were installed by CCU personnel in 2015. The pumps are operating satisfactorily and not overheating on hot summer days.

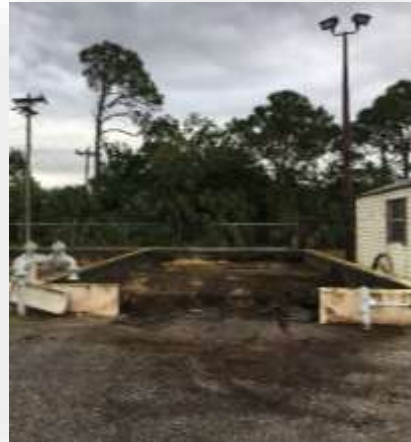
The LTF has a sludge digestion tank that historically was used for solids handling but is no longer in operation. Today, waste solids (mixed carbon and biological waste sludge) are conveyed directly from the PACT tanks and allowed to dry through evaporation. The LTF contains eight 725-square-foot (approximately 5,800 square feet total) sludge drying beds. A Bobcat loader is used for sludge removal for maximum maneuverability within the sludge drying beds. Grit is removed from the batch process tanks, as necessary, and dried with biosolids. The Bobcat removes and dumps dried solids into a dumpster that is hauled to the landfill for use as cover on the landfill. The sludge drying beds are well maintained and sufficient drying bed area for dewatering of solids.

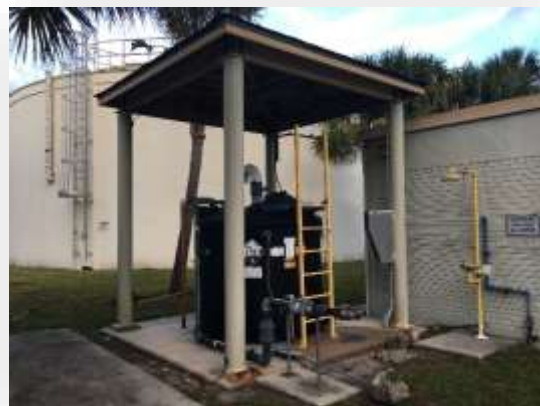
The Eagle Street RWBS, constructed in 2008, is approximately 5 miles west of the East Port WRF along the 16-inch reclaimed water transmission main. The station is within a fenced area in a residential neighborhood near Tamiami Trail and contains two concrete buildings and a 0.5-MG concrete GST. The GST is equipped with a level sensor to regulate volume and a check valve to allow reclaimed water to bypass the station.

The RWBS contains one 125-HP HSP and one 60-HP jockey pump. The HSP has a capacity of 1,440 gpm at 206 feet and 90 psi total dynamic head (TDH) but is currently set at 82 psi. The jockey pump capacity is 577 gpm at 206 feet (90 psi) TDH. Each pump is controlled by a VFD to maintain system pressure for instantaneous customer use. The pumps are housed in a concrete building along with unused chemical feed pumps. An inline filter is downstream of the HSPs, but is currently in bypass mode.

The electrical room equipment, pump room equipment, and tank were found in good condition. The piping was painted purple and clearly marked. The grounds require constant maintenance, which is provided by a private contractor.

is evaluating removing the chemical injection system, including chemical feed pumps and bulk storage tank, at the station.

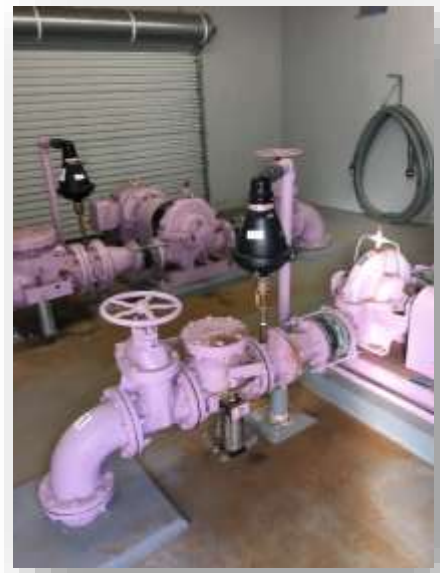
Pump operations, flow, and pressure are monitored 24 hours per day through a SCADA telemetry system. The PLC and electrical control center are housed in a separate air-conditioned building. Similar to the Eagle Street RWBS, operators can add sodium hypochlorite to the reclaimed water before and after the GST, but the chemical feed system is no longer required since operational changes have improved the chlorine residuals in the distribution system.

The Walenda station is available for pumping and storage but currently operates in an as-needed mode by CCU staff based on system demands. The hydraulic modeling for the reclaimed water system indicates that the Walenda station will be an essential component for meeting the future reclaimed water demands.

The electrical room equipment, pump room equipment, and tank are in good condition. The piping was painted purple and is clearly marked. Removal of the on-site chlorine injection system is being evaluated. The grounds are well maintained.

- The tank was inspected in FY 2018 and minor screen damage was repaired.

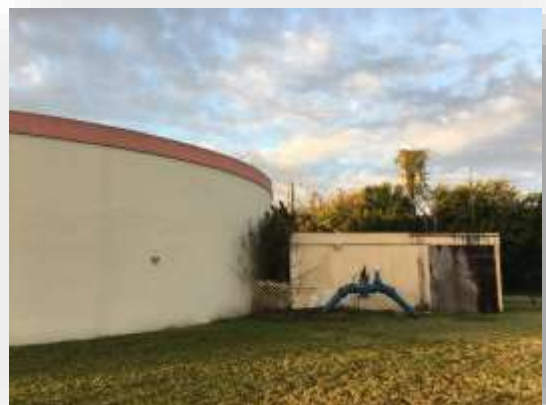
7.1.1.3 Gertrude RWBS

The Gertrude site is at 21131 Gertrude Avenue, Port Charlotte, approximately 4.6 miles northwest of the East Port WRF. The station was originally used for the potable water system but was decommissioned in 2008. CCU is currently rehabilitating the site for use as a RWBS. The site currently consists of a 0.5-MG GST and 600-square-foot concrete building. The GST was previously cleaned and lined in 2004. The addition of the station will increase the resilience of the Master Reuse System, provide operational flexibility, and provide pressure and reclaimed water storage in the surrounding area.

Two HSPs within the building will need to be evaluated and possibly replaced before placing the facility in operation. The electrical components will need to be upgraded including a new RTU and piping reconfigured to tie into the Master Reuse System. The integrity of the structures should be assessed including the roof of the building, which is in poor condition.

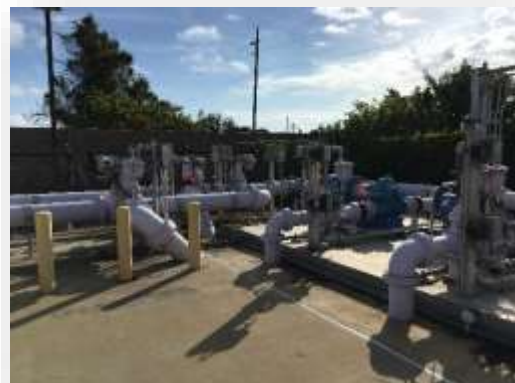
7.1.1.4 Rotonda Blvd East RWBS

The Rotonda Blvd East RWBS is on Rotonda Boulevard East just west of CR 771. The station was completed in FY 2014 and is an in-line RWBS that does not contain a GST. An architectural wall and chain link fence shield the station from the highway, and access gates are kept locked. The RWBS contains one 100-HP high-head HSP and two 40-HP low-head HSPs, each equipped with VFDs. The high-head pump has a capacity of 972 gpm at 200 feet TDH. The low-head pumps have a capacity of 1,045 gpm at 85 feet TDH. Pump operations, flow, and pressure can be monitored 24 hours per day through a SCADA telemetry system. The PLC and electrical control center are housed under a covered area. The station is currently not used; however, it will be necessary as the County's reclaimed water demands continue to increase in West County.

This is a complex pump station with multiple operational configurations. The RWBS was configured to allow operation in multiple modes, which include pumping from Mid County to West County, pumping from Rotonda WRF to West Port WRF, or pumping from West Port WRF to the West County customers. CCU staff are evaluating the hydraulics of this station to improve the operational configurations and settings for the RWBS.

The physical condition of the RWBS was excellent except for HSP No. 2, which was out of service, and minor pipe painting that is scheduled for FY 2021.
