Septic-to-Sewer Program Water Quality Review

October 29, 2019

North Shore – pilot project

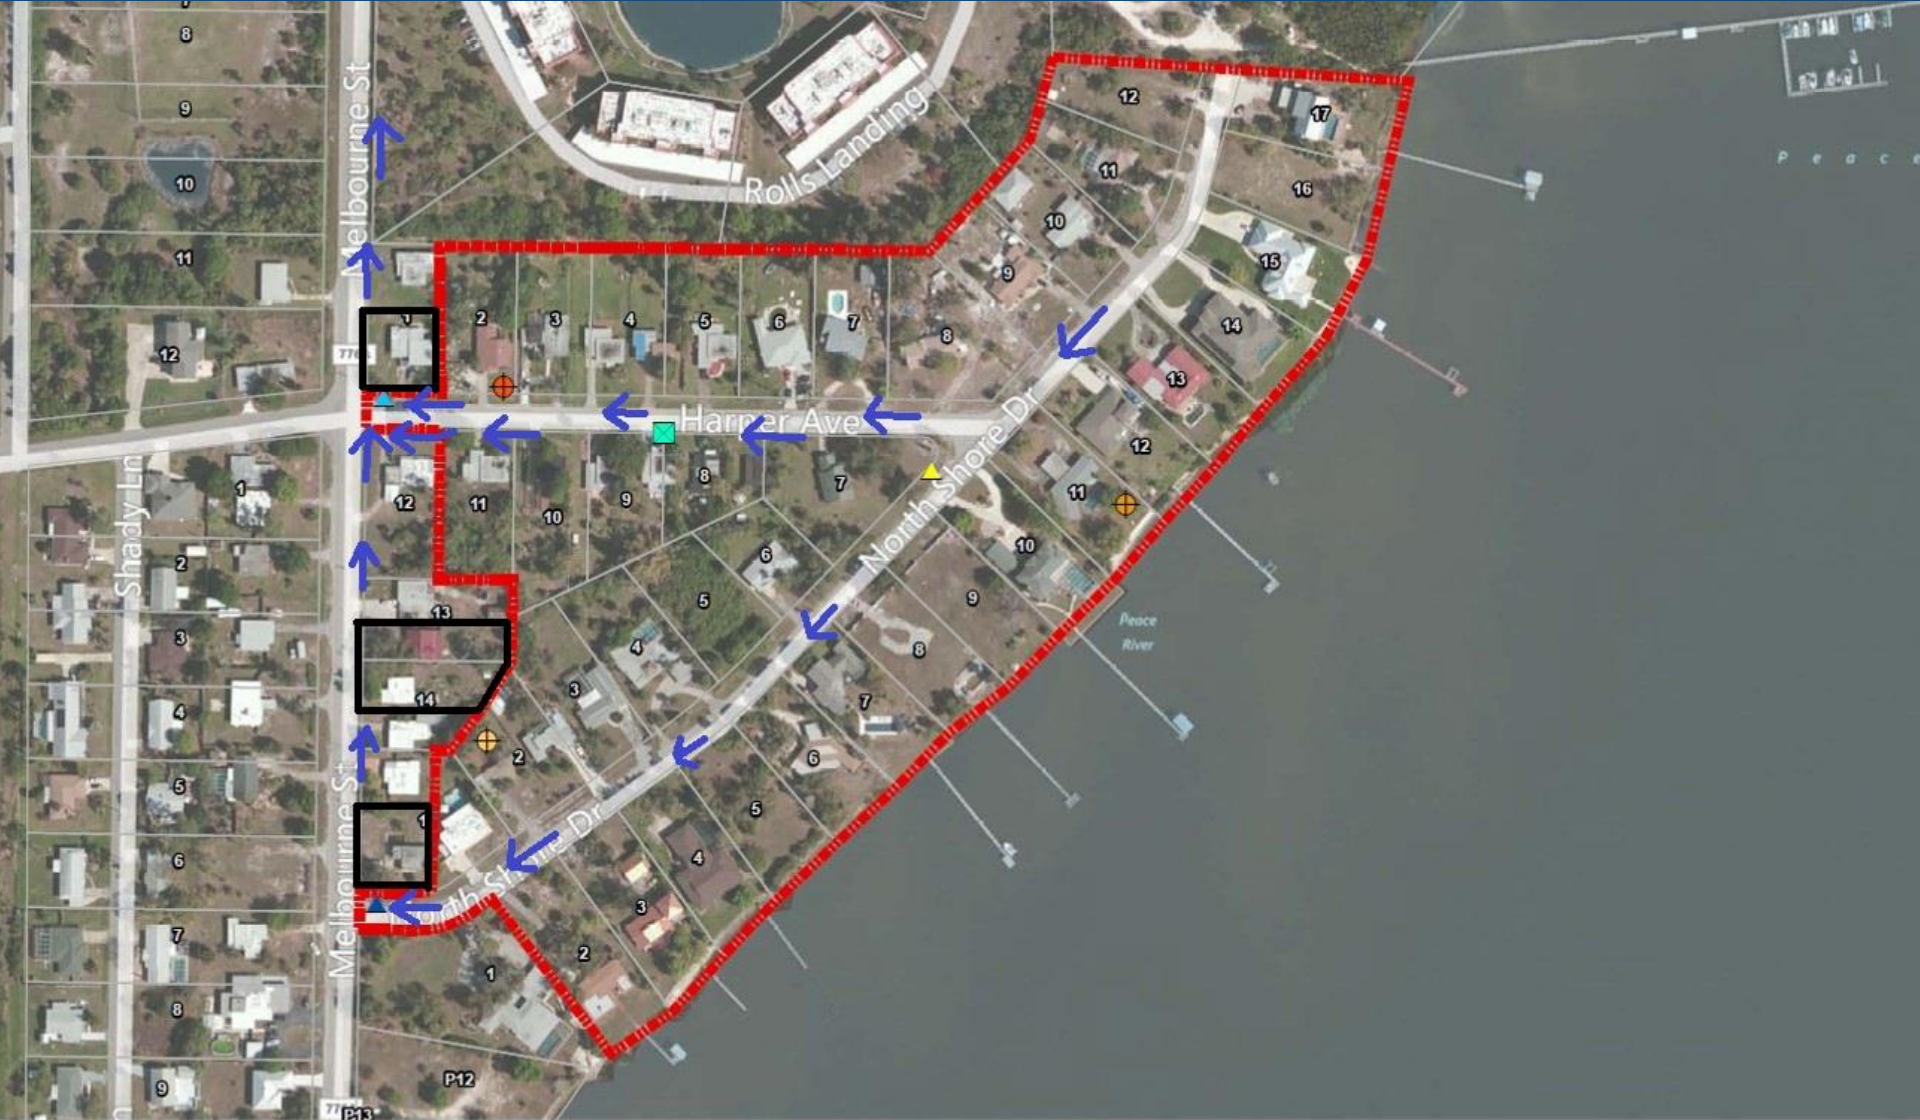
- NS - GW 3
- NS - GW 2
- NS - GW 1
- NS - INF 1
- NS - OUT 1
- NS - OUT 2
- NS - W 1
- Project Area

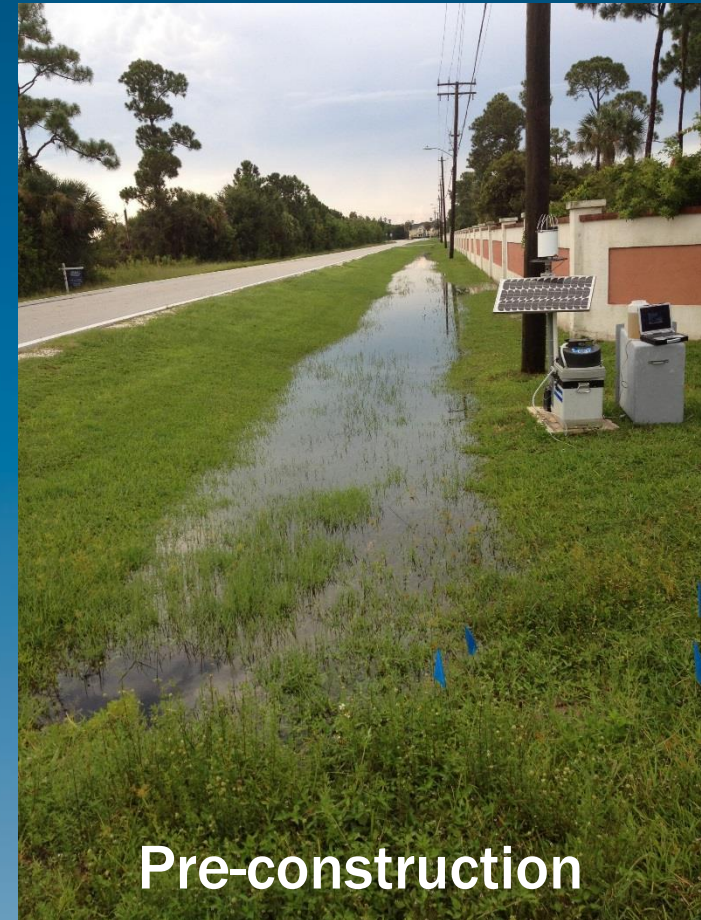
Monitoring

- **Stormwater (after rain events)**
 - Stormwater outfall site
 - Pre-construction (2013)
 - Post-construction (2015 – 2017)

- **Ground water (quarterly)**
 - 3 monitor wells

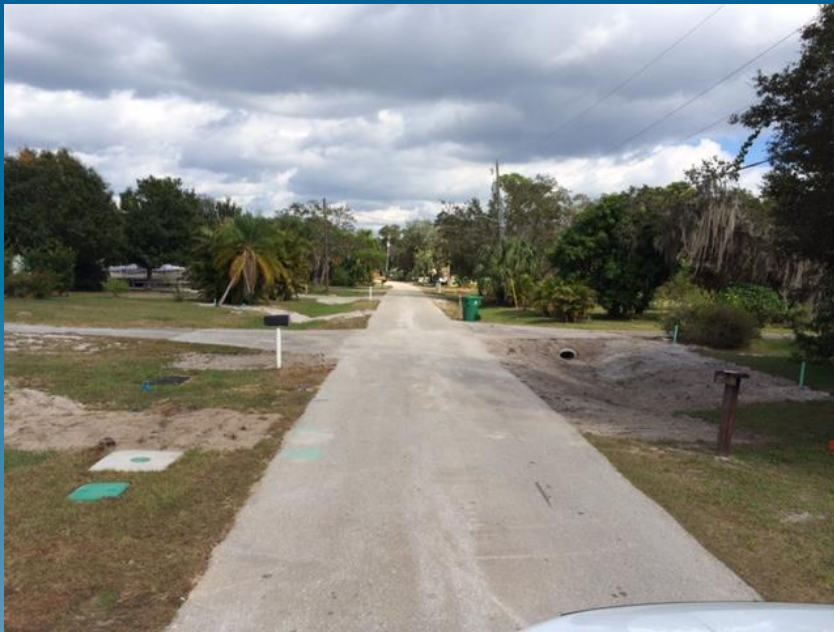
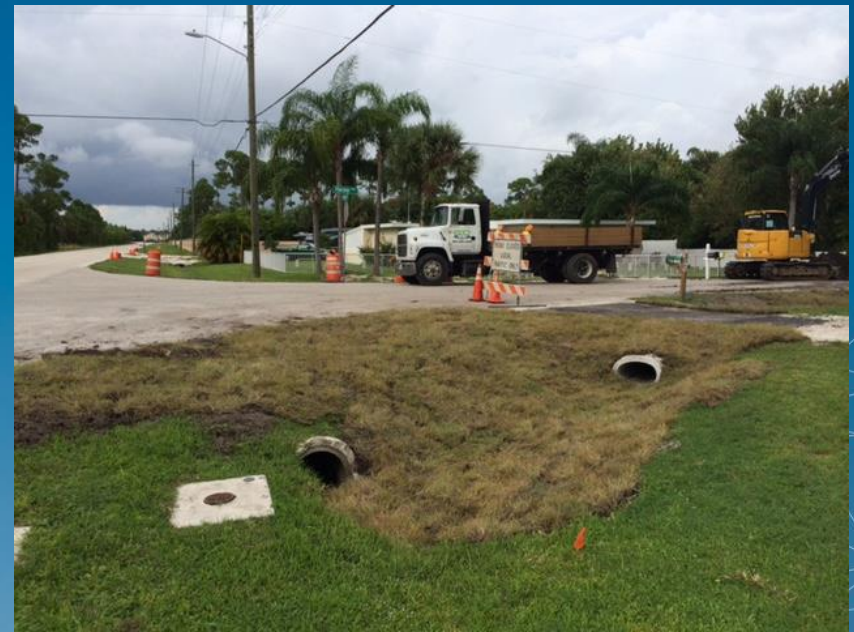
Construction

- Septic tanks removal, sewer connection, and swale restoration fall 2014 – spring 2015

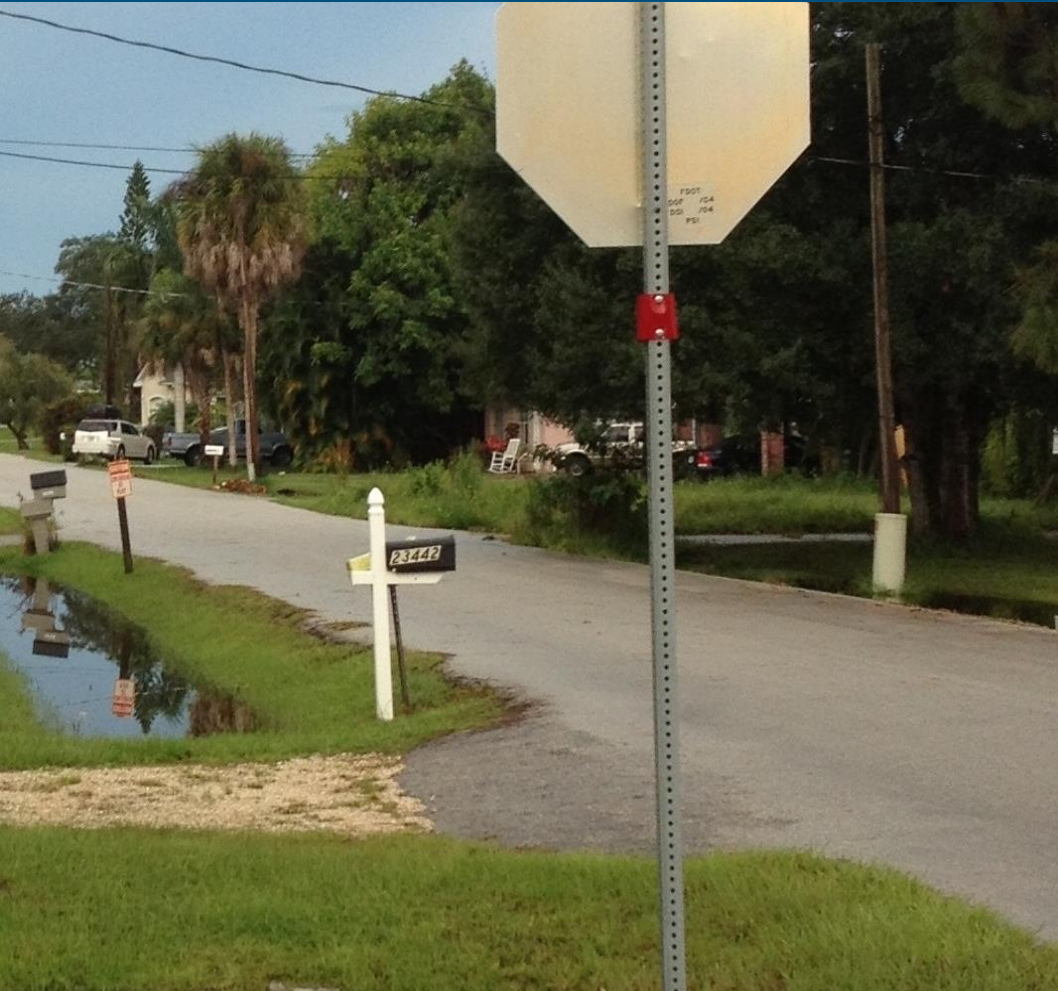
Pre-construction

Stormwater Sampling

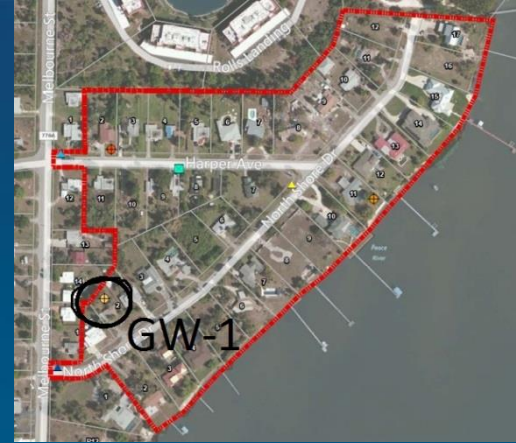
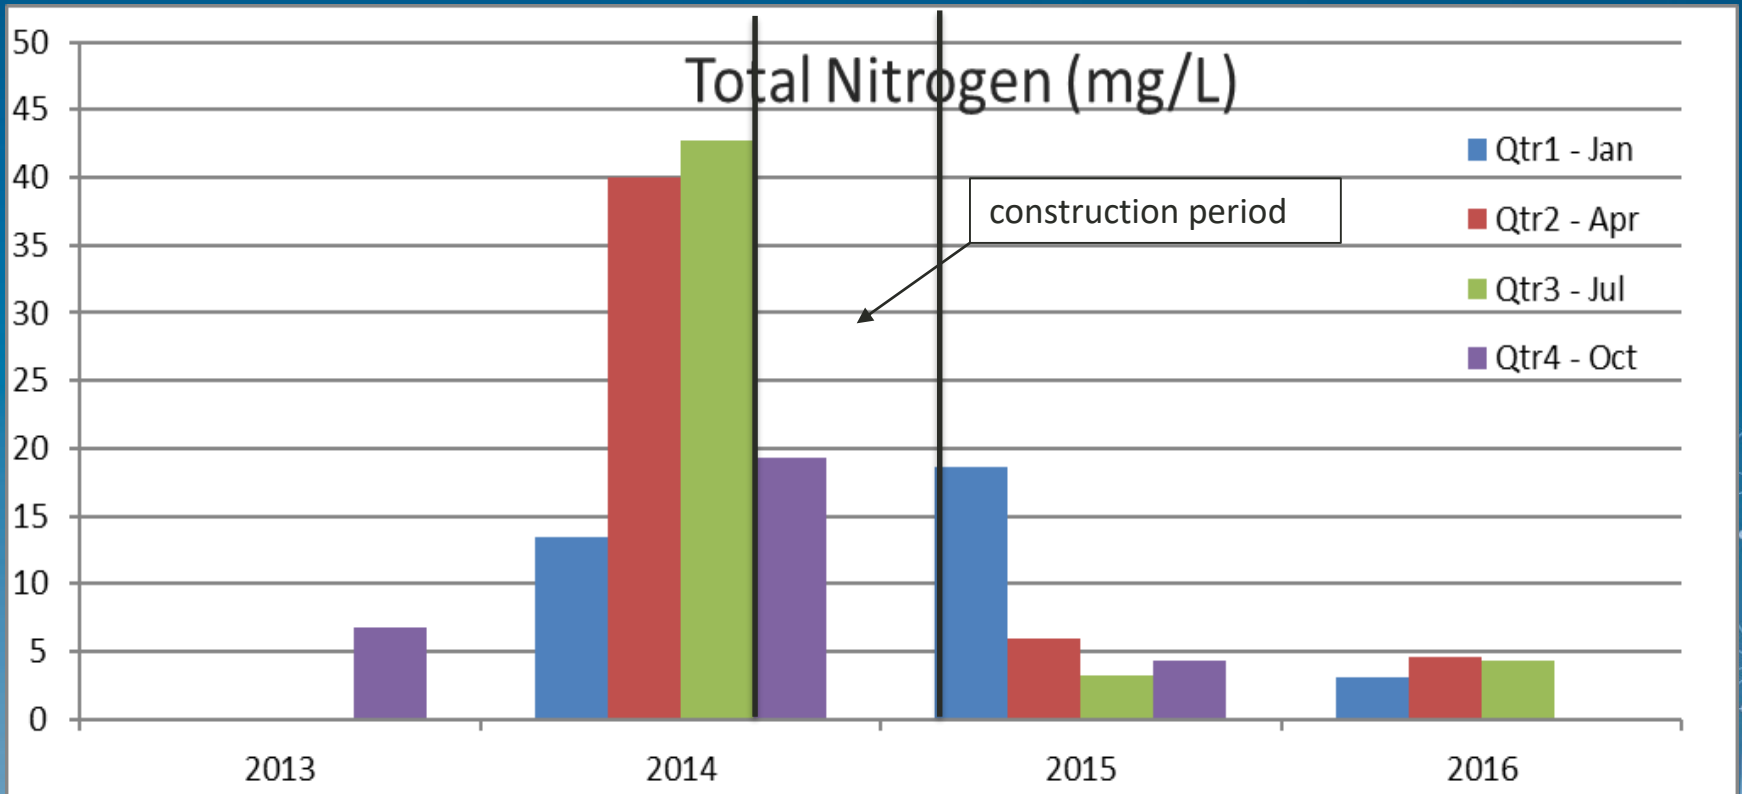
GW-1

Ground Water Sampling

- **Stormwater monitoring**
 - Limited Total Nitrogen concentration reductions in first 6 months after construction
 - Significant Total Nitrogen concentration reductions within 2 years after construction
- **Groundwater monitoring**
 - Significant reduction in Total Nitrogen at Groundwater monitor wells within 6 months after construction

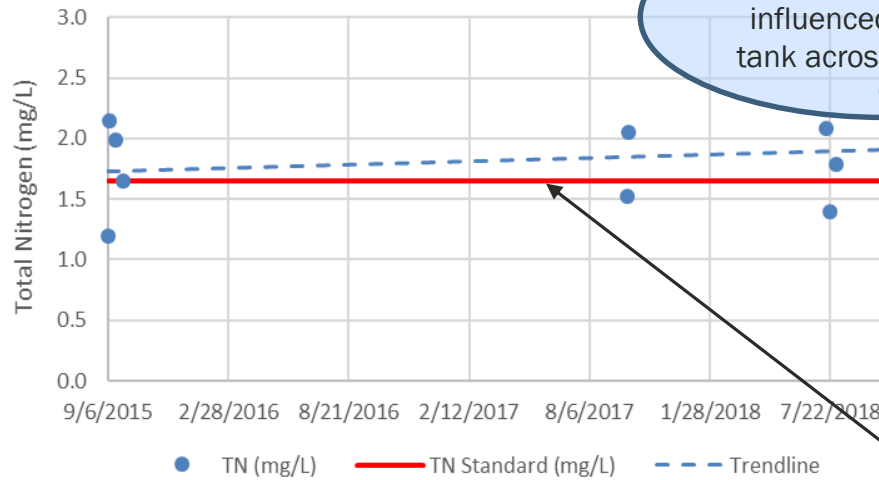
West Spring Lake (WSL)

Total Nitrogen

Class III fresh stream standard of 1.65 mg/L Total Nitrogen (annual geometric mean not to be exceeded more than once in any 3 consecutive years)

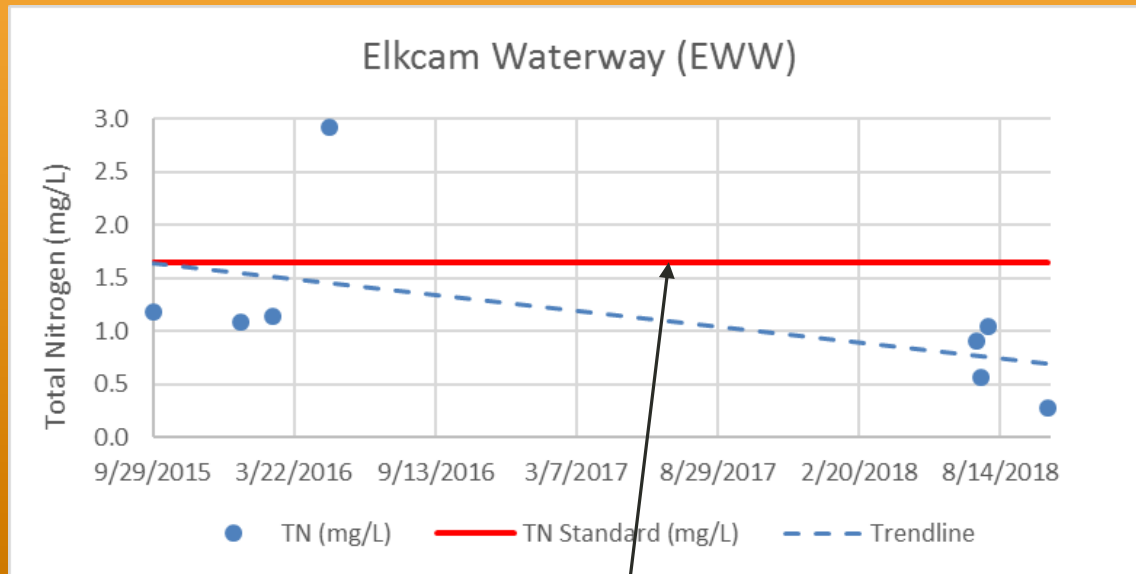
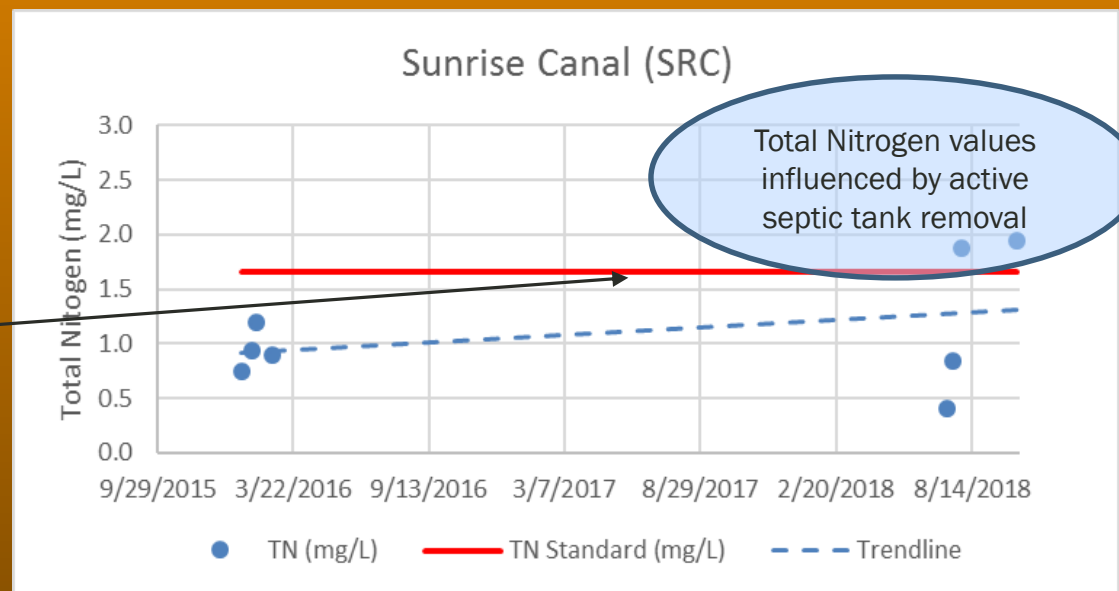
Phase I Storm Event Results

Total Nitrogen

Class III fresh stream standard of 1.65 mg/L Total Nitrogen (annual geometric mean not to be exceeded more than once in any 3 consecutive years)

- The load reduction for Total Nitrogen is lower than expected and Total Phosphorus shows a negative load reduction
- Post-construction samples were collected while septic systems were being connected and soon after swale restoration
