# memorandum

subject 2022 (Year 7) Annual Report for Sunshine Lake and Sunrise Waterway

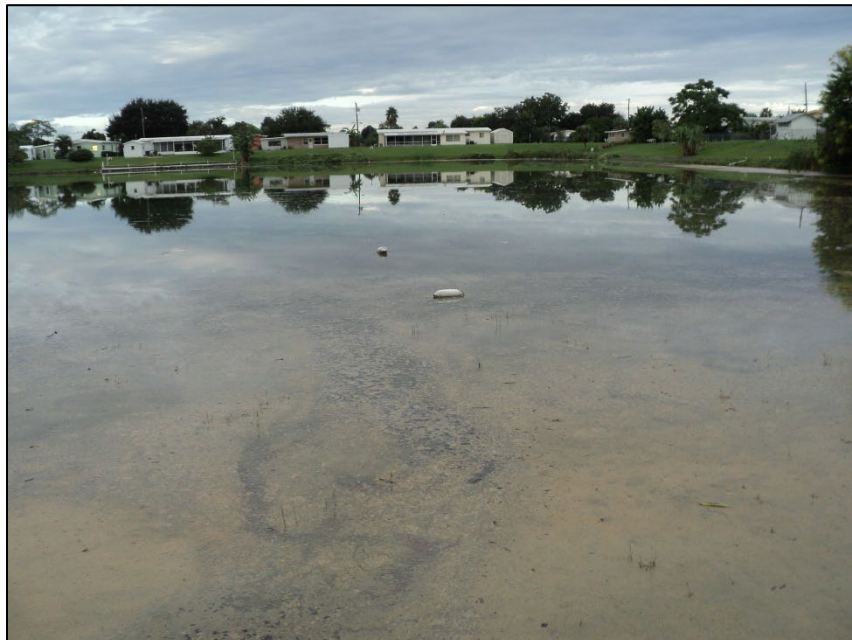
**Figure 1. Photo of northwest portion of Sunshine Lake. Photo from November 2010.**

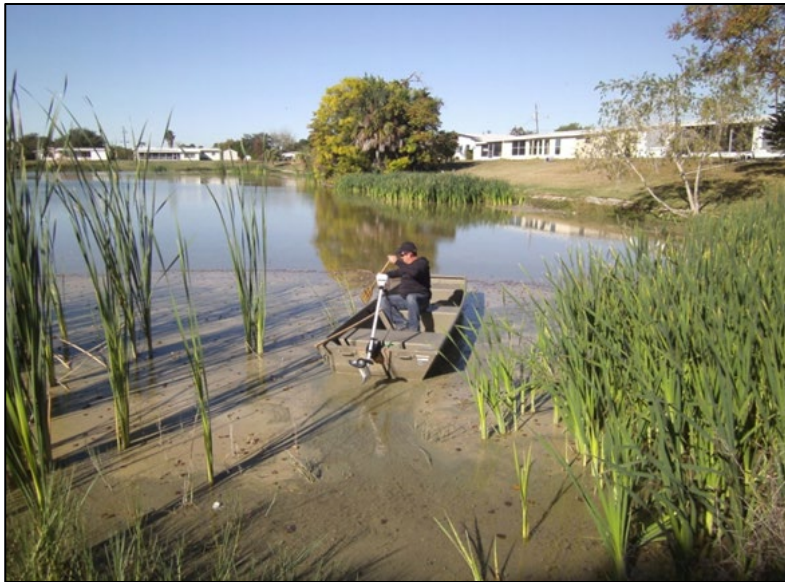
**Figure 2. Photo of northeast portion of Sunshine Lake. Photo from January 2012.**

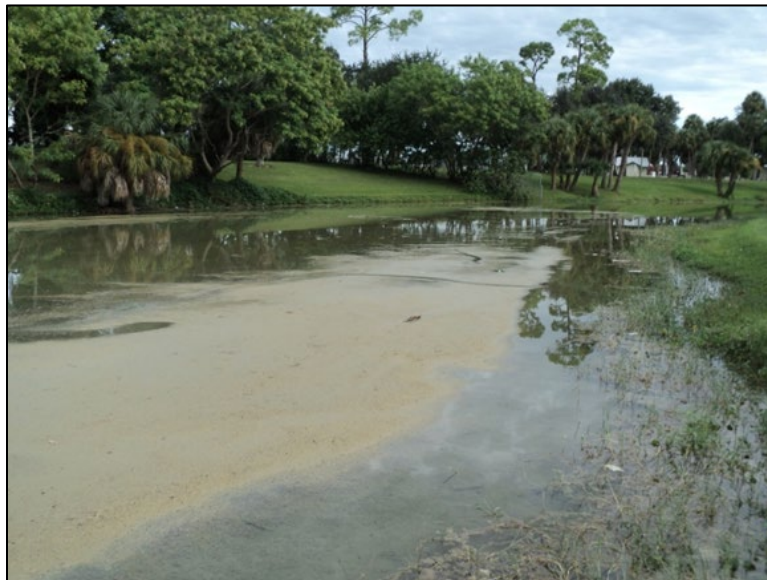
**Figure 3. Photo of southern portion of Sunshine Lake. Photo from January 2012.**

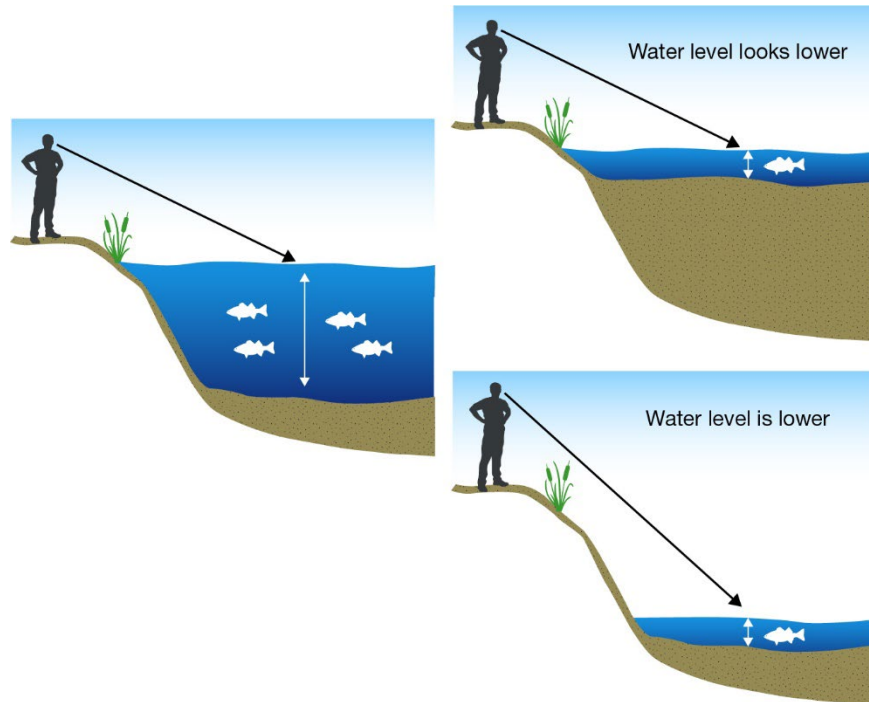
In response to these conditions, an initial assessment of the lake and waterway was conducted to evaluate potential causes (Atkins 2012). Prior to this initial investigation, several residents of the surrounding neighborhoods believed that the County might have lowered the lake and exposed the lake bottom. In fact, the algal bloom had been intense enough that the biomass of algae had actually filled in the lake from the bottom. The two scenarios are illustrated in Figure 4.

**Figure 4. Illustration of prior condition in Sunshine Lake (left side image) compared to perceived condition of lake lower (bottom right image) vs. actual changes in the lake (top right image).**

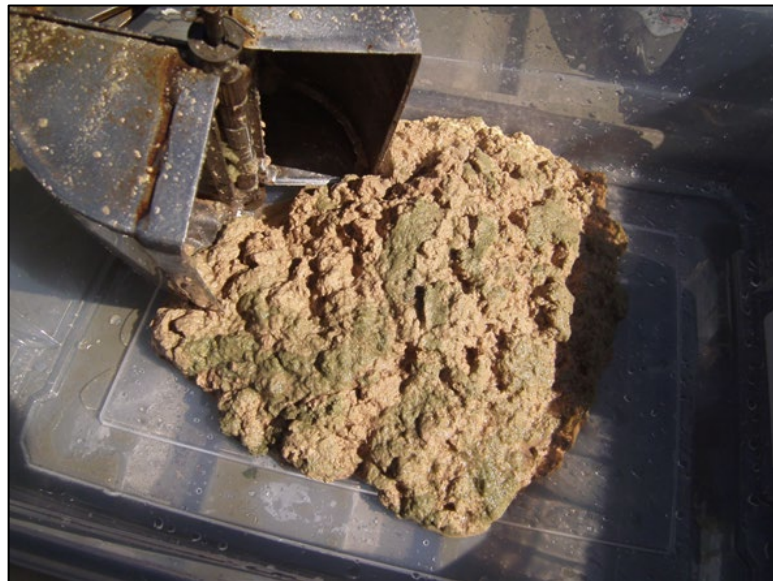
Field work conducted as part of the original investigation determined that the lake and waterway were filling up from the bottom by a mass of cyanobacteria dominated by the species *Aphanothece conglomerate* (Figure 5).

**Figure 5. Photo of algal material along the bottom of Sunshine Lake. Photo from January 2012.**

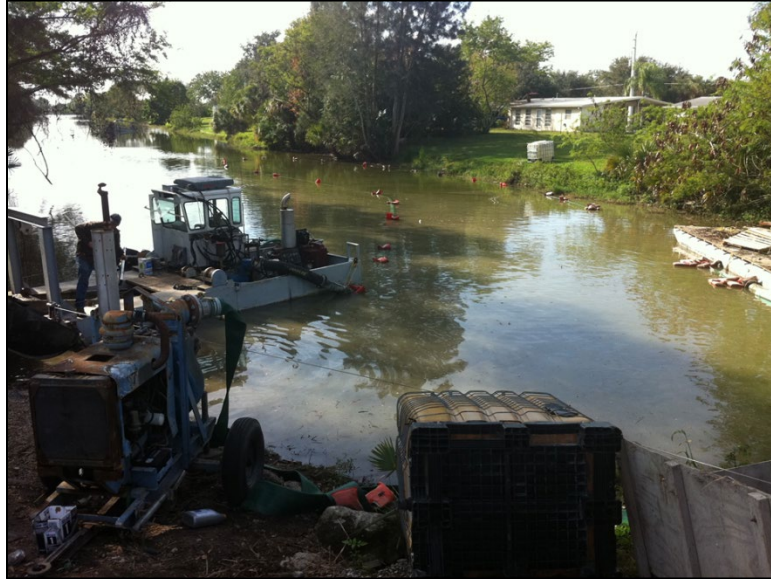
**Figure 6. Photo of dredging operation in the Sunrise Waterway.**

As suggested in the original assessment (Atkins 2012) Charlotte County then conducted a dredging project to remove the algal material from both the lake and waterway (Figure 6).

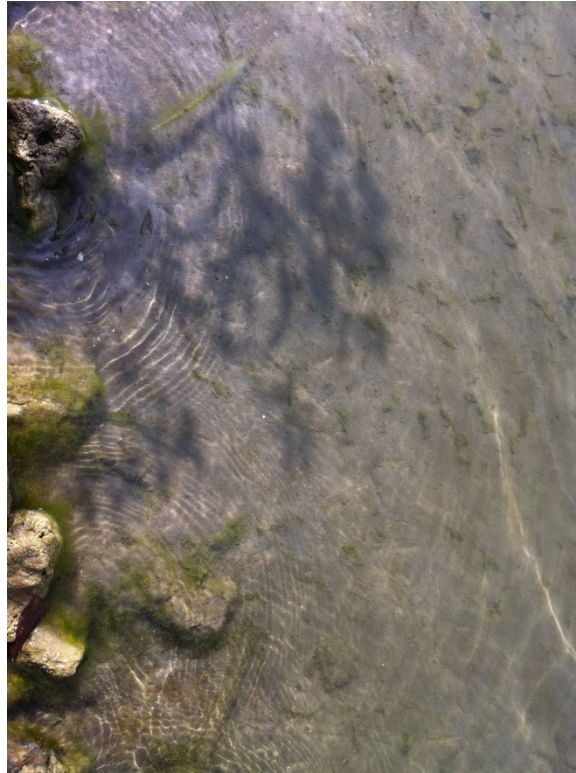
After the completion of the dredging project, the prior cyanobacteria mat was no longer found in Sunshine Lake (Figures 7 and 8).

**Figure 7. Photo of shallow waters along dredged portion of the shoreline of Sunshine Lake, during the County dredging project.**

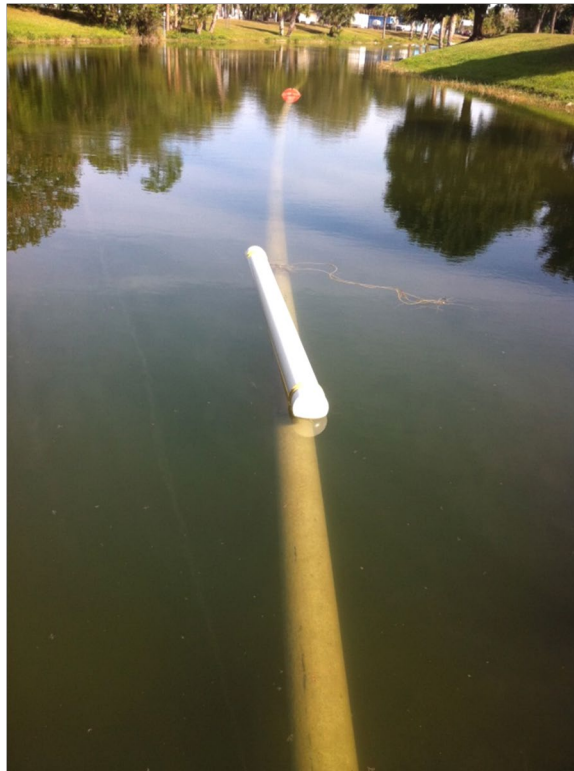
**Figure 8. Photo of southern portion of Sunshine Lake, during the County dredging project.**

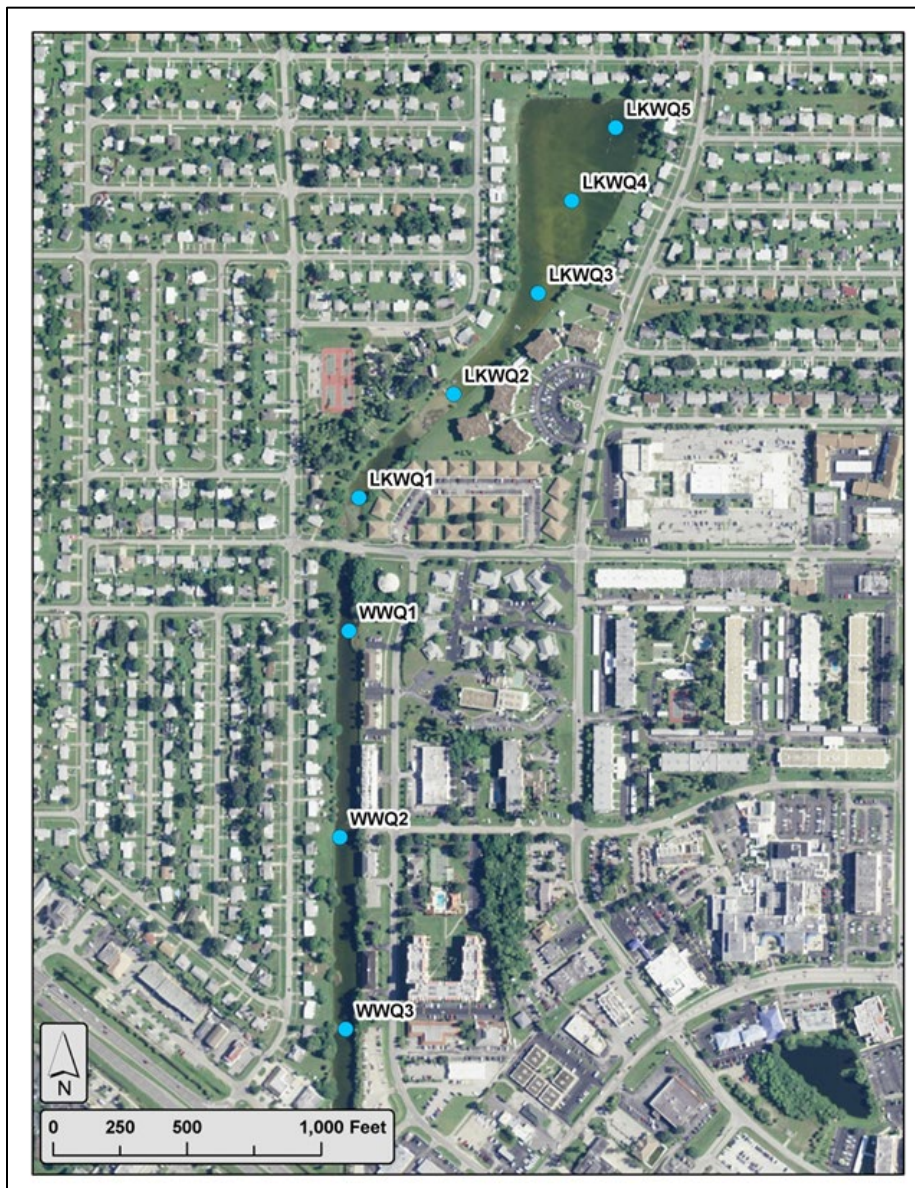
Water samples from quarterly monitoring of 8 surface water sites (5 in the lake and 3 within the waterway; Figure 9) were collected and analyzed for total dissolved nutrients (nitrogen and phosphorus), chlorophyll-a, and *E.coli* bacteria.

**Figure 9. Location of sampling sites for water quality assessment of Sunshine Lake and the Sunrise Waterway.**

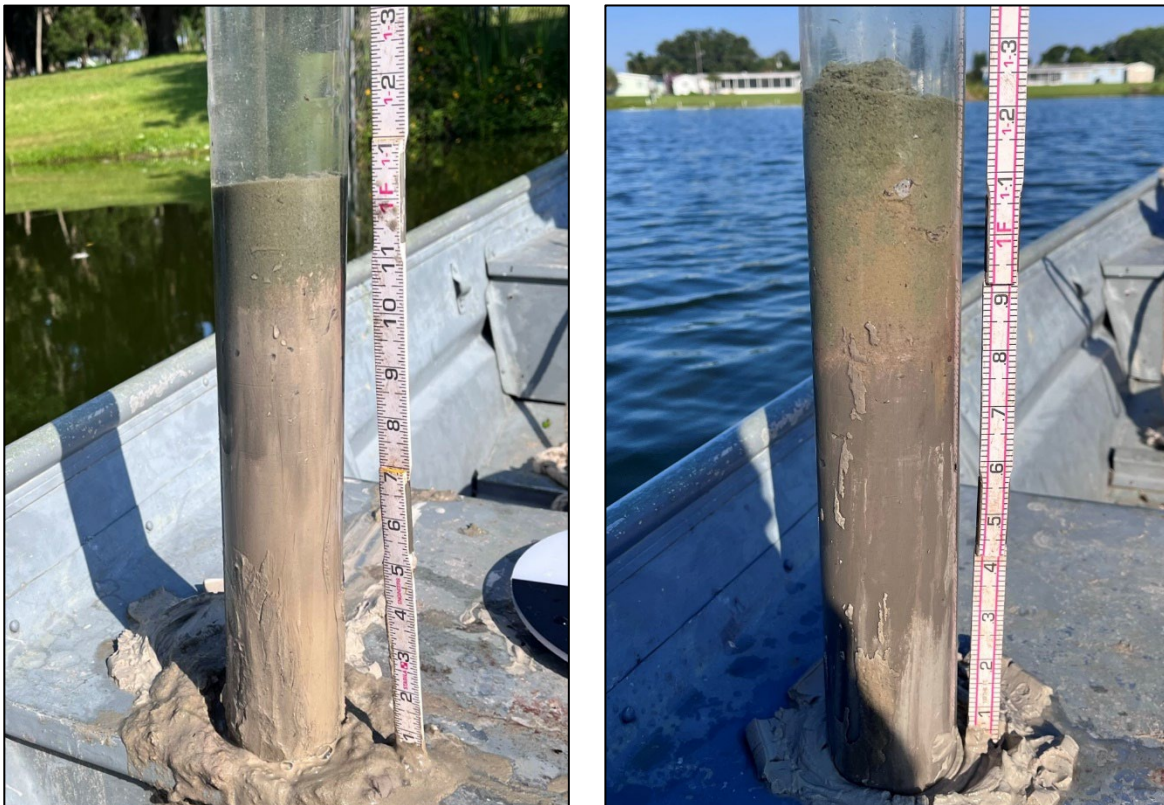
Submerged benthic vegetation in Sunshine Lake and the Sunshine Waterway was assessed during the June 2022 and November 2022 sampling events. No submerged vegetation was found, but limited accumulations of cyanobacteria were found and qualitatively assessed. Potential cyanobacteria accumulation and/or growth on the lake and waterway bottom were documented in June 2022 and November 2022 by collecting cylindrical core samples (Figure 10) at the eight water quality monitoring stations. Core samples were visually evaluated for the relative depths of accumulated cyanobacteria, other (non-cyanobacteria) organic material, sand, and clay. Core samples were photographed, and the relative depth of sediment constituents were measured. Photos of the cores are provided in the appendix.

**Figure 10. Sediment core samples at LKWQ2 (left) and LKWQ5 (right).**

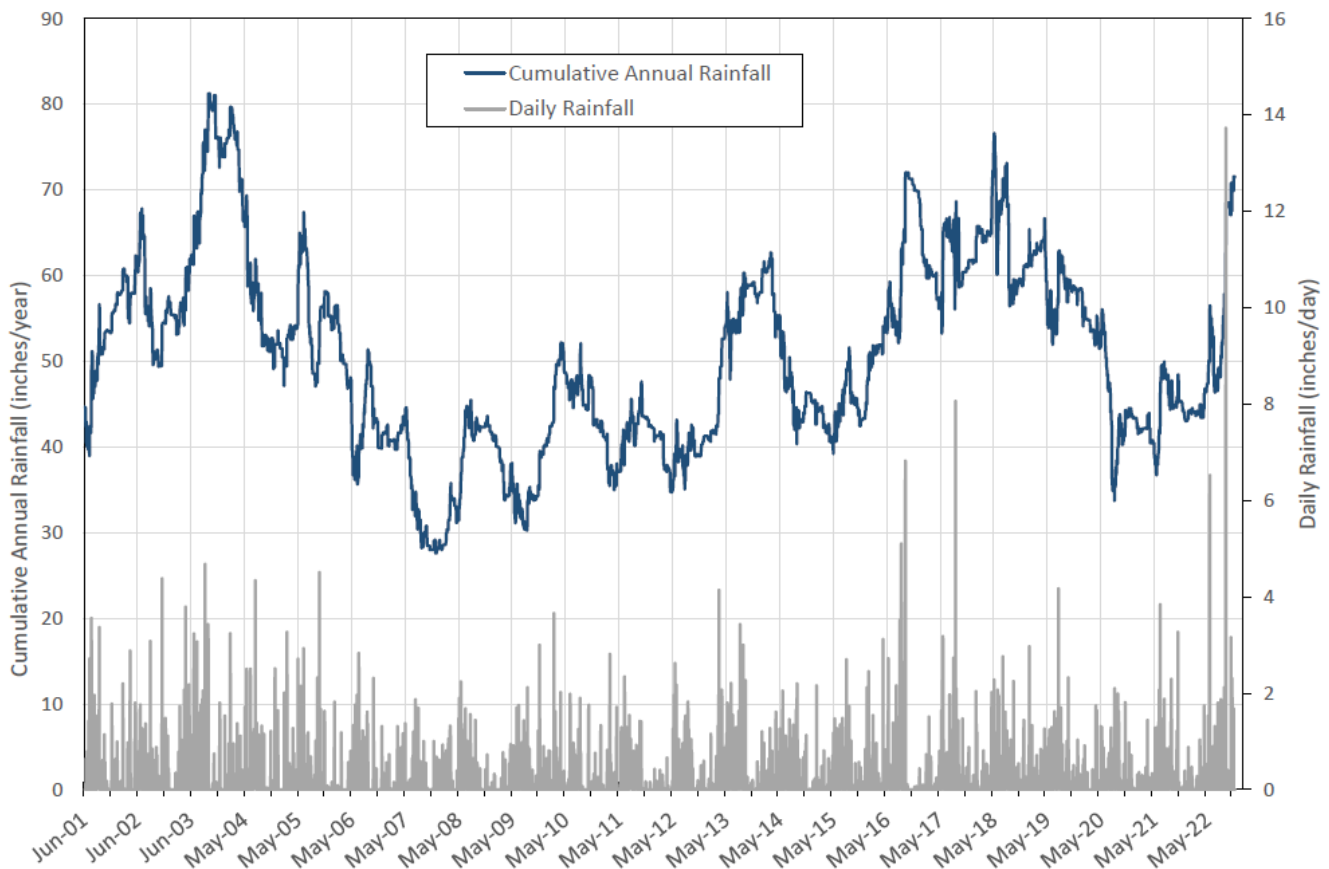
Antecedent rainfall (both short and long term) is an important factor to consider when interpreting water quality data. Daily and cumulative annual rainfall at nearby Harbor Heights since 2001 are shown in Figure 11. Cumulative annual rainfall is equivalent to a running annual sum for rainfall and indicates relative rainfall patterns over time. Cumulative rainfall in 2016 (70 inches) was notably above average (51 inches). Rainfall in 2017 (62 inches), 2018 (61 inches), and 2019 (58 inches) was near average. Rainfall in 2020 (44 inches) and 2021 (43 inches) was below average, with the June through September 2020 period being well below average. Rainfall remained below average through 2022 but increased significantly in September 2022 after hurricane Ian accounted for nearly 14 inches of rain in a single day.

**Figure 11. Daily and cumulative annual rainfall at Harbor Heights.**

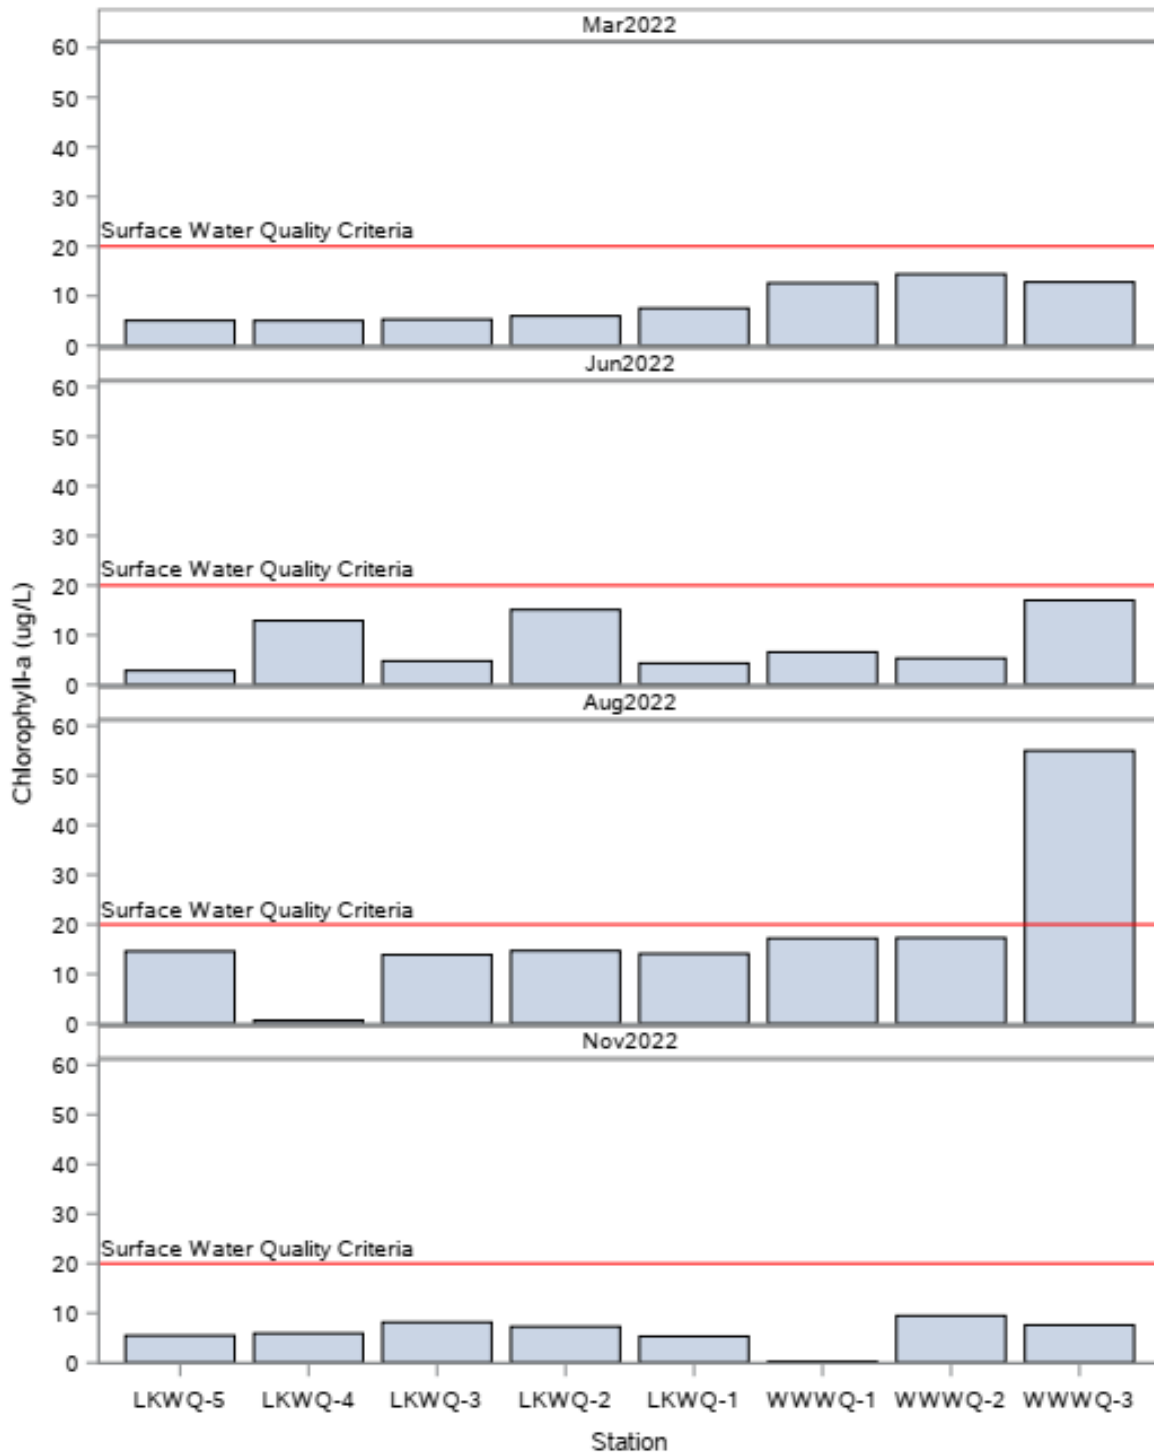
Results for all date and location combinations over the past four quarterly sampling events are displayed below in Figures 12 through 15. As shown in Figure 12, levels of chlorophyll-a were well below the NNC criteria of 20 µg/L at most sampling sites on most occasions. As shown in Table 1, the geometric means of all samples fell below the level at which impairment would be determined. Of the 32 sample points shown in Figure 9 (8 stations visited 4 times), one location exceeded the NNC criteria of 20 µg chlorophyll-a/L, in August 2022 in the Sunrise Waterway (WWWQ-3).

**Figure 12. Chlorophyll-a concentrations ( $\mu\text{g/L}$ ) for each station for each sampling period. For sampling locations, see Figure 9. The relevant NNC criterion for chlorophyll-a ( $20 \mu\text{g/L}$ ) is shown in red.**

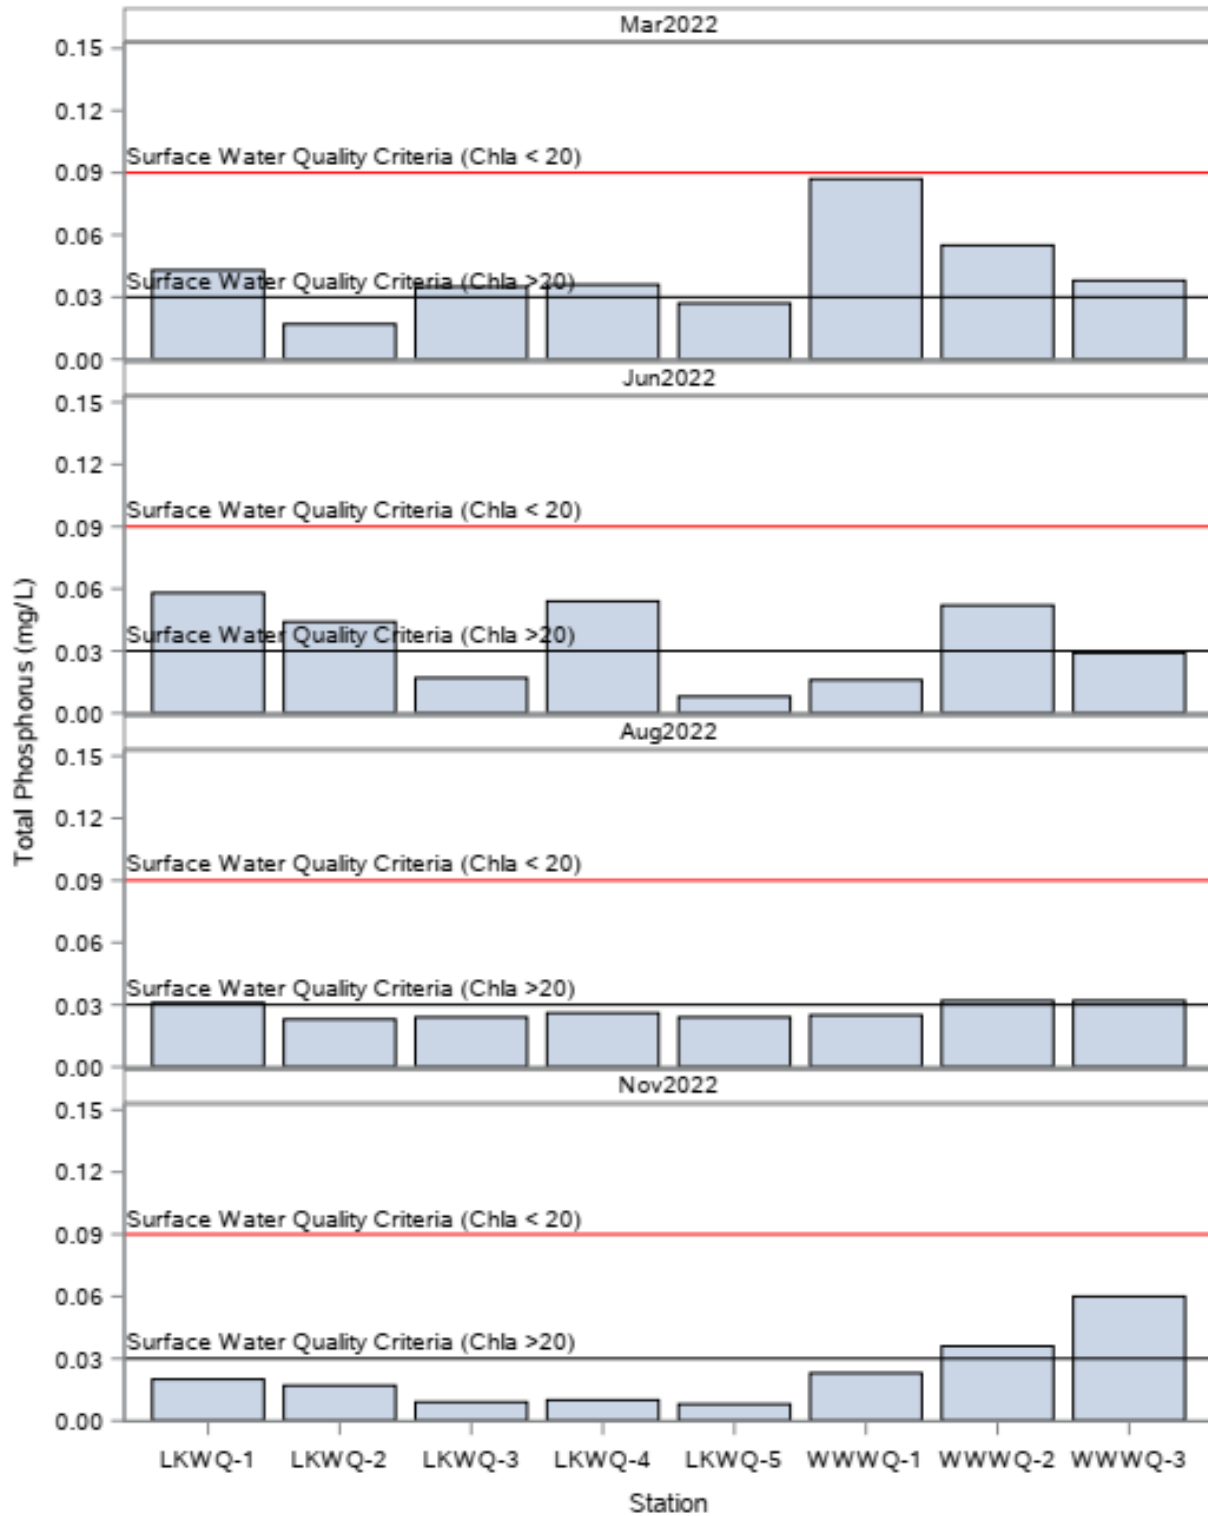
Based on NNC criteria, Sunshine Lake and the Sunrise Waterway would be considered to be impaired for phosphorous only if TP concentrations exceeded 0.09 mg TP/L, and only if values exceeded that threshold value on a frequent enough basis. As shown in Table 1, the annual geometric mean values for the lake, the waterway, and the lake and waterway combined are all lower than the relevant regulatory criterion for TP. Figure 13 shows that no location exceeded the criterion. Figure 13 also shows that if chlorophyll-a values were to exceed 20 µg/L as a geometric mean, the relevant TP criterion would have been exceeded at most locations in the Waterway and some sampling events within the Lake (except for August and November 2022). Ongoing quarterly monitoring is recommended to ensure that water quality does not degrade to a level that the annual geometric mean would exceed 20 µg/L. If such a condition was to arise, the target TP concentration would decrease to a value low enough that the lake and waterway would likely become impaired for phosphorus.

**Figure 13. Total Phosphorous concentrations (mg TP/L) for each station for each sampling period. For sampling locations, see Figure 9. The relevant NNC criterion for phosphorous (0.09 mg TP/L) is shown in red.**

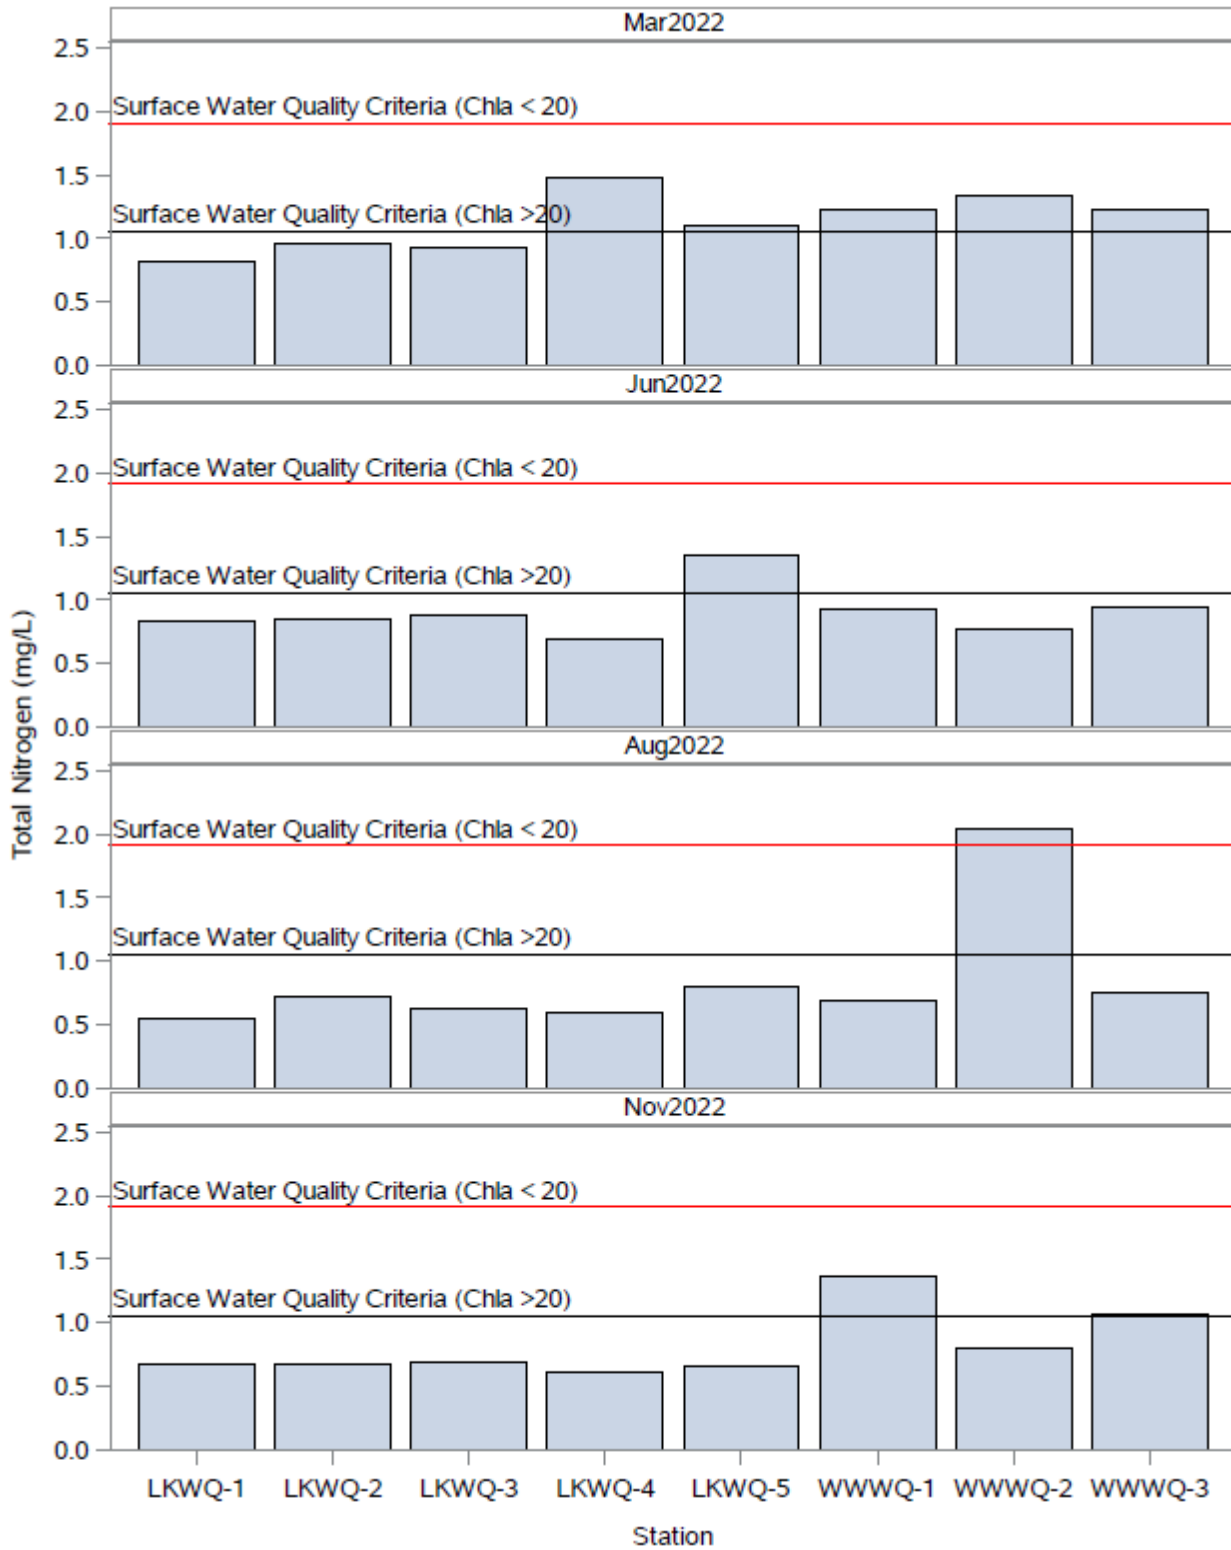
Based on the non-exceedance of the 20 µg chlorophyll-a/L NNC criterion, Sunshine Lake and the Sunrise Waterway would be considered to be impaired for nitrogen only if TN concentrations exceeded 1.91 mg TN/L, and if values exceeded that threshold value on a frequent enough basis. As shown in Table 1, the annual geometric mean values for the lake, the waterway and the lake, and waterway combined are well below the appropriate regulatory criterion for TN. Figure 14 shows that there is only one example where a location or sampling event exceeded that criterion (WWWQ-2 in August 2022). As was the case with phosphorus, these results suggest that the County should continue to carefully manage and monitor the lake to make sure the chlorophyll-a values are not increasing to a level such that the annual geometric mean would exceed 20 µg/L.

**Figure 14. Total Nitrogen concentrations (mg TN/L) for each station for each sampling period. For sampling locations, see Figure 9. The relevant NNC criterion for nitrogen (1.91 mg TN/L) is shown in red.**

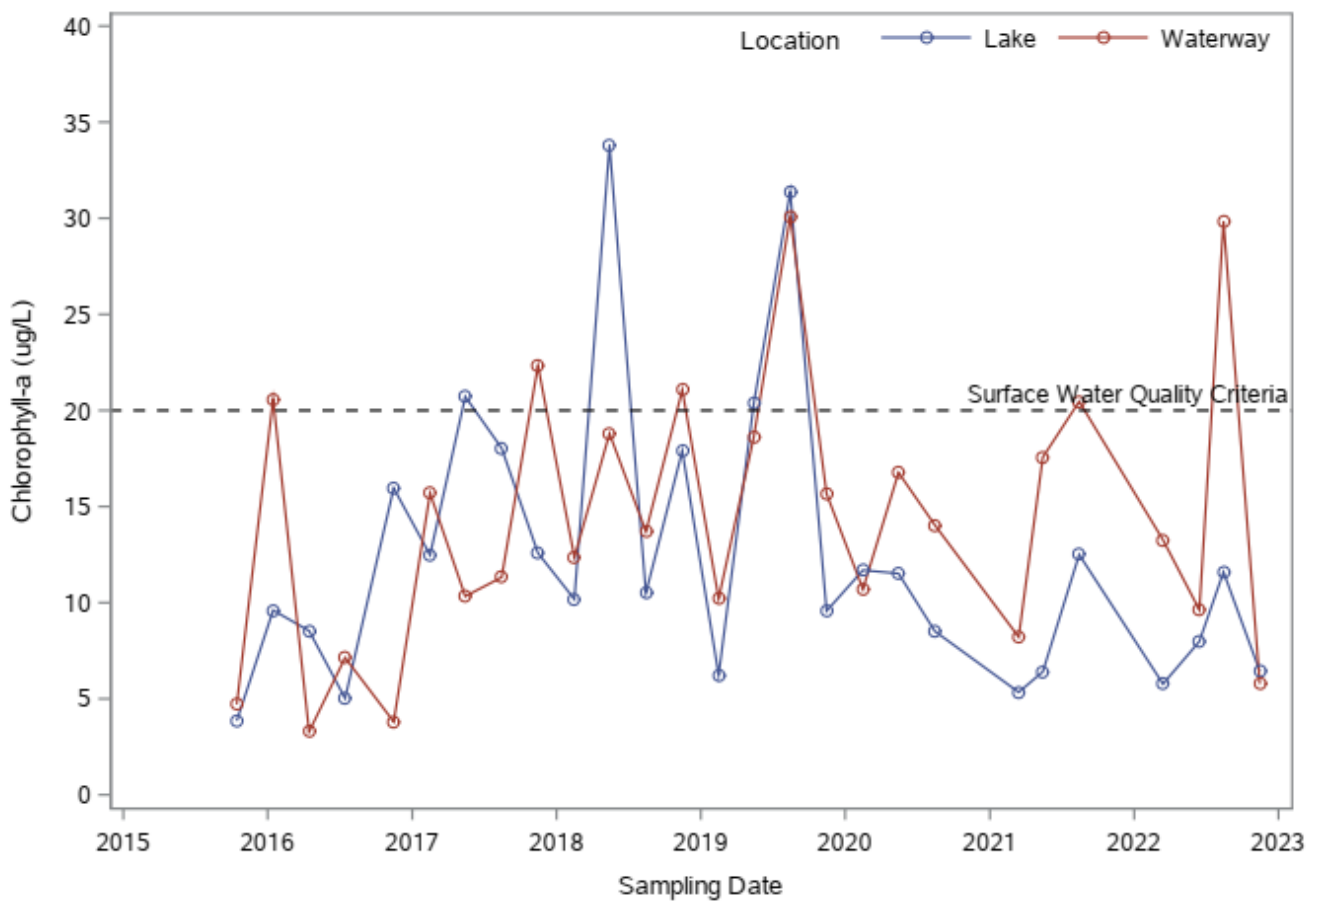
Figure 15 displays the chlorophyll-a data as the averages of each quarterly trip over the entire monitoring effort, from October 2015 to November 2022. The data displayed in Figure 15 show a pattern of increased trends in chlorophyll-a from April of 2016 until May of 2018. This was followed by a stabilization in values from May 2018 to August 2018 in both the lake and waterway. Elevated chlorophyll-a concentrations were observed in August 2019 in both the lake and waterway. More recently, most sampling events have concentrations trending lower, with one exception above 20 µg/L (WWWQ3 in August 2022).

**Figure 15. Average values of chlorophyll-a in both Sunshine Lake and the Sunrise Waterway over the period of October 2015 to November 2022. Values are means for the lake (n=5) and the waterway (n=3) for each quarterly sampling effort.**

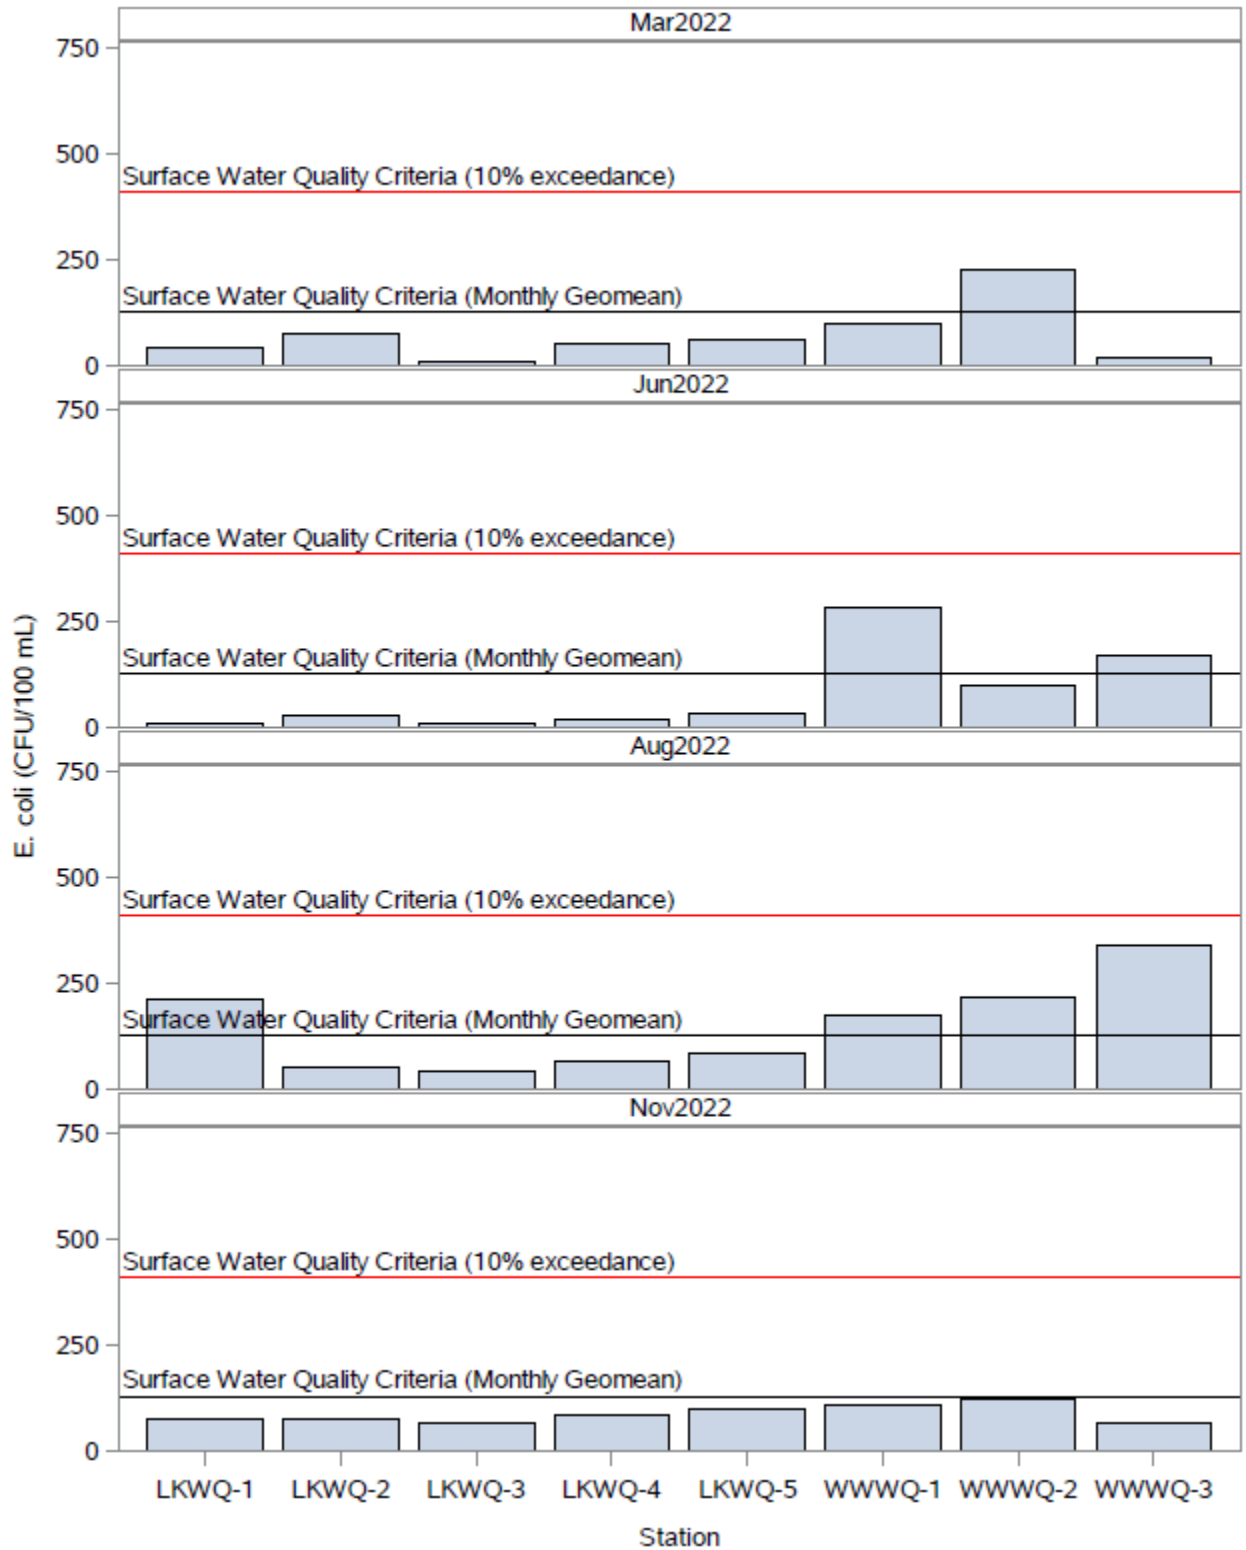
(nor does this program), FDEP has determined impairment based on the 10 percent exceedance threshold. Therefore, the appropriate threshold value used to determine the degree of impairment for bacteria in the lake and waterway is that of 410 cfu of *E. coli* bacteria / 100 ml (Figure 16).

*E. coli* bacteria levels were consistently below the regulatory standard of 410 units per 100 ml in both the Lake and Waterway (Figure 16). Due to the lack of exceedances, the bacteriological status of the lake and waterway would be classified as unimpaired.

**Figure 16. *E. coli* bacteria concentrations (cfu / 100 ml) for each station for each sampling period. For sampling locations, see Figure 1. The relevant criterion for *E. coli* bacteria (410 cfu / 100 ml) is shown in red.**

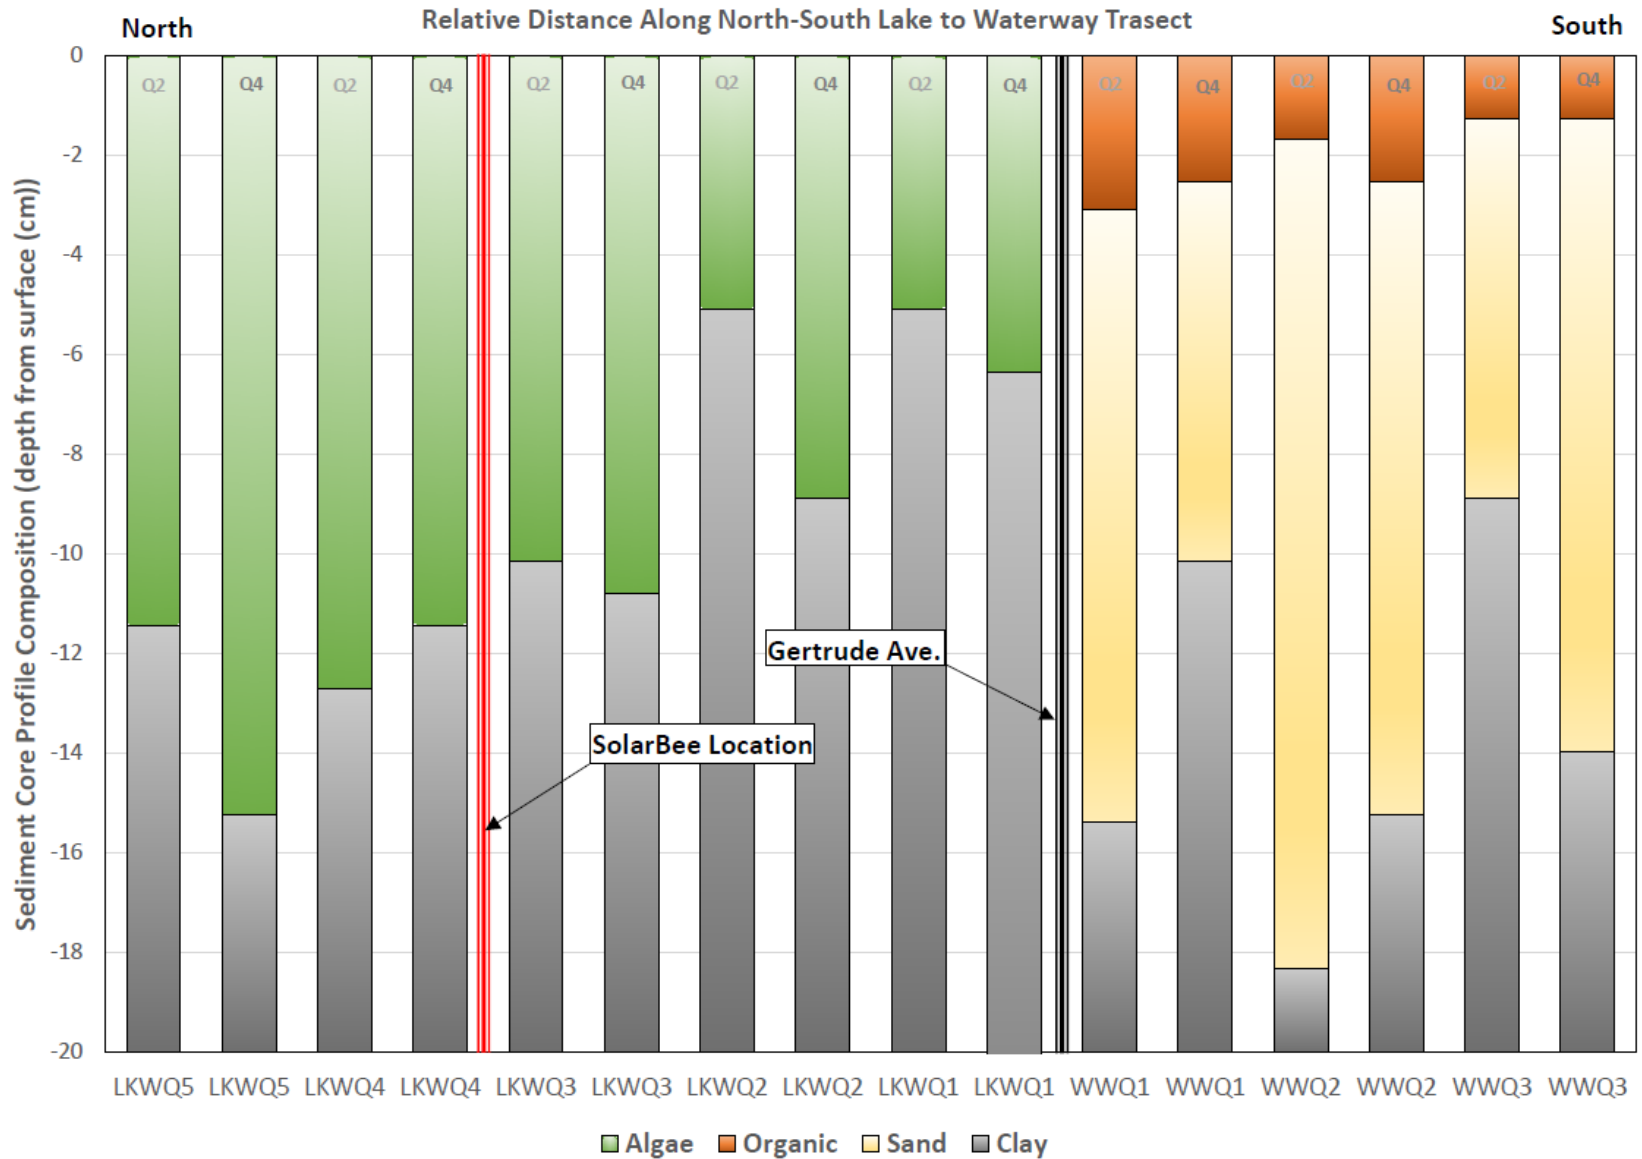
Sediment characterization data are shown in Figure 17. Photographs of the sediment cores are included in the appendix. No submerged, benthic plants were found in the lake or waterway. Benthic algae (algae layers on the bottom of the lake and waterway) ranged from 15 cm thick at the northernmost end of Sunshine Lake to 5 to 6 cm thick at the southern end of the lake (Figure 17). Measurable benthic algae were not present in Sunshine Waterway. The algae layer was underlain by a thick layer of clay in Sunshine Lake. Sunshine Waterway was characterized by a thin layer of non-algae organic matter underlain by a thick layer of sand. The lake algae layers appear to be moderate close to the SolarBee, thicker at a greater distance from the SolarBee, and thinnest at the farthest distance from the SolarBee. This is consistent with SolarBee induced water flow moving existing algae towards the edges of the lake but not pushing the algae into the farthest reaches of the lake. It is likely that a small amount of algae either remained in the lake after dredging or has grown since dredging and that the location of this algae has been reworked by SolarBee flow such that the algae accumulates at the edge of the SolarBee flow field. Results from 2022 sampling compared to 2021 show generally similar trends in algae distribution.

**Figure 17. Sunshine Lake and Waterway sediment core profile composition from north to south (collected 06/24/2022 (Q2), and 11/29/2022 (Q4)).**
