# Charlotte County Utilities Department

**2019 Annual Report**  
**March 2020**

## **2019 ANNUAL REPORT**

Jones Edmunds Project No.: 03405-029-03

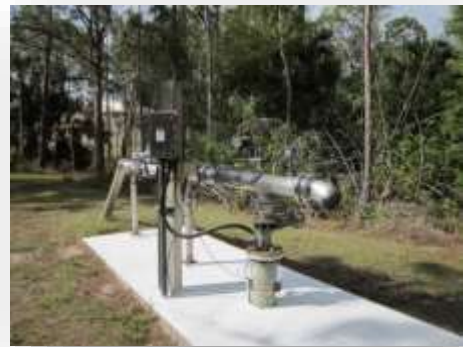
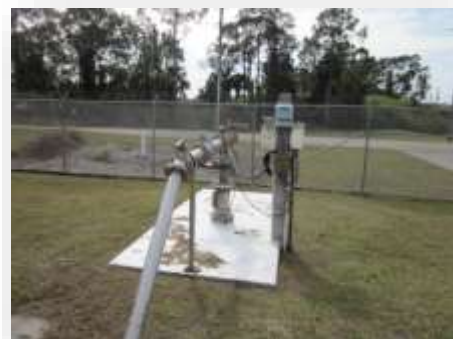
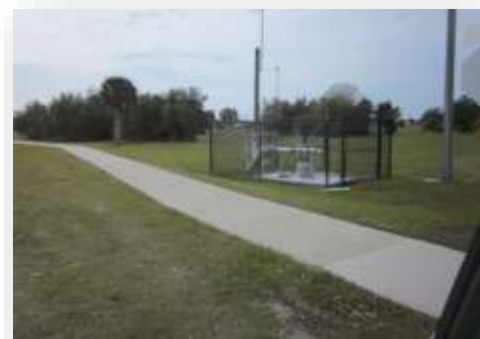
- Well No. 11 is a 12-inch-diameter well located off site on Burnt Store Road. The well meter flow tube and check valve were replaced in February 2016 and are in excellent condition. Minor rust was observed on the wellhead stainless-steel pipe.

- Well No. 12 is a 12-inch-diameter well located off site on Burnt Store Road. A small burrow was found under the concrete, which should be filled to prevent concrete cracking. Minor rust was observed on the stainless-steel wellhead pipe, but the pump and motor are in excellent condition.

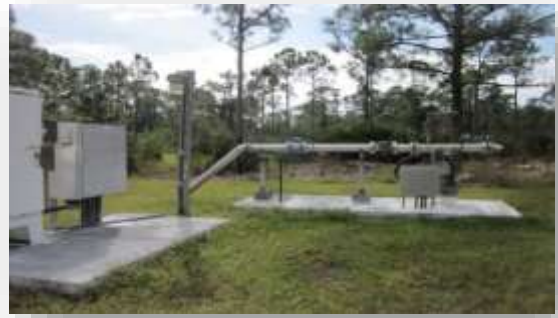
- Well No. 15 is at the rear of the site. The well pump and piping are in excellent condition. However, Well No. 15 is currently not in service due to suspected intrusion of lower quality water from this well's terminal strata. The 2013-issued WUP required this well be abandoned and capped. A study was completed in 2017 to evaluate an alternative way to bring this well back into service.
- Well No. 16 is a 12-inch-diameter well on the east side of the site. The well pump is in excellent condition.

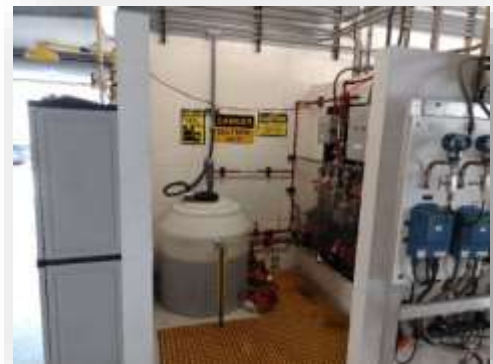
Sulfuric acid is used to decrease the pH of the raw water and prevent calcium carbonate precipitation. The 1,000-gallon bulk sulfuric acid storage tank is outside in the covered bulk storage area. The 100-gallon sulfuric acid storage tank is indoors near the chemical feed skid. The sulfuric acid skid contains two metering pumps. The metering pumps are in good working condition. The concrete in the secondary containment in the bulk chemical storage area was painted in 2018, and the 100-gallon tank inside the process room was replaced.

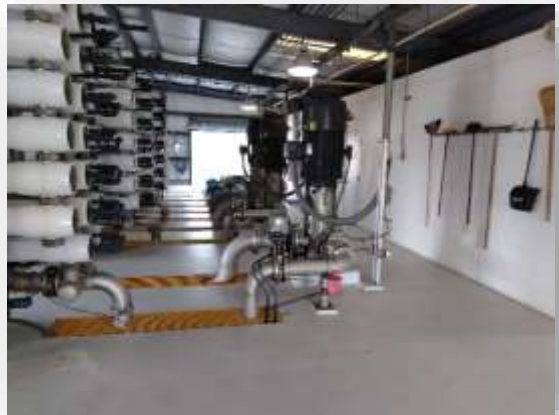
The Burnt Store RO WTP has five two-stage RO process trains, A through E. Trains A and B were installed in 2007, and Trains C, D, and E were installed in 2009. Trains A and B are served by two horizontal split-case pumps, and Trains C, D, and E are fed by vertical turbine pumps. Each RO feed pump is painted and in good condition.

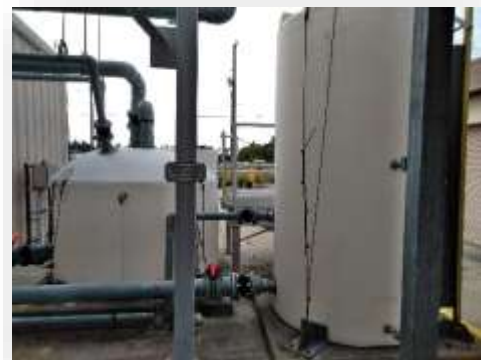
Over time, membranes may experience fouling due to scaling, plugging, break-through, or several additional factors. Reversible fouling can be mitigated by in situ cleaning of the membranes, whereas some fouling may require membrane replacement. The WTP's membrane cleaning system has not been used in over 5 years. Operators restored the system in 2018 and will test the system's functionality in 2019.

The older trains (A and B) are still producing good-quality permeate but operate at a higher pressure, indicating minor fouling is occurring. Cleaning was last conducted on Train A in 2012 to reverse the effects of fouling and reduce the operating pressure. Minor improvements were achieved indicating that fouling is irreversible and will eventually require membrane replacement. Treatment Trains C, D, and E are in good working condition, except for some leaks on the concentrate port seals on Trains C and D. The port seals should be replaced.

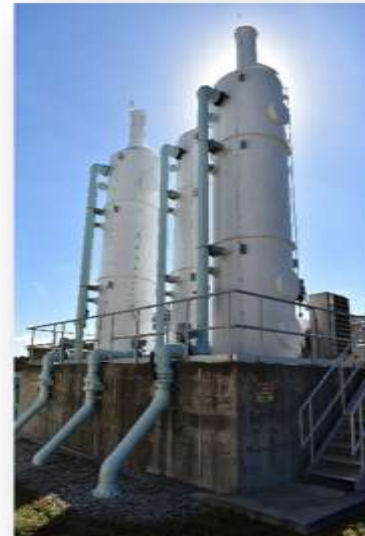
Hydrogen sulfide is removed from the RO permeate via packed-tower degasification. Three packed-tower degasification units are on top of the concrete clearwell and can be operated automatically or manually. One of the degasifier blowers was repaired in February 2017. The degasifier media is expected to be in good condition but should be inspected and potentially cleaned or replaced pending the inspection. In 2014, the clearwell was temporarily taken out of service for inspection. The clearwell inspection report noted for staff to paint the clearwell and exercise the isolation valve between the two tanks. The clearwell valve has been exercised by staff and found to be operational in 2019. The outside of the clearwell should be painted.

Degasified water is transferred from the clearwells to the GSTs by three horizontal centrifugal pumps. In 2013, two in-line static mixers were installed in the transfer pipe leading to the GSTs to mix sodium hydroxide, corrosion inhibitor, and sodium hypochlorite. We recommend that these injection points be labeled. In 2015, two additional air-release valves (ARVs) were installed downstream of the pumps. We recommend that the pumps and piping be covered to prevent sun damage and to prolong the equipment life.

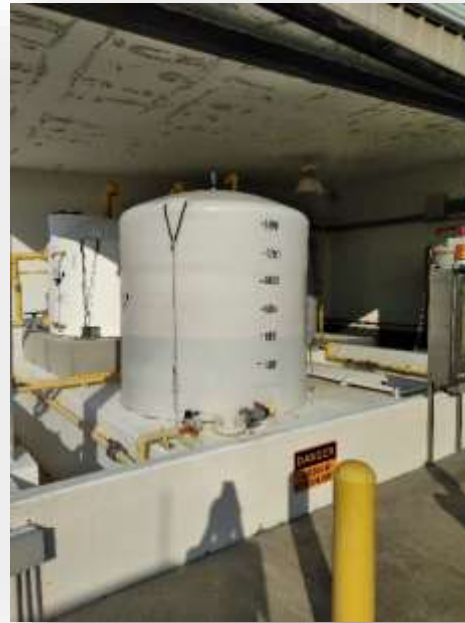
The sodium hypochlorite system consists of two bulk storage tanks, one 200-gallon storage tank, two chemical metering pumps, and two injection points. The bulk storage tanks are outside the process room and hold 1,400 and 1,100 gallons, respectively. The chemical containment area for the bulk storage tanks showed signs of deterioration and should be painted. The smaller storage tank and chemical feed skid are in a segment of the RO process room. Sodium hypochlorite is primarily injected before water enters the storage tanks (pre-disinfection), although operators also have the capability of injecting after the GSTs (post-disinfection) if needed to boost chlorine residual. The sodium hypochlorite system is in good operating condition.

Redundant analyzers that monitor post-treatment conditions of the water are on the wall of the clearwell. The instruments are well organized with SCADA connections to the Wonderware program, which can be monitored from the operations building. Instruments and chemical feed rates can be adjusted to obtain the proper water quality. Instrumentation is calibrated and up to date. Operation staff reported that the conductivity meter requires periodic replacement. We recommend the cover of the analyzer panel be extended to prevent water from contacting the equipment during rain events.

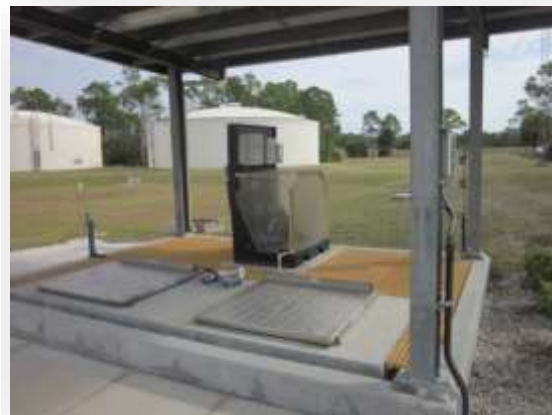
Because the distribution system currently operates with free chlorine, the ammonia system used to produce combined chlorine residual (chloramine) is not being used. Disinfection via chloramination may be used when the Burnt Store water system is expanded or connected to another water system that uses chloramines such as the PRMRWSF. In the meantime, the chemical feed pumps for this system have been stored indoors for use as spares for other chemical feed systems.

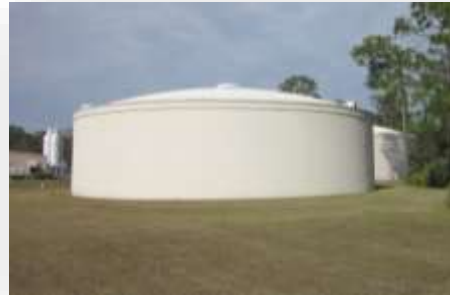
The Burnt Store RO WTP contains three 0.5-MG concrete GSTs housing a total of 1.5 MG of finished water. GSTs A and B were cleaned and inspected in FY 2013, and GST C was inspected in FY 2019. No sedimentation or defects were found in any tank. The outside of GST B was painted in 2019. The outside of the GST A is scheduled to be cleaned and painted in 2020.

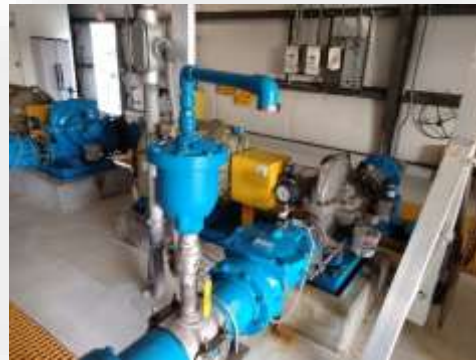
The RO WTP has one high-flow HSP (Pump A), two medium-flow pumps (Pumps B and C), and two jockey pumps (Jockey Pumps A and B) providing flow to the distribution system. The two medium-flow pumps were installed in early 2012 to more accurately match the system flow needs. One of the jockey pumps was installed in August 2017.

The variable-frequency (motor speed) drives (VFDs) on the pumps provide a constant pressure of 55 pounds per square inch (psi) at the beginning of the distribution system at the WTP regardless of the water use. Pump C was offline for maintenance at the time of the site visit, but the other HSPs are operational and in good condition.

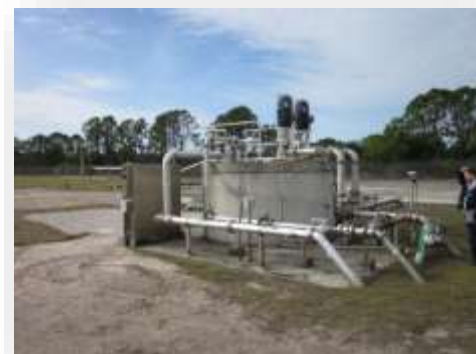
Concentrate from the RO process is disposed of by means of the on-site Deep Injection Wells IW-1 and IW-2. Both wells are permitted to accept concentrate and treated wastewater effluent. Concentrate is transferred to the deep well pumping station clearwell by latent pressure in the RO trains. There it is combined with wastewater effluent and injected into the deep wells. The maximum capacity of IW-1 is 0.564 MGD at a maximum rate of 392 gallons per minute (gpm). The maximum capacity of IW-2 is 2.88 MGD at a maximum rate of 2,000 gpm.

Both injection wells have flow meters and pressure gauges that can be monitored in the control room. Both wells undergo mechanical integrity testing every 5 years. A mechanical integrity test was successfully performed on IW-2 in 2013. A vibration analysis was also conducted for the vertical turbine injection well pumps in 2017. Due to the test results, the pumps were reprogrammed to minimize wear and appear to be functioning properly at the time of the site visit. The pumps at the station were painted in 2018, but the concrete wetwell needs to be painted.

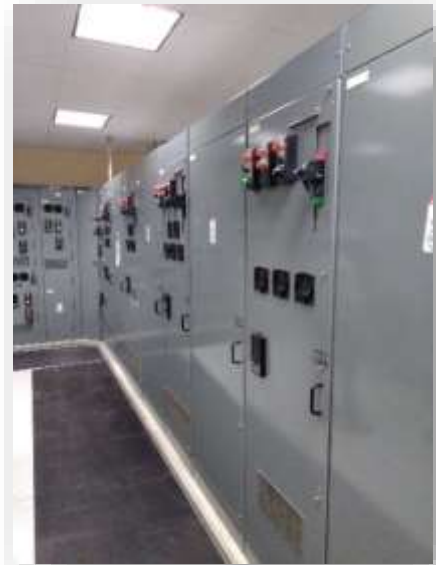
The main electrical components of this facility include the electrical components of the RO process buildings, one 1,250-kW standby generator, and two 80-kW portable generators. The distribution transformer, which provides power to the site, was in good condition with no obvious signs of significant concern.

The incoming switchgear was in good condition with minor issues. The switchgear contains warning labels identifying parts and components behind blank cabinets as being energized. The block wall in the northwest corner of the MCC building is eroded and should be repaired and painted. The floor near the electrical equipment is marked with hazard tape, but none of the equipment includes the appropriate arc flash labeling as required by the National Fire Protection Association (NFPA) 70E.

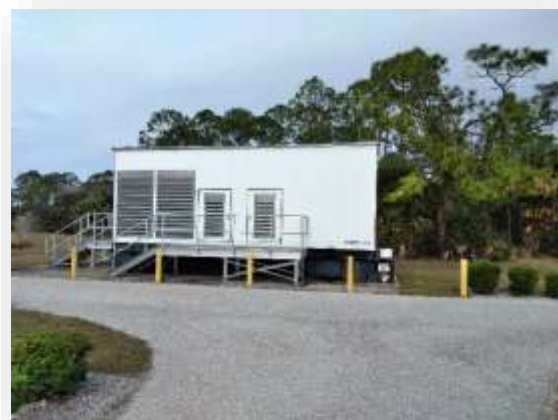
Auxiliary power is adequately sized to run the WTP. The WTP generator and automatic transfer switch were part of the 2009 upgrade of the WTP. The standby generator is operated for 4 hours under load twice per month. An outside contractor performs the maintenance. The generator was cleaned and serviced in 2019. Two generators that were historically attached to Wells No. 15 and 16 were converted to portable trailers. These generators can now be used to power the pumps at Wells No. 11, 12, 15, and 16 through permanently mounted generator connections at each well.

Overall, the electrical equipment is in good functioning condition based on information from the Operations staff.

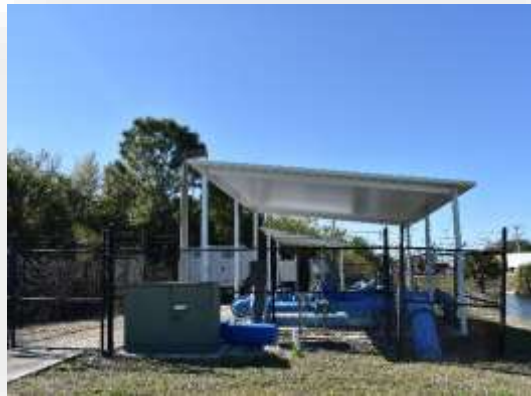
Overall, the interconnect is in good condition, but the lights should be lowered so the cover does not block the illumination of the pumps and equipment.

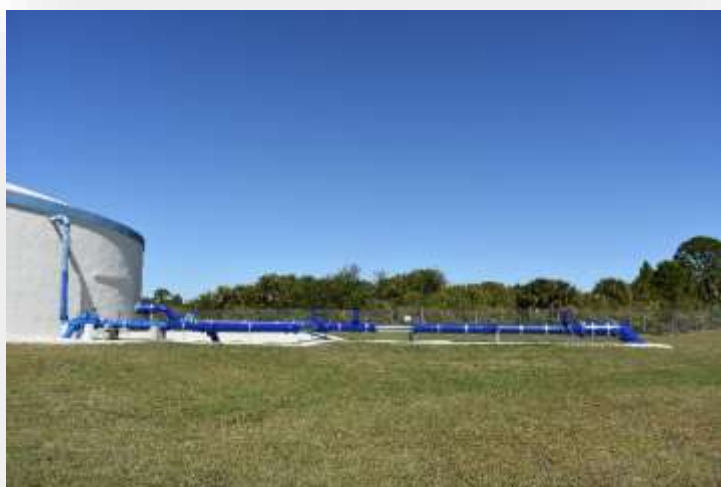
The station is in good condition. Roads and landscaping are in fair condition. Graveled areas around the facility infrastructure are weeded, but minor plant growth on the perimeter fencing was observed. The indoor buildings are kept clean, and tools and equipment are organized and stored properly.

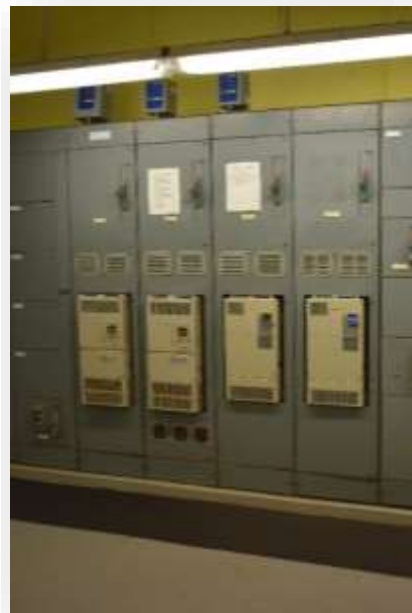
The incoming switchgear and distribution transformer appear in fair condition. County staff reported that the incoming main breaker failed to reclose during the last maintenance and likely indicates that the breaker is near failure and should be replaced. The incoming power company transformer showed signs of surficial rust. The standby generator reportedly functions properly and has no issues. The generator equipment inside the enclosure showed signs light surface corrosion and wear. Overall, the electrical equipment is in good functioning condition based on information from the Operations staff with the exception of the issue above. The equipment is quite dated with several components no longer manufactured. Several of the drives have been updated to Yaskawa VFDs and were retrofitted into the existing cabinets. However, the spaces provided did not match the drives, and there is now a gap between the drive and the enclosure (see photo at right) which may be problematic. Although no live parts appear to be exposed, this does raise a maintenance concern and the possibility of exposed parts.

- The wall that contains the HMI in the pump room requires painting.
- Much of the switchgear appears to be in only fair condition and is possibly reaching the end of its service life. Many components may no longer be manufactured, making long-term maintenance an issue.
- An exterior-mounted automatic transfer switch (ATS) appears to be in fair condition and degraded due to exposure to weather.
- The switchgear contains no warning labels identifying parts and components as being energized.
- Gaps exist between the updated VFD drives and the enclosure.

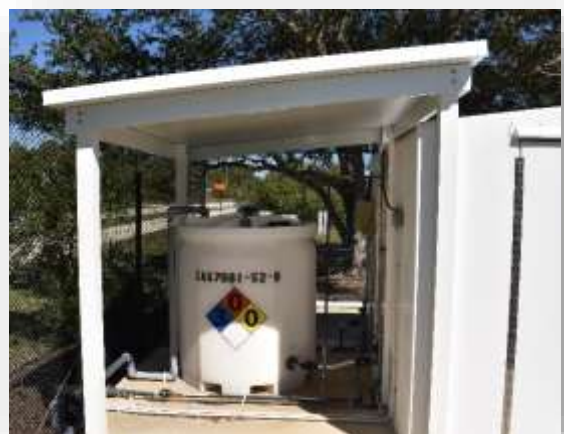
The general condition of the station is fair. The buildings are weathered but in operational condition. The landscaping is maintained.

- The doorstep to the water quality testing and storage shed needs repair.

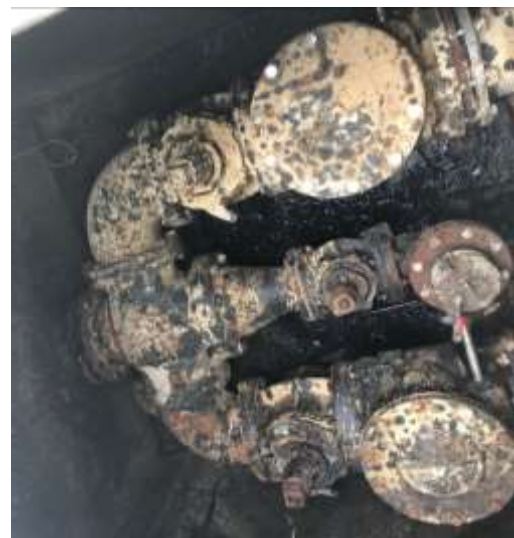
- Signs of corrosion on the wetwell interior wall likely due to high hydrogen sulfide concentration.
- Corrosion of piping and valves in the underground vault.
- Seepage under the west discharge pipe in the wetwell.
- Substantial concrete wear around the odor-control intake piping.
- Minor wear of the fence barbed wire due to local vegetation.

- Provide a stationary generator.
- Coat the wetwell.
- Replace concrete control panel posts with County aluminum standard.
- Replace/repair check valves.
- Replace pumps and other related equipment.

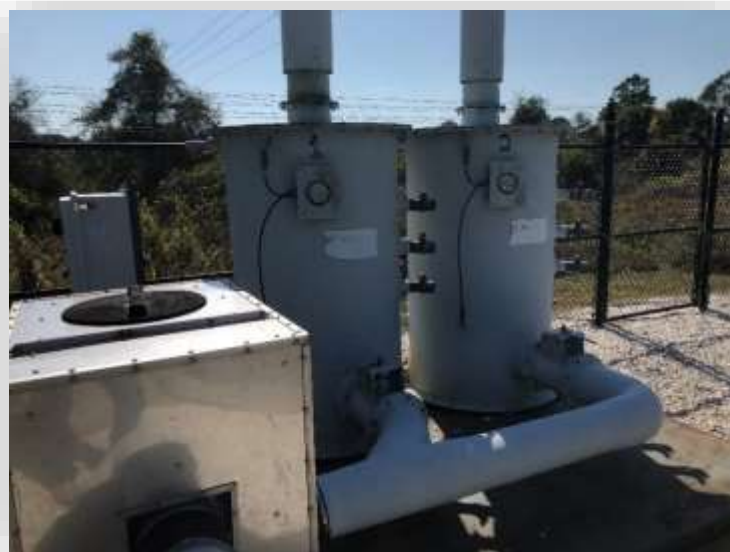
The station is fenced and has a dual carbon vessel odor-control system. A single photometric-operated overhead light is between the generator and the operating panels. The power service to the station is 480-volt, three-phase. The station has a SCADA system with a telemetry transmitter/receiver in the control panel. A 200-kW Kohler generator, rated at 250 kilovolt-amperes (kVA), with an ATS within the fence at the north end of the site. The fenced area also contains a 460-gallon fuel tank. The generator is operated once a week each Monday morning at 9:00 a.m. to maintain generator operability. The station has a potable water hose bibb for washdown.

- The generator door was replaced due to vandalism.

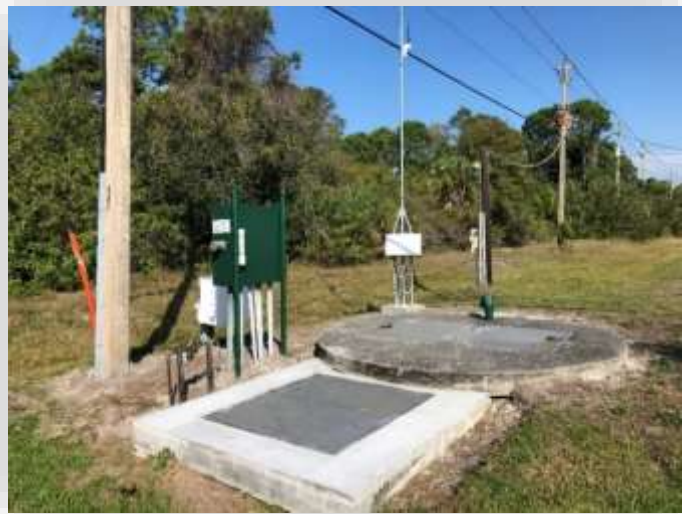
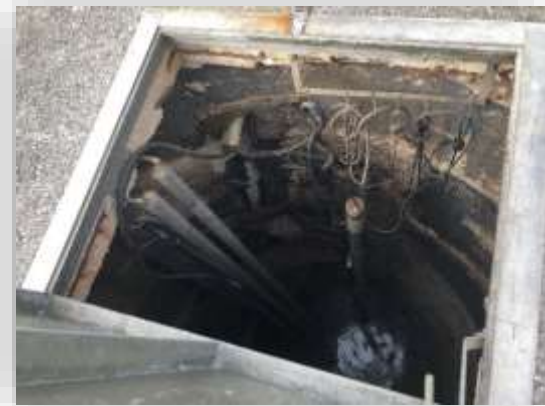
The station wetwell exterior and electrical equipment are in relatively good condition, and the station wetwell interior is showing signs of corrosion. The valve vault cover was recently replaced with a concrete slab and updated hatches; however, significant mud is filling the valve vault and partially covers the valves. The new concrete slab appears to be partially covering some of the valve bolts, which may cause future maintenance issues. The wetwell interior has sufficient storage capacity and does not incur significant impacts from I/I, but the coating is worn, and the concrete top slab is degraded, exposing structural rebar and wood.

The valve vault's surrounding concrete wall base exhibits significant wear-through. The degradation and exposure of the vault has resulted in partially buried valves.

- Signs of corrosion on the wetwell interior wall likely due to high hydrogen sulfide concentration.
- Interior concrete slab shows wear, exposing structural rebar and wood.
- Valve vault includes partial burial of the valves.
- No dedicated suction or discharge bypass piping.
- Phase monitors appeared to be missing.
- The low height of the aerial power supply to the electrical meter possess a potential electrical hazard.
- Missing seal-offs from the control panel conduit. This represents a significant code violation as well as a potential explosion hazard.

- Coat the wetwell.
- Repair or rehabilitate the concrete top slab.
- Modify the valve vault to allow full access to the valves and to prevent them from being buried.
- Evaluate relocating the power supply underground.
- Install seal-offs on any electrical equipment within 10 feet of the wetwell to conform with current codes.
- Evaluate the adjacent lot for future lift station conversion.

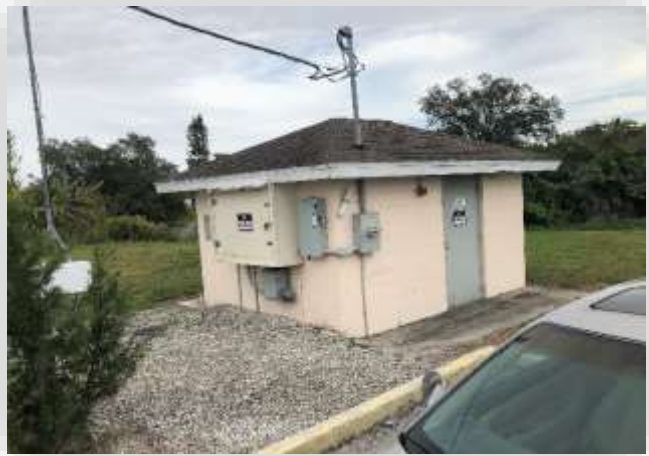
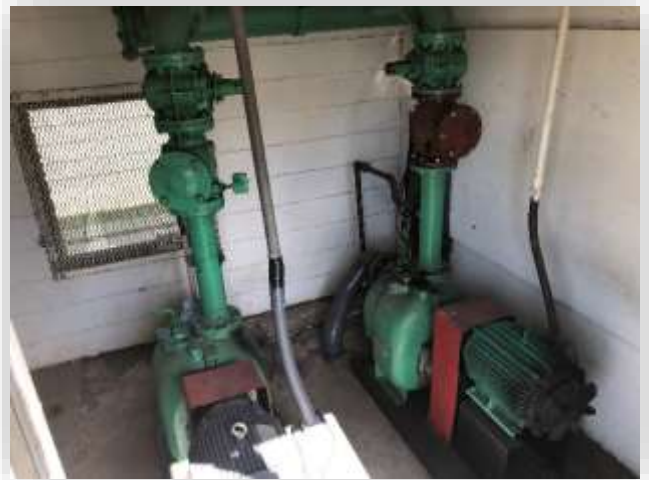
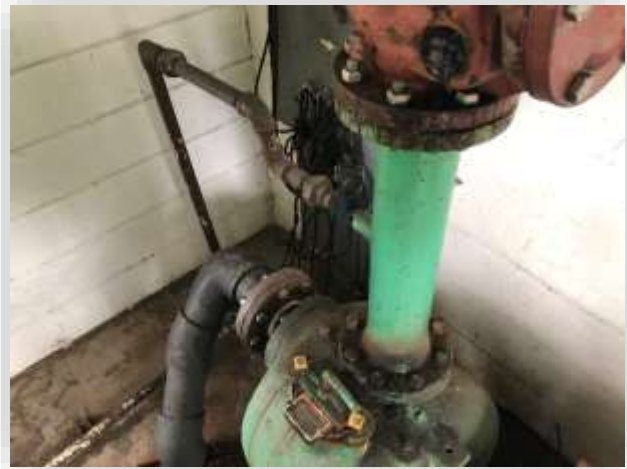
Power service to the station is 240-volt, three-phase, and a pole-mounted transformer directly west feeds the station. The station is not fenced, and metal reinforcement had to be installed behind the vented window after the plexiglass panels were broken by vandals. The building door and panels are typically locked, and the station has internal building lighting. The station has no odor control and no dedicated well suction bypass piping, although a circular penetration in the wall directly above the wetwell cover is available for local pump trucks to access. The site has no potable water available.

The main control panel is a wooden box mounted on the outside the building. The space inside the building is exposed to sewer gases because access for the wetwell entry and float switches are open holes in the floor of the building. A portable generator receptacle with a manual transfer switch was added in recent years. A portable pump connection is in a valve box outside of the building. The station has a SCADA system with a telemetry transmitter/receiver.

- Deteriorated roof overhang.
- Missing glass windowpanes.
- Missing seal-offs from the control panel conduit.
- Obstructed access for a crane truck.
- Remove existing aerial power supply and install underground supply.

- Repair the roof overhang.
- Replace the glass windowpanes.
- Evaluate odor-control opportunities.
- Install seal-offs on any electrical equipment within 10 feet of the wetwell to conform with code.
- Evaluate current pump performance to verify if it is operating efficiently.
- Evaluate possibilities for a dedicated access to the station.
- Perform thorough rehabilitation including the improvements listed above or replace the station with a modern submersible configuration and all new equipment.

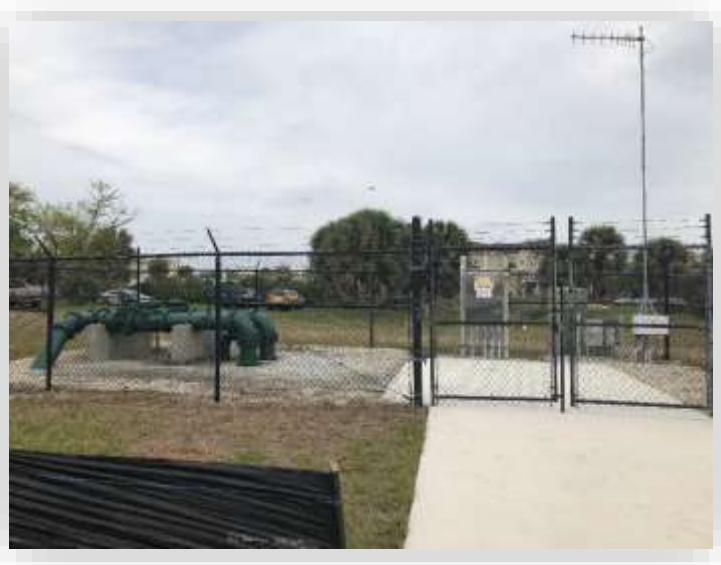
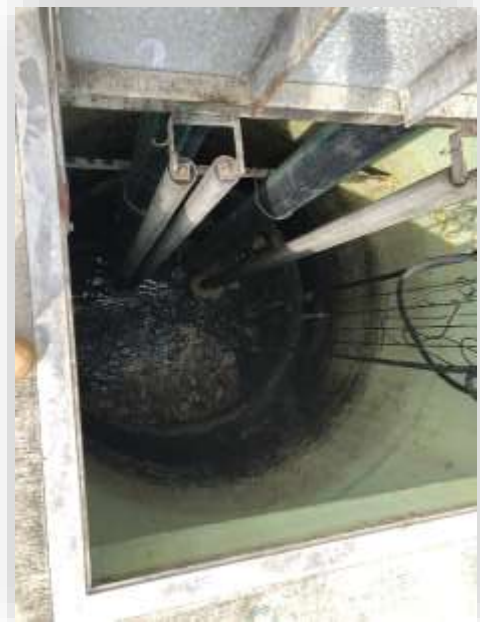
Operations staff noted that the hatch doors at this station are significantly heavier than others in the system and lack a shock or spring system to assist in operation.

- Hatches did not have adequate shocks or springs to assist in their operation.
- Inadequate lighting for evaluating control panel or wetwell.

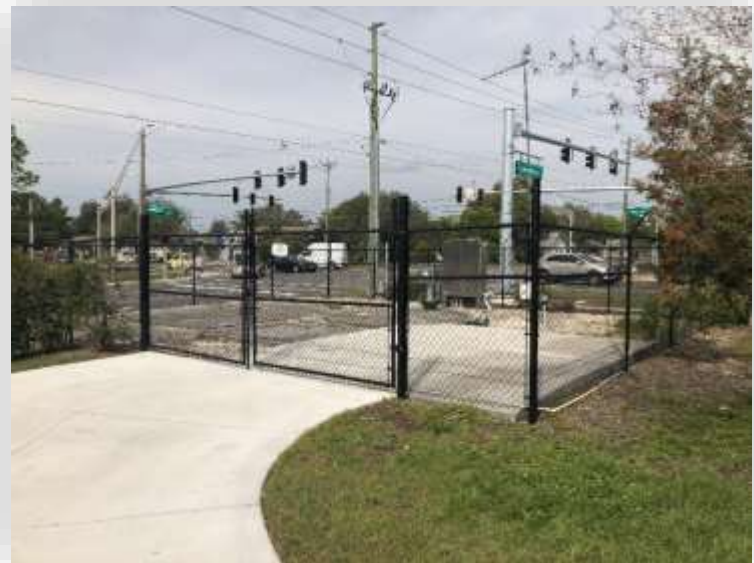
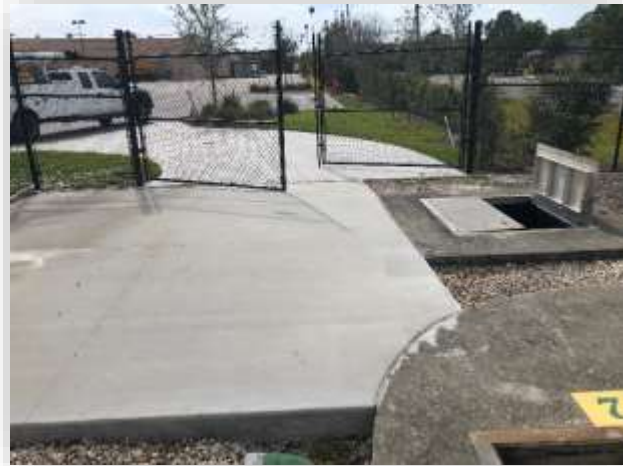
The wetwell lining is largely unaffected by hydrogen sulfide; however, the seams including those in the liner and the pipe penetrations all have signs of seepage and wear. The discharge isolation valves and the emergency dedicated-pump discharge connection are below ground in an adjacent valve vault that is locked with a padlock. The pipe penetrations appear to have been sealed after the HDPE discharge piping was installed; however, an active steady drip from the pipe penetrations has resulted in standing water in the vault despite an open drain port. This condition was observed during a relatively dry period when there was no rain for multiple days.

The power service to the LS 28 is 480-volt, three-phase, and a pole-mounted transformer is south of the site. The station has a SCADA system with a telemetry transmitter/receiver. Minor concrete wear and structural metal rusting were observed on the meter and disconnect switch support posts. Two of the control panel seal-offs were severely discolored and the updated control panel layout covers them, making maintenance difficult. The station has a potable water hose bibb for washdown.

- Minor wear of the concrete meter and disconnect switch posts.
- Rusting of the structural metal supporting the disconnect switch posts.
- Seepage and lining wear around seams and pipe penetrations within the wetwell.
- Nonfunctioning valve vault drain.

- Replace concrete control panel posts with County aluminum standard.
- Re-line the wetwell or specifically address the exposed penetrations and seams.
- Grout the valve vault at the appropriate slope for proper draining.
- Correct the leak in the valve vault piping.

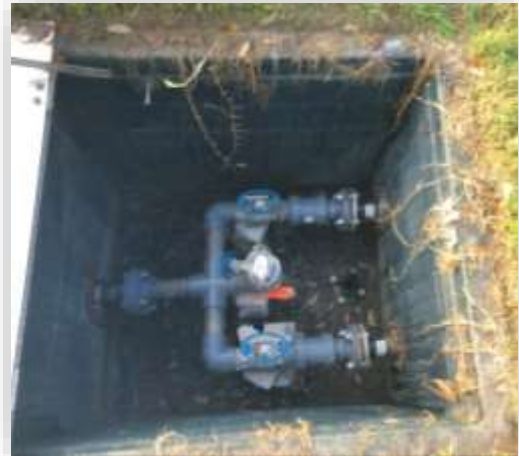
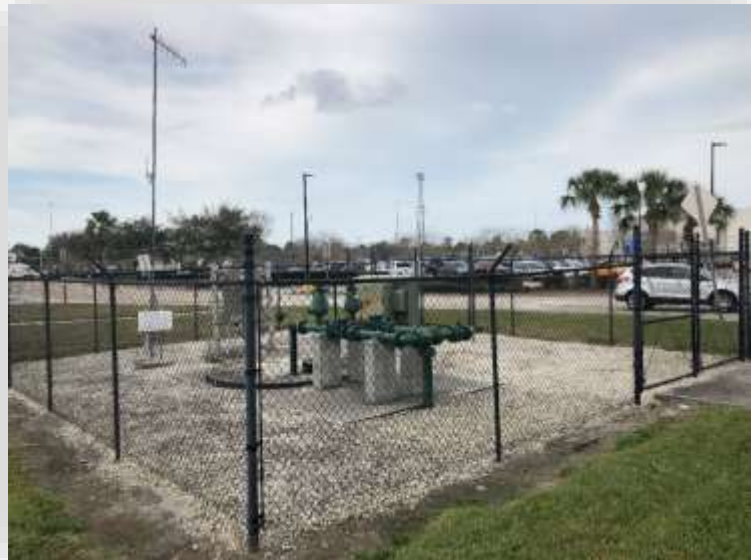
In a previous report, staff had observed severe settling. During the recent site visit, Operations staff noted that site work on this station had been completed. The site work included digging around the station and compacting the layers to prevent additional settling from occurring.

- Settlement impacts including, but not limited to, concrete cracking, pipe bending, PVC cracking, metal bending, and conduit separation.
- Difficult driveway for County trucks to access lift station pumps for maintenance.

- Evaluate two major improvements for the lift station:
  - Repair the on-site infrastructure damaged by the former settling and secure the site with flowable fill.
  - Evaluate the need for driveway relocation.

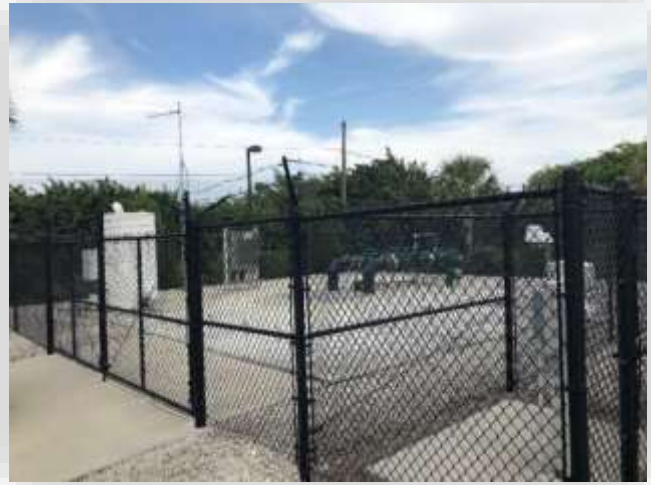
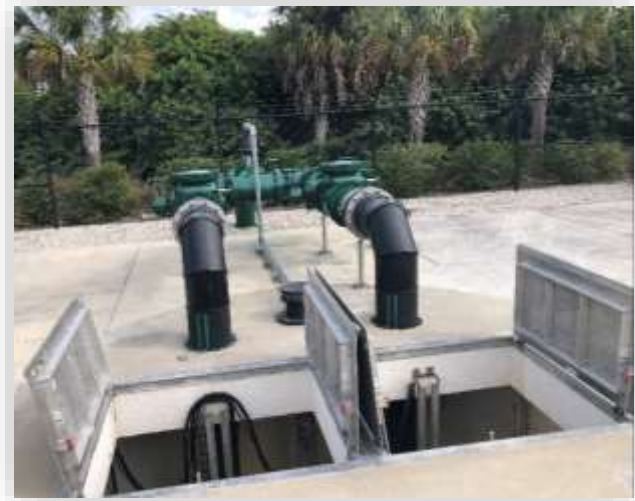
The odor-control blower motor was not operating during the visit. The Operations staff noted that the breaker had been tripped and the unit had not been functioning.

- Tie the odor control into SCADA and evaluate the cause of the breaker tripping.

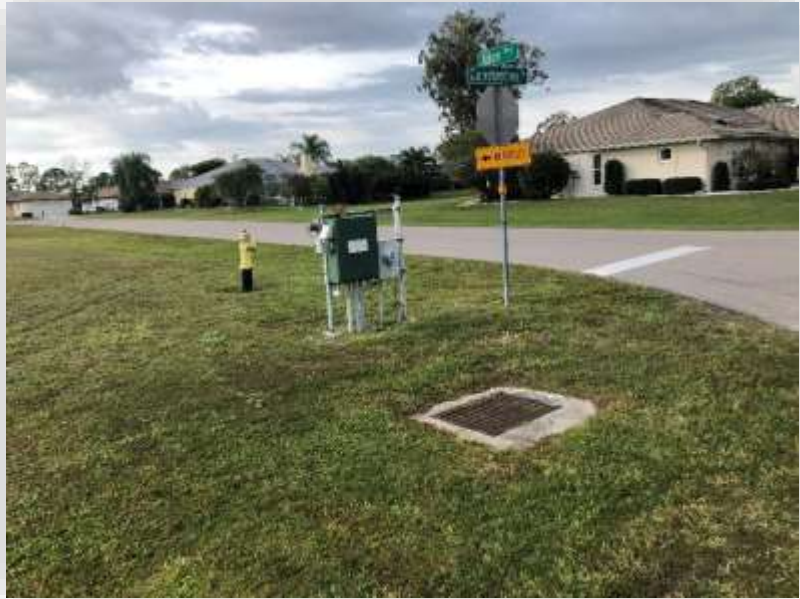
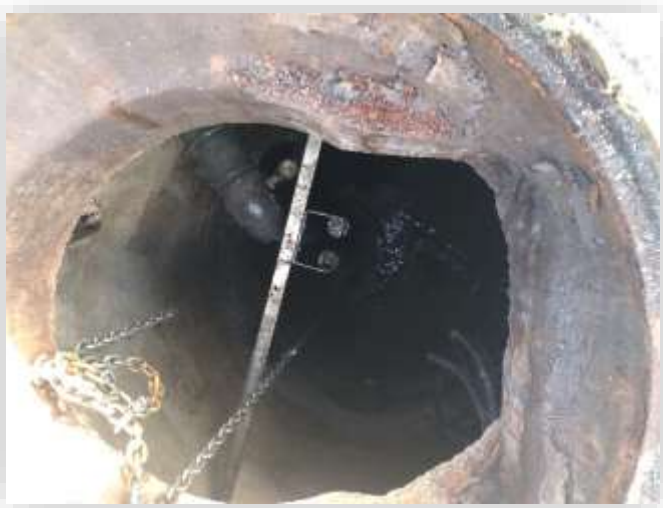
The lift station contains a single 3-HP Flygt submersible pump that was replaced in 2016 along with the floats and drive to include a model NP3085 pump with 462-mm cutter impeller due to significant ragging in the system. The pump has an estimated capacity of 312 gpm at 16 feet of head and is installed in a 7-foot-diameter, 14-foot-6-inch-deep concrete wetwell. The station has no emergency dedicated pump discharge connection, and there are no guardrails to guide removal of the pump.

The wetwell is in the center of the road intersection, which requires Operations staff to manage traffic during routine maintenance and any pump removal. The wetwell has some signs of corrosion and seepage under pipe penetrations in addition to having an older conical lid design that obstructs access during the maintenance events. The County owns the adjacent lot southeast of the intersection. The design to move the lift station into the lot and the existing wetwell converted to a master manhole has been completed. The new design includes isolation valves and bypass piping, which currently do not exist at this simplex station.

- Signs of corrosion on the wetwell interior wall likely due to hydrogen sulfide concentration.
- No interlock between the generator breaker and the main breaker.
- Missing seal-offs from the control panel conduit.
- Difficult to access wetwell.
- No isolation valves.

- Coat the wetwell or repair some of the degraded concrete.
- Install seal-offs and interlocks on electrical equipment and perform a detailed electrical code review to return to conformance with code.
- Evaluate the installation of a secondary standby pump.
- Prepare for construction of improved design noted by Operations staff.

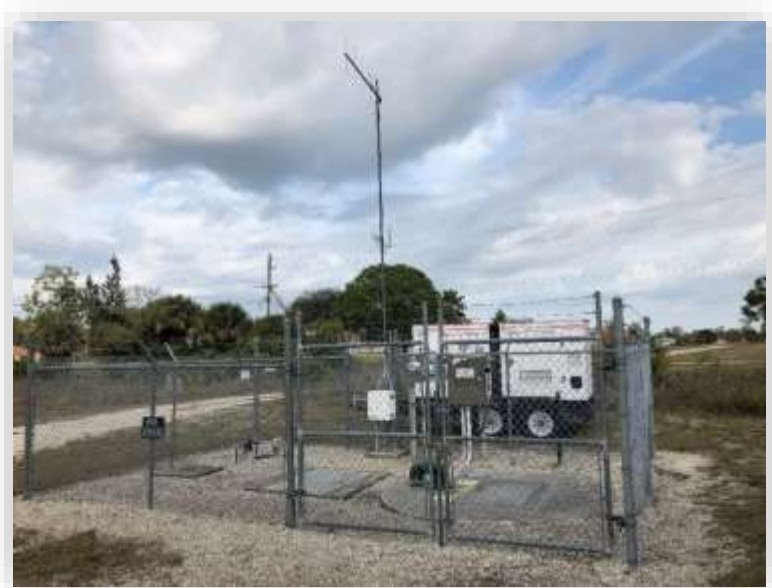
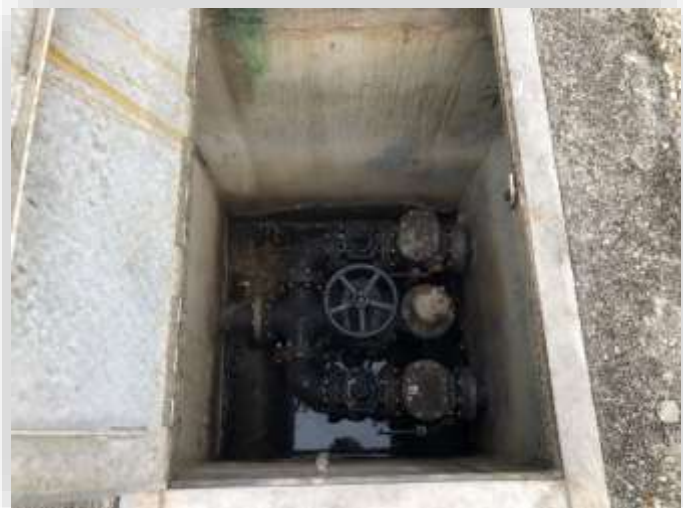
- Signs of corrosion on the wetwell and valve vault interior due to hydrogen sulfide concentrations.
- The valve vault is very deep and may be a confined space.
- Missing seal-offs from the control panel conduit.
- The conduit was partially installed within the concrete of the wetwell, possibly undermining the integrity of the concrete and resulting in difficulty performing electrical maintenance.
- Check valve was noticeably leaking.

- Coat the wetwell and seal and repair the contents of the valve vault.
- Evaluate replacing the valve vault with all above grade discharge piping for easier maintenance and to prevent any confined space concerns.
- Install seal-offs on electrical equipment within 10 feet of the wetwell to conform with code.
- Evaluate an upgrade to the electrical equipment including replacing the aging control panel, updating the conduit location, and generally bringing the system up to current standards.

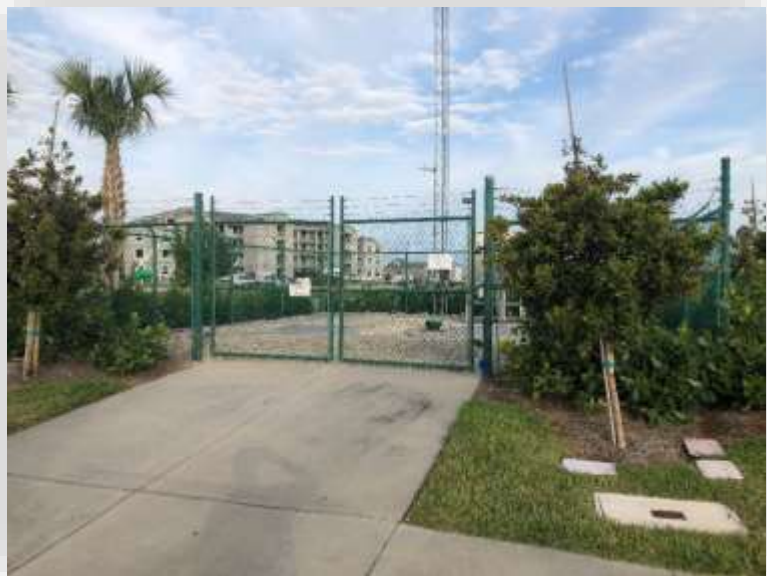
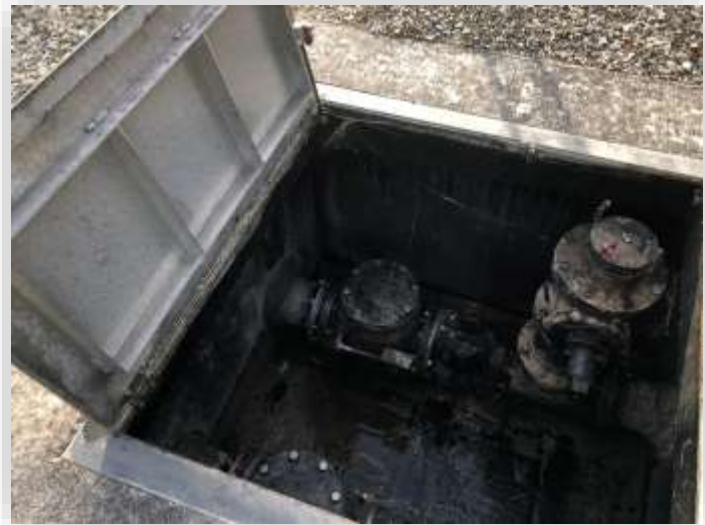
The station contains two 30-HP Flygt model CP3170 submersible pumps with 443-mm impellers in an 8-foot-diameter, 23-foot-6-inch-deep concrete wetwell. Each pump has an estimated capacity of 878 gpm at approximately 82 feet of head. The wetwell hatches are in good condition and provide adequate access to remove the pumps from the lift station rail retrieval system; however, the rails appeared to be composed of two rails welded together and appear to be buckling slightly at their connection point, causing potential difficulty in pulling or

- The guide rails were noted to be jutting out.
- The pumps in the wetwell were extremely large for the small flow being observed, resulting in short run times.

- Continue to monitor the station as flows increase.
- Evaluate replacing the guide rails with a single rail of the correct length.
- Evaluate if a smaller impeller diameter might be worth considering while the flow demands are still low.

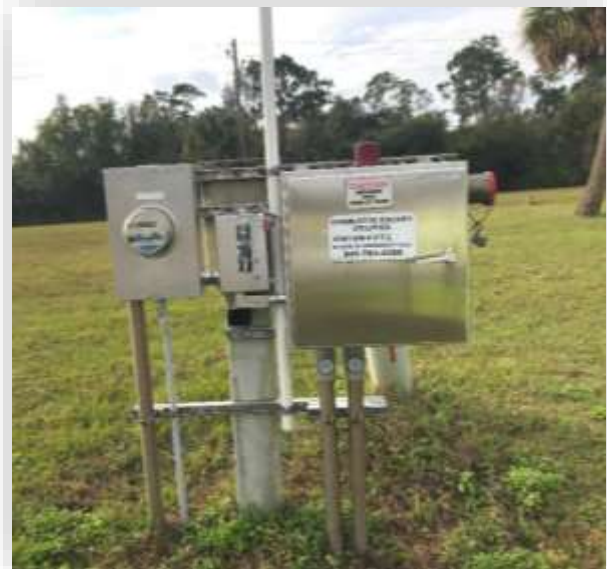
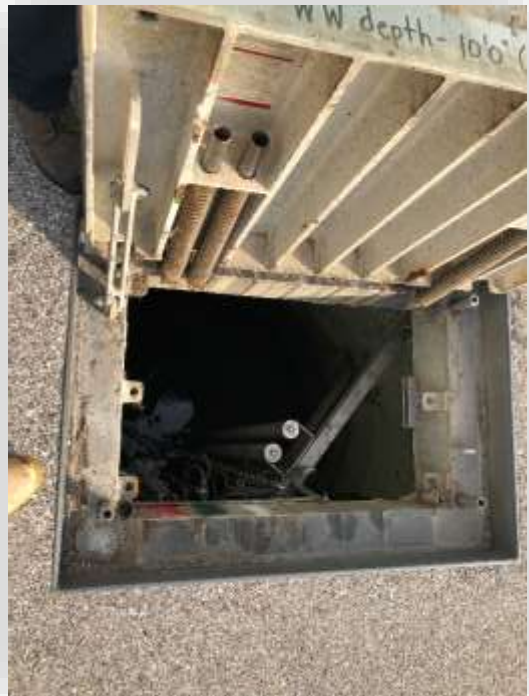
The wetwell has almost no signs of corrosion and has bolt-down access hatch. The wetwell is in the center of the intersection, which requires Operations staff to manage traffic during all maintenance activities. Additionally, Operations staff may schedule some operations to be performed at night when warranted.

- Location of wetwell and method to access hatch requires maintenance of traffic to avoid endangering staff.
- No isolation valves.
- No stand-by pump.
- No bypass piping.

Recommendation:	<p>Lift Station No. 442 – Doredo 2</p> <ul style="list-style-type: none"> <li>▪ Evaluate an adjacent lot for future lift station conversion.</li> <li>▪ Evaluate the installation of a secondary standby pump.</li> </ul>
<i>Progress:</i>	<i>Not completed.</i>

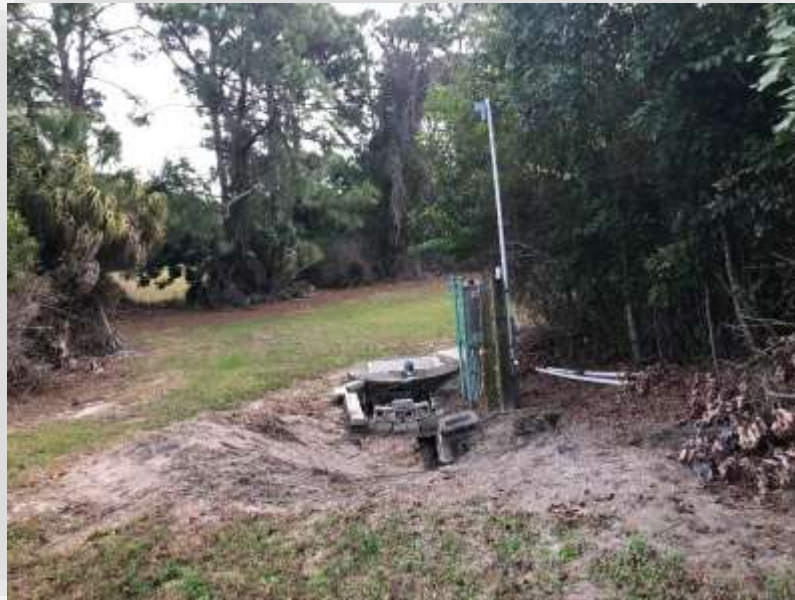
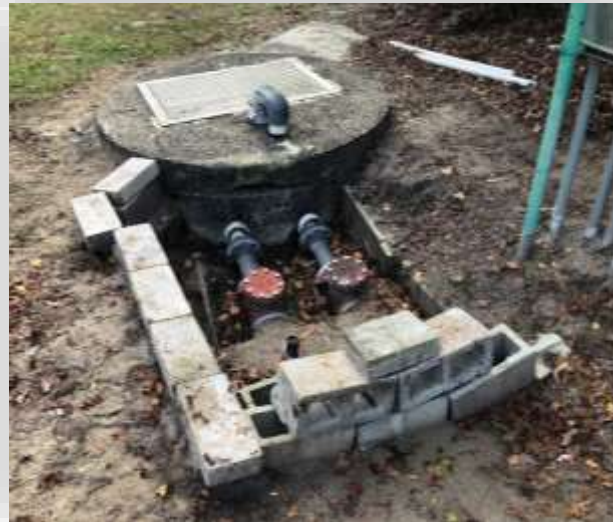
The station is not fenced and has no odor control. The wetwell has cracking and root intrusion. Previous sealing patches inside the wetwell have corrosion, which may allow I/I into this wetwell. The station has no valve vault cover, and the surrounding soil erosion has filled the remaining cracked concrete walls, partially burying the isolation and check valves. The area around the valves was recently built up with cinder blocks in FY 2019; however, the valves remain buried, likely due to rainfall runoff shifting the soils. The pipes appear to have been sealed to prevent the water from leaking from the discharge force main into the valve vault, but there are signs of damp soil in this area. No hose bibb is provided for washdown.

- Signs of corrosion and intrusion in the wetwell.
- Missing seal-offs from the control panel conduit.
- Despite recent improvements, worn and partially buried valve vault.

- Coat the wetwell and seal and repair the contents of the valve vault.
- Install interconnect and seal-offs on any electrical equipment within 10 feet of the wetwell to return to conformance with code.
- Repair the dead front panel or modify to bring back to conformance with OSHA, NEC, and County safety requirements.
- Evaluate the two proposed adjacent lots for future lift station conversion.

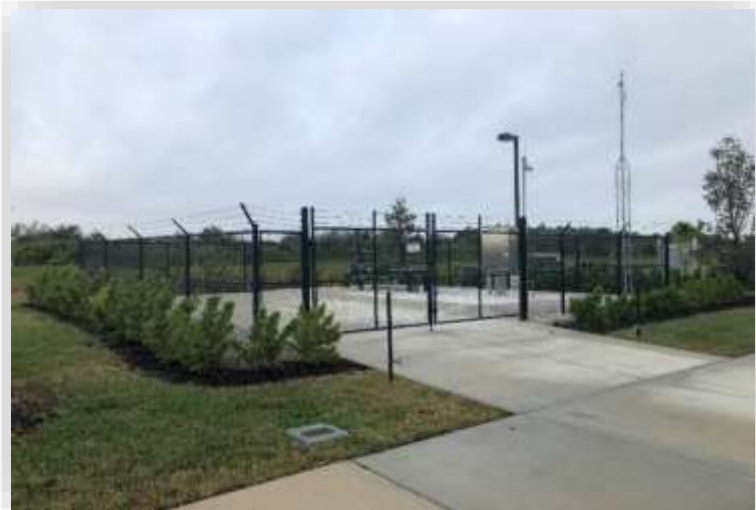
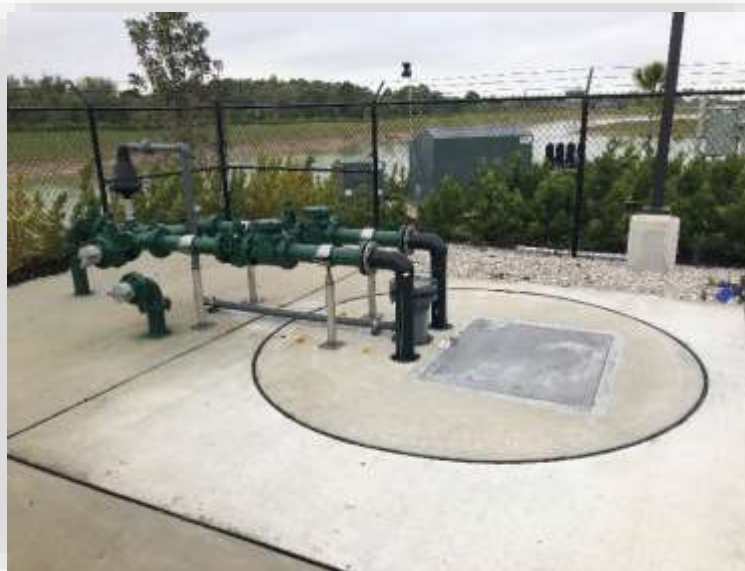
The wetwell hatches are in good condition and provide adequate access to remove the pumps from the lift station's rail retrieval system. The wetwell lining is largely unaffected by hydrogen sulfide. The discharge isolation valves, and the emergency dedicated pump suction and discharge connections are above grade to the north of the wetwell.

- Evaluate if a smaller-diameter impeller might be worth considering while the flow demands remain low.

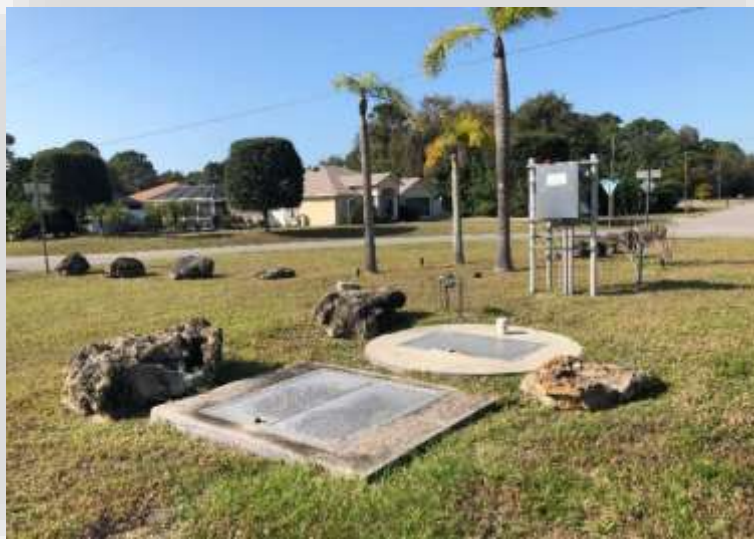
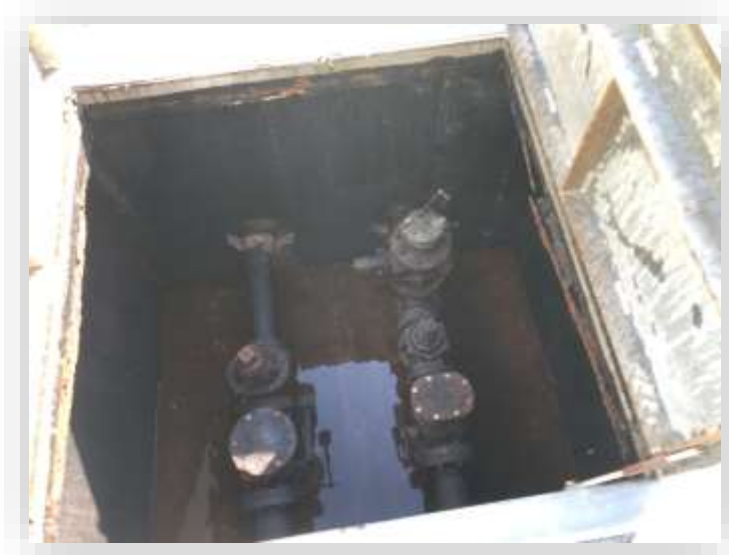
Signs of hydrogen sulfide corrosion and wear exist on the influent manhole and in areas where the wetwell coatings are separated and where pipes penetrate the walls. The valve vault had standing water despite an open drain port and no recent rainfall.

Additionally, signs of corrosion were observed in the valve vault, likely due to hydrogen sulfide gas. The bypass pumping connection in the valve vault was directly tied into one of the discharge pipes instead of the combined discharge header. The valves also had significant rust and wear.

- Wetwell and valve vault corrosion.
- No fencing or odor control.
- Standing water in valve vault
- No SCADA or Omni-Beacon system.

- Coat the wetwell and seal and repair the contents of the valve vault.
- Evaluate fencing and odor control.
- Grout the valve vault at the appropriate slope for proper draining.
- Evaluate installation of a SCADA or Omni-Beacon system for remote monitoring or control.
