# Charlotte County Utilities Department

**2019 Annual Report**  
**March 2020**

## **2019 ANNUAL REPORT**

Jones Edmunds Project No.: 03405-029-03

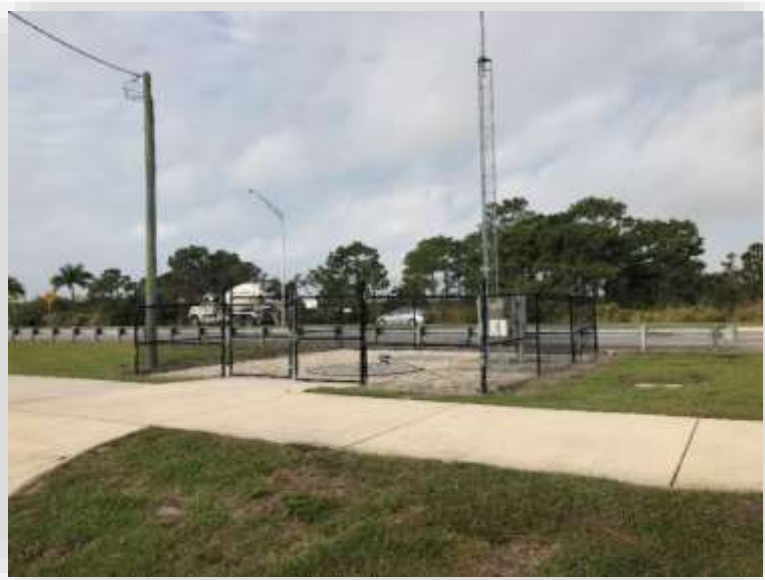
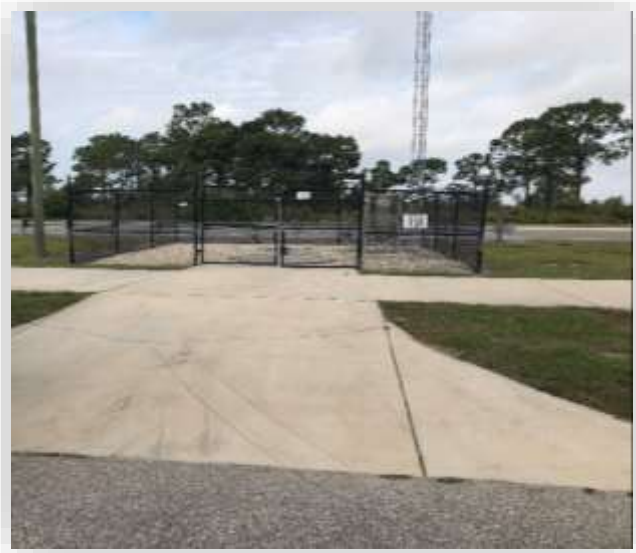
The station recently received improvements related to the adjacent highway design. The updated layout included a steep driveway leading up to the lift station. Operations staff noted this has caused difficulty bringing trucks and generators up to the lift station site.

- The driveway leading up to the station is steep and may provide difficulty driving over or bringing a generator over it.
- One of the pumps was removed during the on-site visit.
- Operations staff noted that the station only runs about 5 to 7 hours per month.

- Evaluate lengthening the driveway to reduce the slope or provide a smoother access point to prevent damage to vehicles or generators.
- Evaluate the benefit of either an uninstalled spare or keeping an emergency pump connection on site when only one pump is available.
- Evaluate if a smaller impeller diameter might be worth considering while the flow remains low.

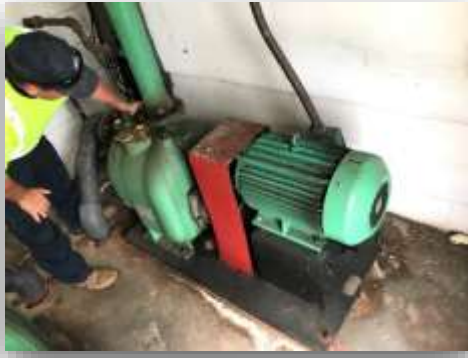
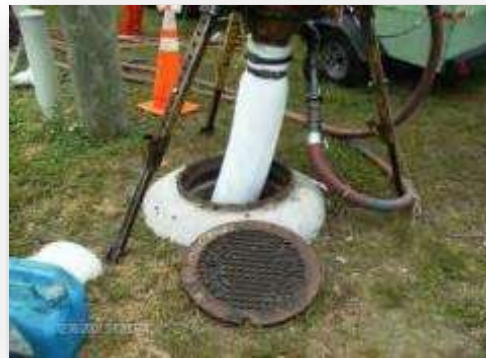
The average age of the CCU gravity system is nearly 50 years. Older sewers were typically installed in swales, which made them more prone to I/I. Also, design and construction standards were not as stringent as the current practices. Pipe material and joints were constructed with material that deteriorates with time. The older gravity sewer pipes are vitrified clay with frequent joints that are sources of infiltration. Vitrified clay pipe is resistant

to corrosion but is more brittle than PVC and HDPE pipe. After many years of service, cracks develop and pieces of the clay pipe protrude into the flow stream. Although CCU has relatively few plugged sewers, the broken clay pipe will cause blockage and must be repaired.

CCU Wastewater Collections staff performs in-place pipe repairs to fix most of the broken pipes in the system. Most of these repairs involve a cast-in-place lining, fold-and-form lining, or PVC lining. These repair methods restore the integrity of the sewer system without requiring excavation.

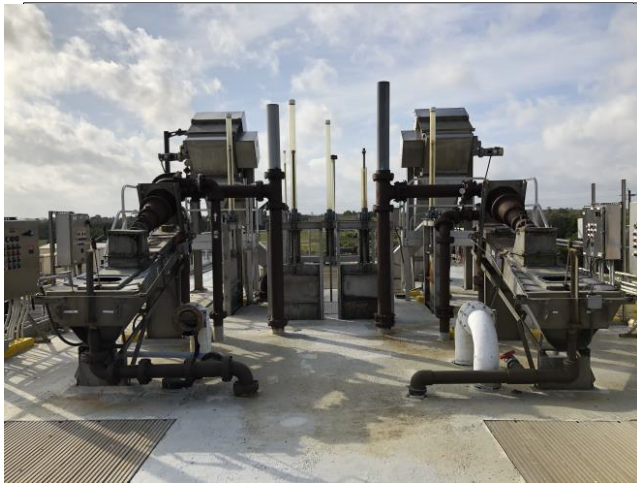
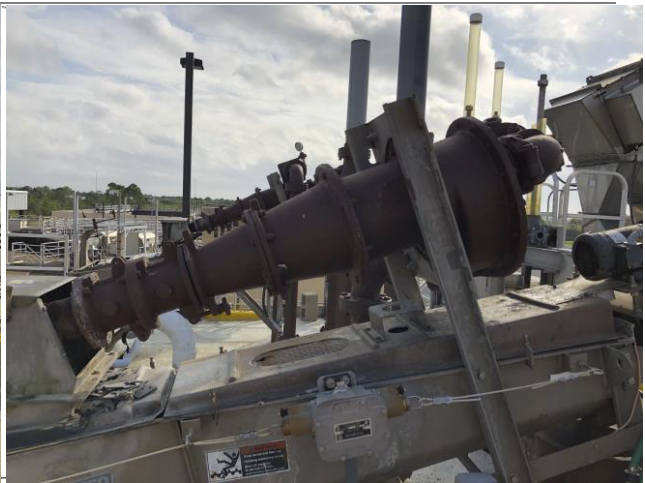
The old grease dewatering building is now used for bulk storage. The screening and grit bagging system that was attached to the chutes that discharge into the dumpsters has significantly reduced the water on the floor, flies, and odors that usually accompany headworks' dumpster areas. The floor is clean and dry.

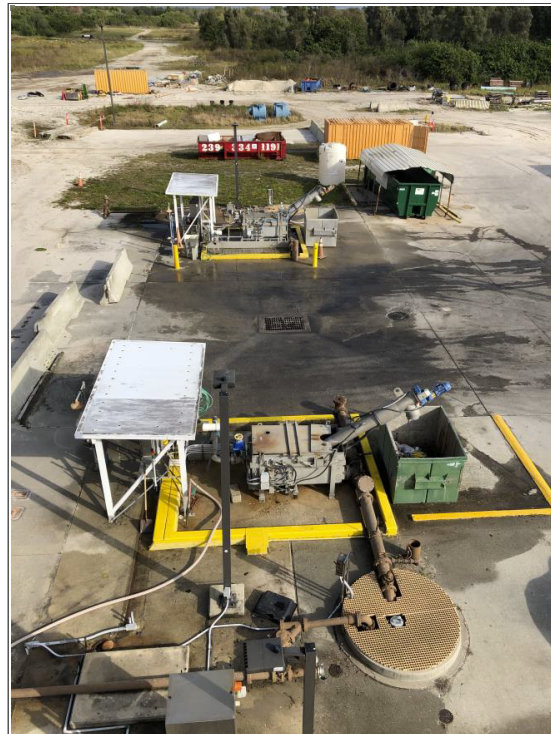
The two septage receiving stations require constant maintenance due to the high number of septage haulers that use the facilities and the nature of the waste. The septage receiving units are aging and need to be included in future capital replacement plans. Replacement of moving parts on Septage Receiving Unit No. 1 was completed in FY 2016.

The septage receiving units and the adjacent driveway area collect grit and spillage of septic waste. A hose is used by the haulers to clean the area. The wash water is collected in the plant sewer system and pumped to the headworks for treatment. A steam cleaner is used by CCU WRF staff for cleaning this area periodically.

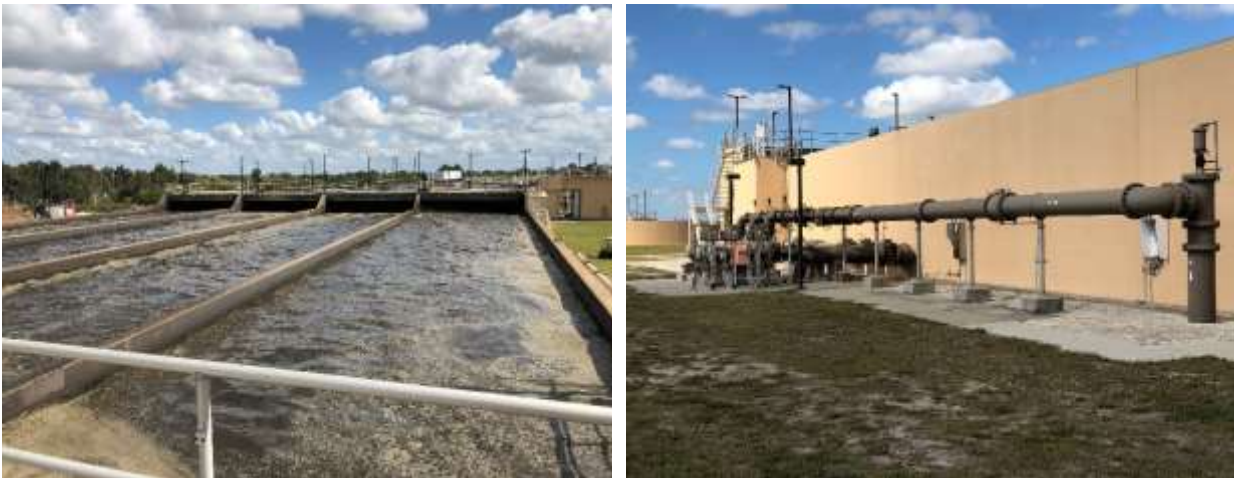
The overall condition of the MLE process is good following the Stage 1 and 2 Improvements in 2015 and 2016, respectively. The concrete is in good shape for its age and showing very little cracking or spalling. The anoxic zones are thoroughly mixed by four submerged mixers. A baffle wall was installed in both anoxic tanks to minimize short-circuiting and improve performance.

Four VFD-controlled surface aerators are in operation in the oxidation ditches. The aerator speed is adjusted based on the dissolved oxygen (DO) probe at the end of the ditches. The aerators are well maintained. The DO control system helps the WRF lower its power consumption and improve the denitrification process by minimizing DO carry-over to the anoxic zone. Six VFD-controlled IR pumps were replaced in the Stage 1 and 2 Improvements. These pumps are controlled by the SCADA based on operators' settings. The IR pumps are well maintained and in good working order.

The five RAS pumps are VFD controlled. The two WAS pumps are controlled by operators' settings in the SCADA system. Both pumping systems are well maintained and in good working order.

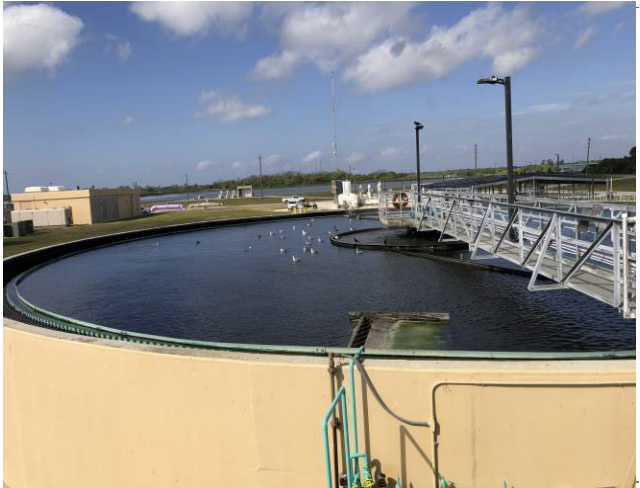
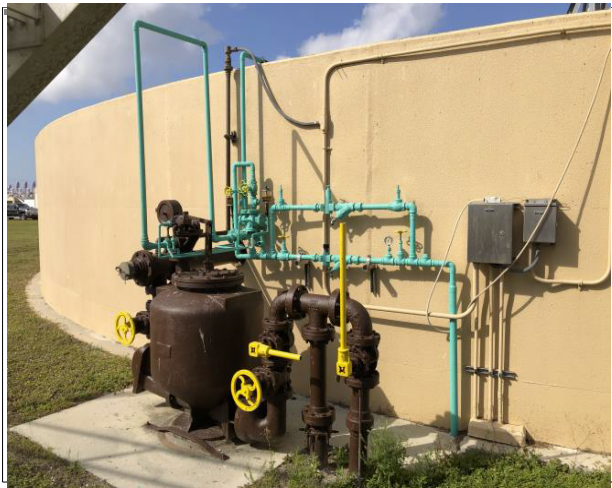
In 2016 the two clarifiers were rehabilitated as part of the Stage 1 and 2 upgrades, which included replacement of the clarifier scraper mechanisms. The overall condition of the sedimentation process is well maintained and clean, and the clarifiers are producing a high-quality effluent.

The existing scum ejectors are out of service and should be replaced with a cost-effective scum-removal system as part of future plant expansion.

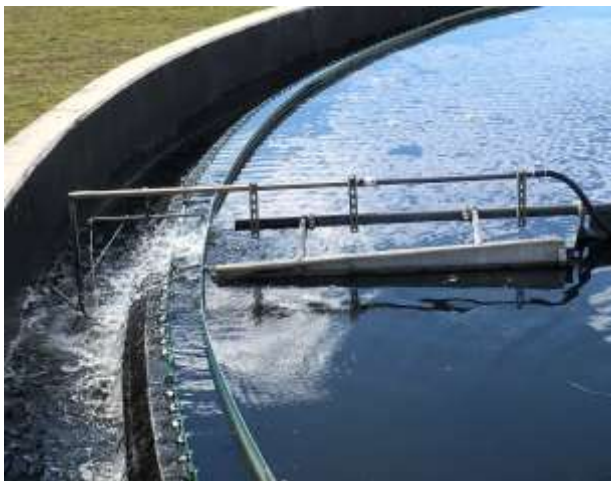
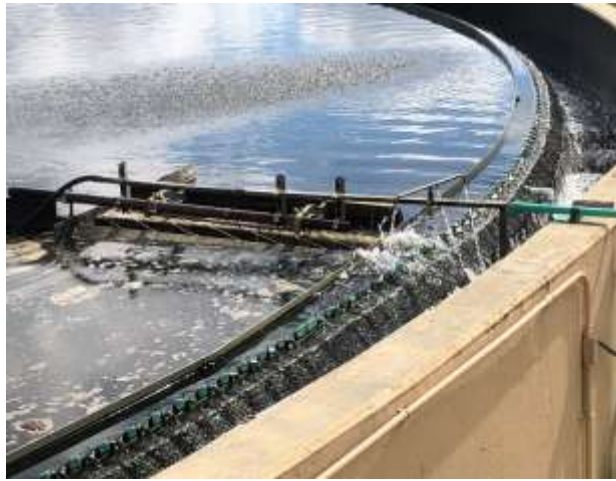
A “weir washer” system was installed on Clarifier No. 1 and Clarifier No. 2 in 2017 and 2018, respectively. The weir washers eliminate the need to have O&M staff enter the clarifier effluent launders to remove algae, eliminating associated safety concerns. The weir washers do an excellent job keeping the clarifier effluent weirs and troughs clean. An excellent-quality effluent is being produced by both clarifiers.

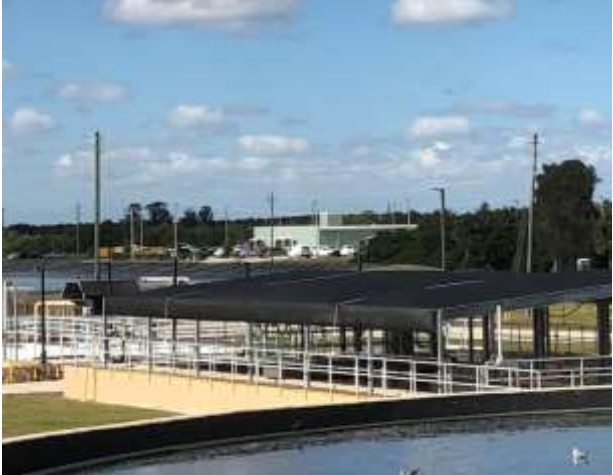
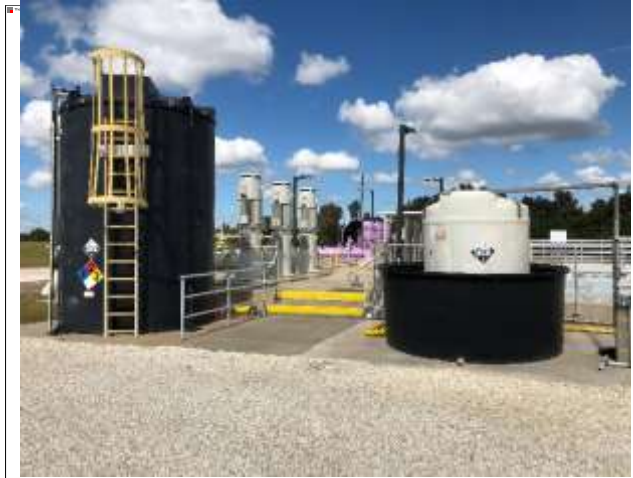
The overall condition of the effluent filtration system is excellent and well maintained. Filters were rehabilitated as part of the Stage 1 and 2 Improvements.

The two-traveling bridge sand/anthracite filters were both in operation at the time of the site visit. Turbidity results indicate that the filters are producing an excellent effluent for unrestricted public-access reuse water. Additional anthracite is scheduled to be added during FY 2020.

A galvanized metal frame was installed over the filters in the Stage 1 and 2 Improvements to support a fabric roof constructed of UV shade cloth. The cloth roof reduces algae growth and lowers the temperatures within the travelling bridge filters to produce a higher quality effluent and reduce the amount of chlorine cleaning needed to remove algae from the filters.

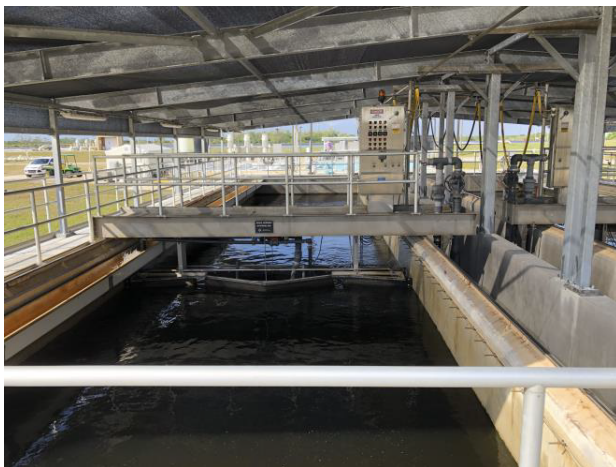
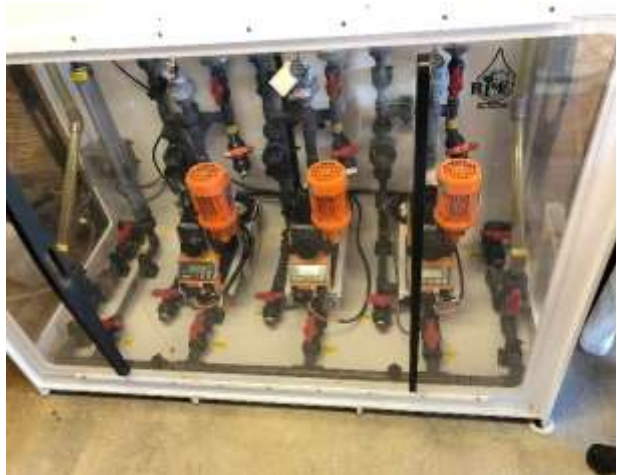
The CCCs are in good condition, well maintained, and operated to produce RCW for unrestricted public-access reuse. A UV shade cloth was recently installed over the CCCs to reduce the loss of chlorine residual in the tanks. The previous UV shade cloth was removed by strong winds during Hurricane Irma in September 2017. Liquid Sodium Hypochlorite (12.5 percent) is used for disinfection to maintain a residual of  $\geq 1.0$  mg/L to meet unrestricted public-access reuse standards. In 2018, the old liquid reagent chlorine residual analyzer was replaced with a non-reagent analyzer to control chlorine feed rates. Another non-reagent analyzer is used for chlorine residual compliance measurement. The new skid-mounted chlorine feed system is encased in a clear plastic enclosure to control the spray of liquid chlorine for safety purposes. The two sodium hypochlorite storage tanks are well kept and meet regulatory requirements. The overall chemical feed systems and instrumentation are well operated and maintained to meet regulatory permit requirements.

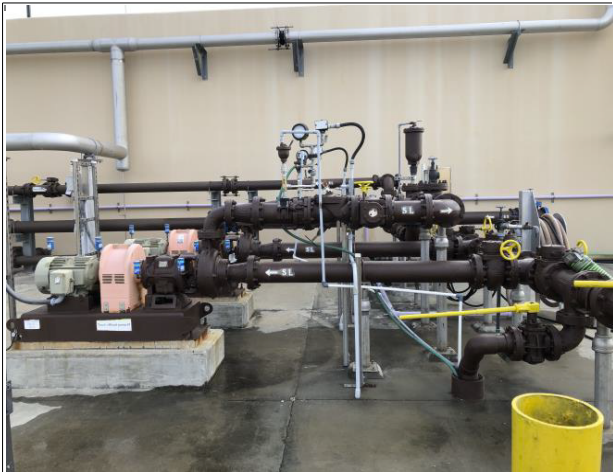
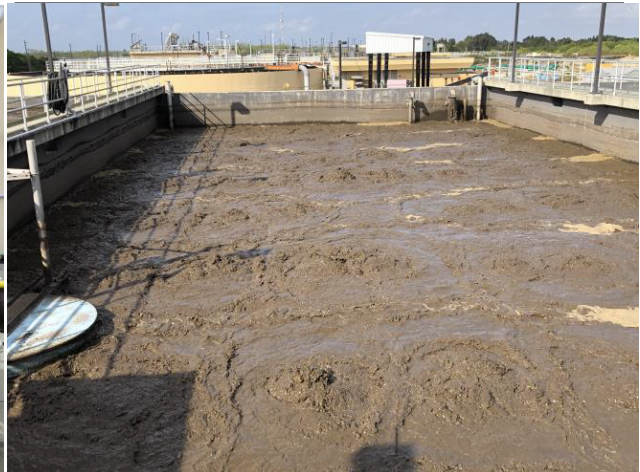
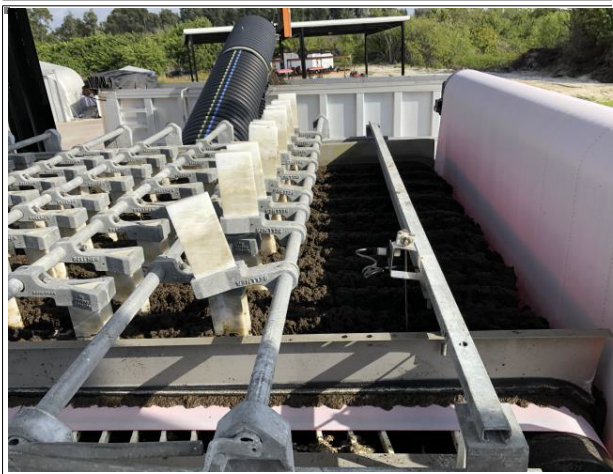
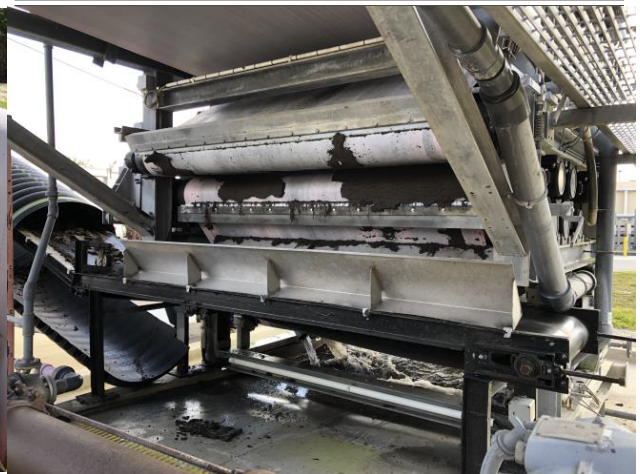
The Lead Operator noted that in 2019, the capacity of the aerobic digesters to handle biosolids from all four facilities is starting to become an issue where sufficient time to allow tank decanting is limited due to the increased sludge flows. As illustrated in Table 6-8, the total processed biosolids at the East Port WRF was more than available digesters' capacity during March 2019 and August 2019. This limited capacity led to holding back on hauling of biosolids from the other three facilities, which negatively impacted their performance.

The Lead Operator also indicated that the aeration and decant equipment associated with the aerobic digesters are not functioning properly and require extensive O&M effort for up to 16 hours a day including weekends. One of the blowers is down and being rebuilt. In addition, the BFP requires constant attention and experiences a lot of down time, reducing the dewatering capacity of the WRF. Installing a third BFP is recommended to add more dewatering capacity and allow for refurbishing of the older units.

Improvements to the feed piping to the two 2-m BFPs were completed under the Stage 1 and 2 Improvements. The BFPs run 5 days per week, 8 hours per day to dewater the CCU's biosolids. Dewatered biosolids are hauled to the County's Zemel Road Landfill Compost Facility for composting.

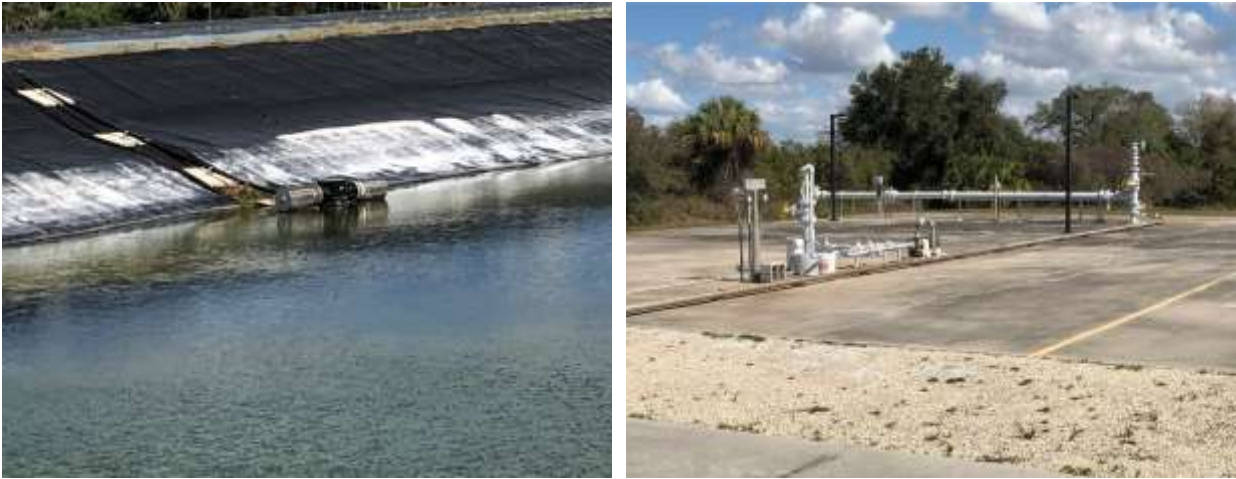
Excess RCW or effluent not meeting RCW standards (reject water) is disposed of through two deep injection wells and a restricted-access, on-site slow-rate irrigation system (on-site sprayfield). The 45-MG effluent storage pond is used to store effluent before injection well and/or sprayfield disposal. The 45-MG pond liner is in good condition.

Effluent transfer pumps are well maintained but are showing signs that they need to be repainted. The irrigation pump station is on the east bank of the 45-MG pond and pumps water from the pond to the deep injection wells or the sprayfield.

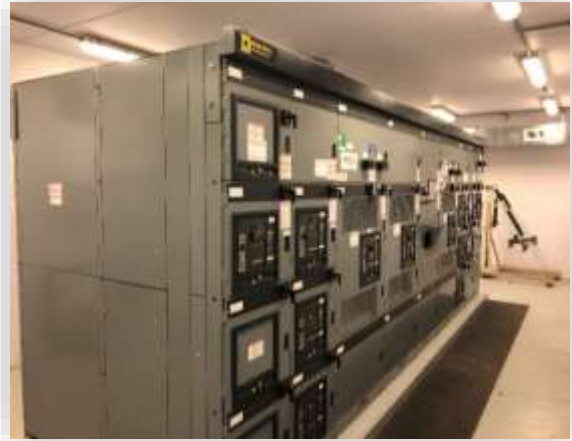
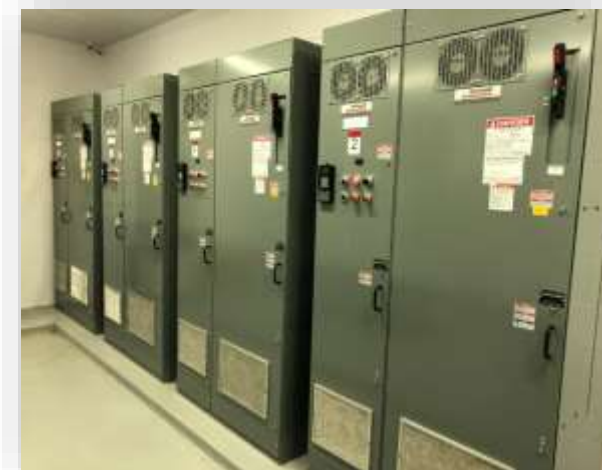
The incoming service and distribution transformers at the administration building are relatively new and in excellent condition with no obvious signs of concern. The standby generator functions properly and is in good condition. Since it was relocated from another location, it does show signs of wear and deterioration but with no major issues to interfere with its function. The distribution switchgear of the administration building was in excellent condition with minor issues (see below). Overall, the electrical equipment is in good functioning condition based on information from Operations staff.

The incoming switchgear building was constructed only a few years ago. As such, all equipment is in excellent condition (see photograph at left). The facility is fed from two power company transformers, also newly installed. A thermographic survey of the facility showed no anomalies or issues.

The generator/MCC building is an existing building with older equipment and new equipment installed under Stage 5, and Stage 1 & 2 Improvements. The existing switchgear appears to be in good condition. The switchgear includes complete arc flash labeling required by NFPA 70E. The existing 1,250-kW generator is in overall good condition, but the Chief Operator reported that it requires upgrades and an overhaul. The generator set shows minor points of fluids seepage.

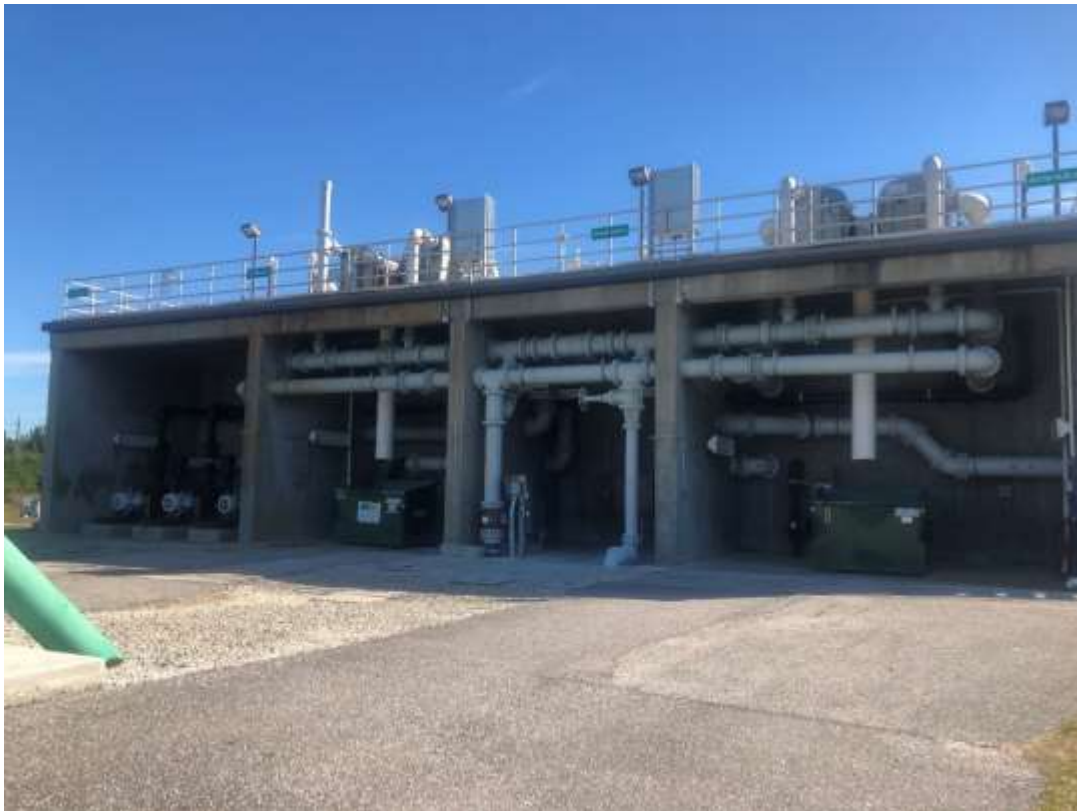
The rotary screens were rebuilt in 2017 but are still having problems. At the time of the site visit, two screens were out of service. Therefore, the rotary screens will be replaced in FY 2020.

Pin holes have developed in the 304 stainless steel housing due to the highly corrosive gases released in the headworks. To help protect the equipment, the screen housings have been sand blasted and painted with epoxy paint. Other alternatives to reduce or eliminate the highly corrosive hydrogen sulfide gasses at the headworks include flow equalization and chemical oxidation.

Most components are stainless steel, but the few carbon steel components are a constant maintenance challenge. Staff clean the screens twice daily to help delay rusting from exposure to hydrogen sulfide. The Type 316 stainless steel wedge wire drums are in very good condition. The concrete area around the screens is cleaned twice daily by hosing down screenings liquid into the aeration basins.

At the time of inspection, the dumpster area was found to be clean with only slight leakage of water from the dumpsters to the drains under the dumpsters.

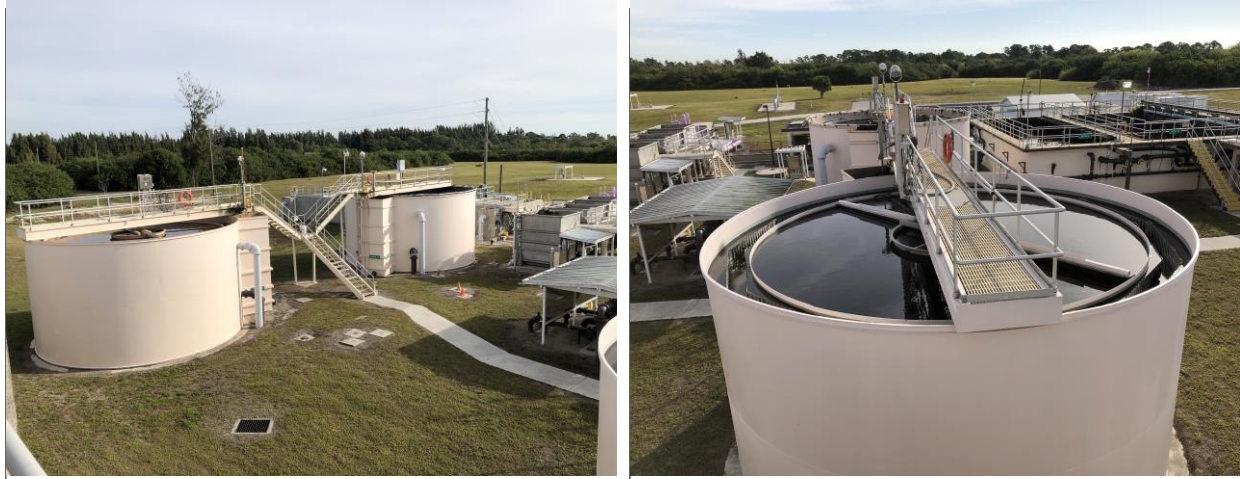
Plant Operations staff follows a routine schedule of clarifier inspection, repair, and painting. At the time of inspection, three of the four clarifiers were in service. Clarifier No. 3 was taken offline, serviced, and painted in FY 2018, and put online in FY 2019. Servicing and painting of Clarifier No. 4 is scheduled to follow Clarifier No. 3 in FY 2020. However, due to some warranty claims on the painting of Clarifier No. 3, painting of Clarifier No. 4 may be delayed.

Overflow weirs are hosed daily and brushed weekly to keep them clean. The overflow weirs were leveled in FY 2017. New weirs were installed in Clarifier No. 1 and Clarifier No. 2 in 2018. Clarifier No. 3 and Clarifier No. 4 are scheduled to have new weirs in FY 2020.

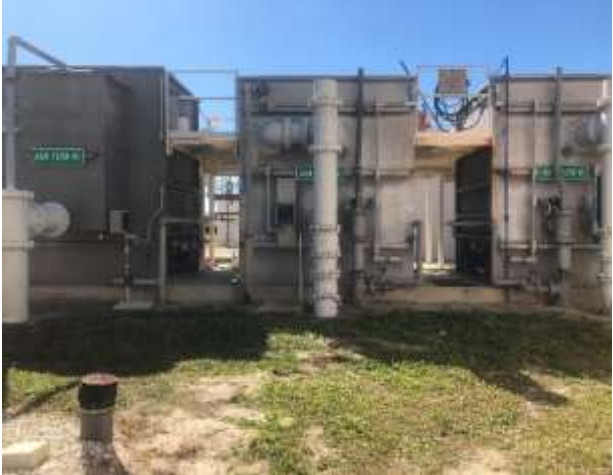
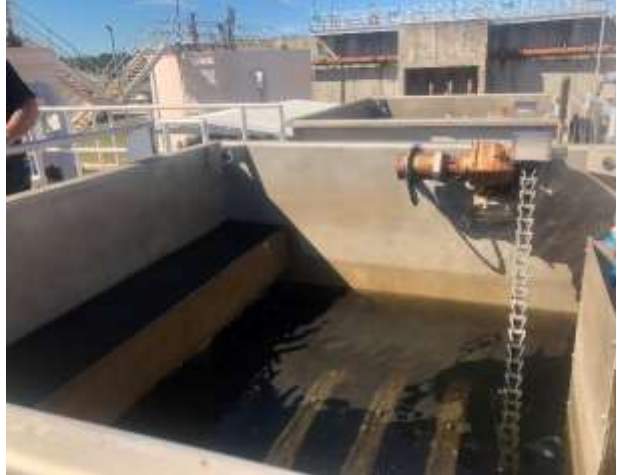
The filters are in good condition. The tanks are cleaned every month with 5 gallons of bleach. A UV cover was put on the filter tanks and then removed because access to the filters during maintenance activities was blocked. We recommend installing a galvanized metal frame and UV cover above each tank to prevent algae growth in the filters.

All three filters were in operation at the time of the site visit and working properly. All three filters have been replaced with new 5-micron filter cloths. The Chief Operator stated that a higher-quality effluent is obtained when all three filters are operating in parallel.

The filters are constructed of Type 304 stainless steel, but the fiberglass grating platform between the filters is supported by carbon steel angles. The paint is in good condition.

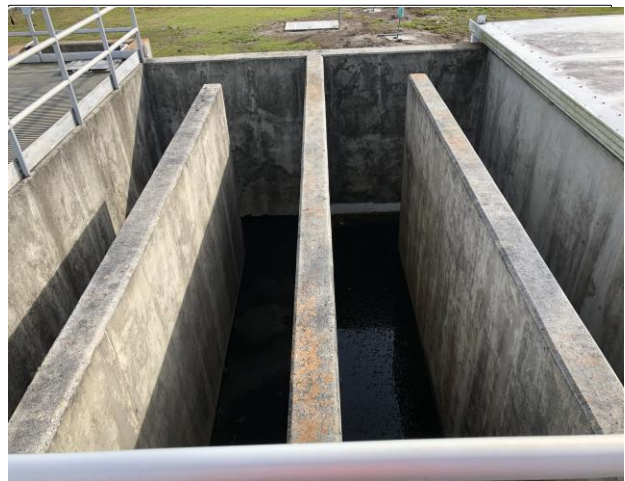
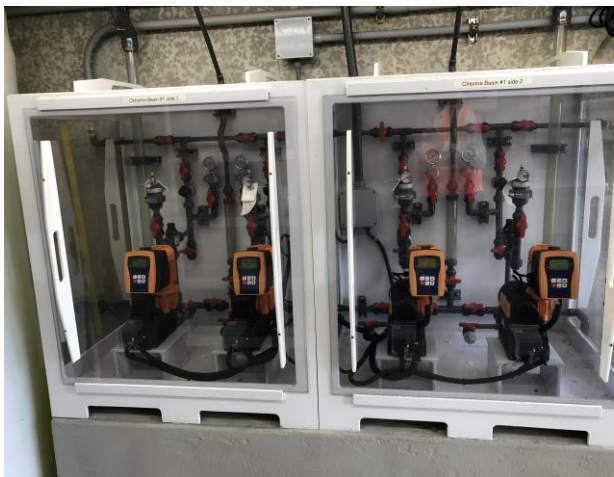
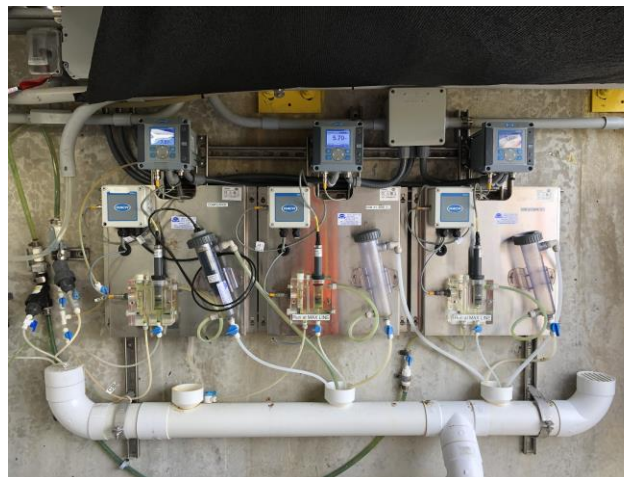
The overall condition of the chlorination system is excellent. Only one CCC was in operation at the time of the site visit. Good turbulent flow in the inlet boxes to the CCCs created effective mixing. The pH and chlorine analyzers are in good working order. Plant operators clean the analyzer assemblies at regular intervals to remove any algae buildup.

In June 2017, a new chlorine feed system with two chemical feed pumps for each CCC and new storage tanks was installed in a new chlorine storage and feed area between the two CCC structures. This will enable two parallel CCCs to operate when peak hourly flows exceed 955 gpm. The new dosing pumps have double-containment protection.

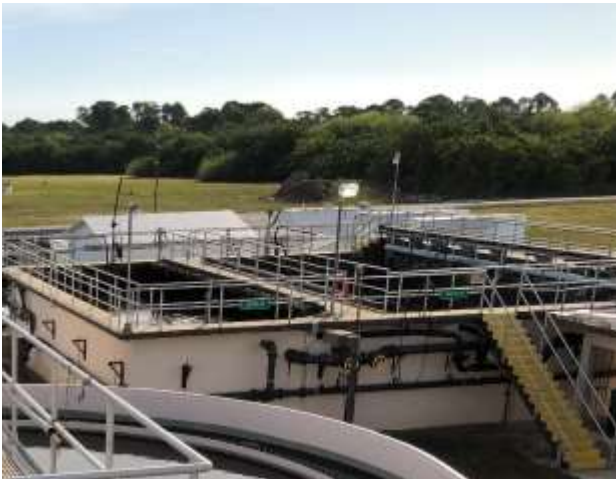
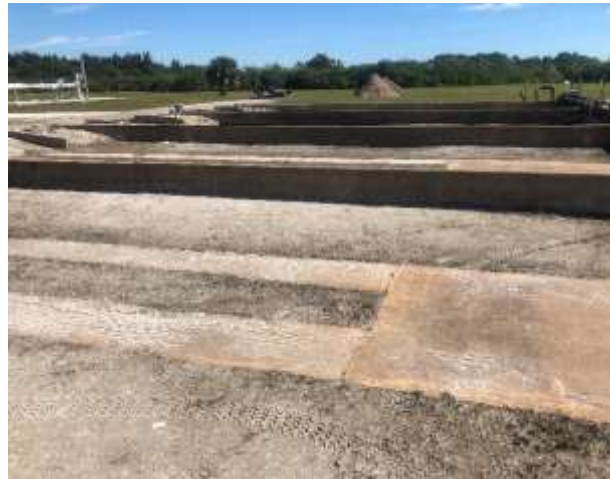
The overall condition of the sludge holding tanks is good, but the capacity of the aerobic digesters is limited. Expanding the sludge holding tank storage will improve sludge decanting and thickening.

The liquid sludge load-out pump was replaced in 2017.

The WRF has four emergency sludge-drying beds.

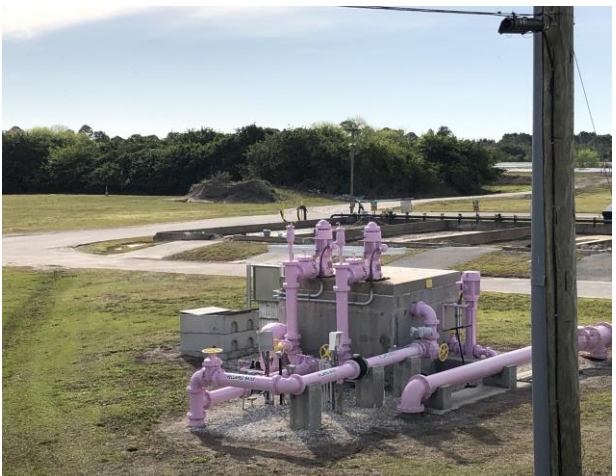
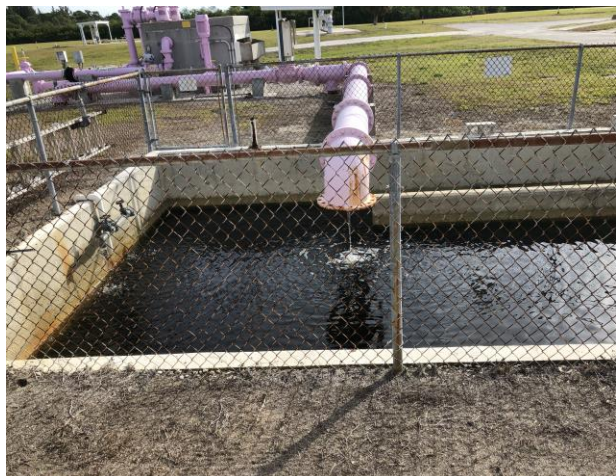
The overall condition of the effluent disposal system is good.

Effluent disposal is accomplished through an RCW distribution system and one deep injection well. A total of 20 MG of on-site RCW storage is provided. The two HSPs and one jockey RCW pump are in good condition.

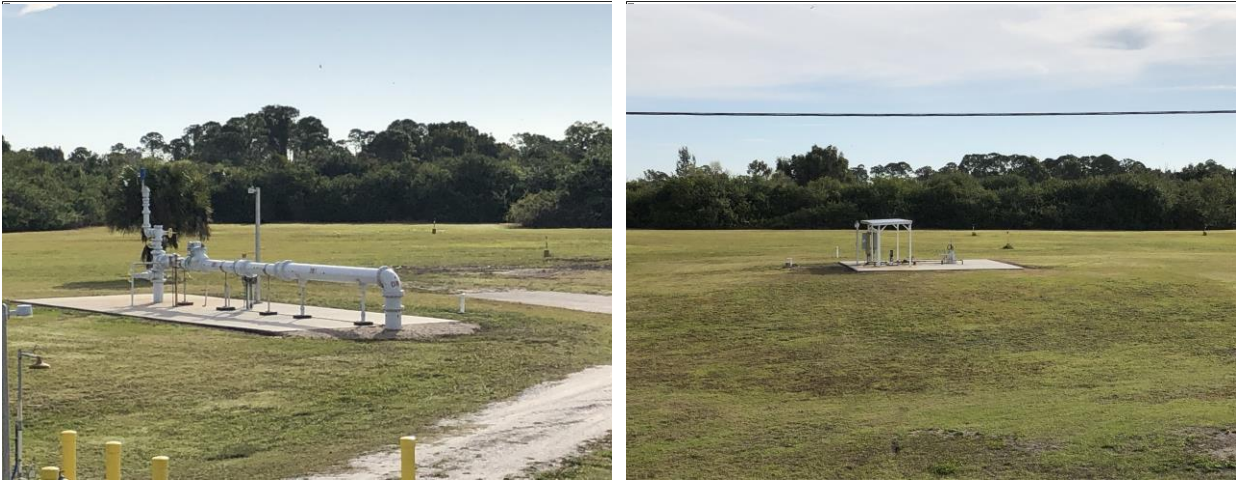
Three new deep-well pumps with a 16-inch manifold pipe connect to the deep well and on-site irrigation pipes. All pumps were fully functioning at the time of the inspection.

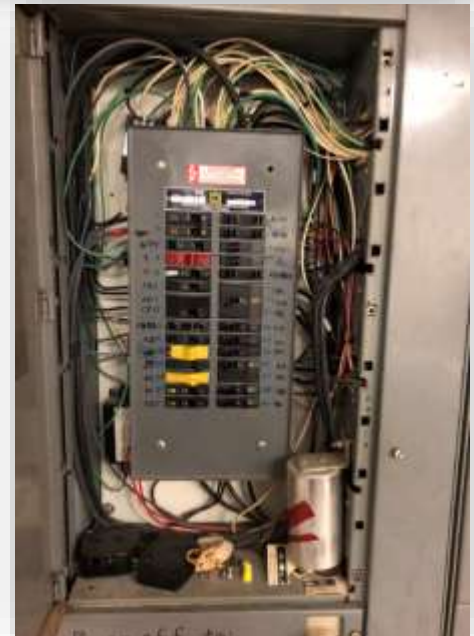
- A power distribution panel within the plant's MCC is missing a protective cover. Access in the panel to activate a breaker could potentially expose personnel to live conductors (see photograph).
- The switchgear contains warning labels identifying parts and components as being energized. However, none of the equipment includes the appropriate arc flash labeling required by NFPA 70E.
- County Staff reported that the existing blowers at the West Port WRF do not operate properly when running under the generator. It is uncertain why this occurs as the existing generators should have ample capacity to operate the blowers.

Recommendation:	Secure all electrical switchgear to prevent unauthorized access or inadvertent exposure to live parts.
Recommendation:	Investigate blower electrical system to determine why the blowers will not run under generator. The capacity onsite should be sufficient.
Recommendation:	Apply appropriate arc flash labeling on all appropriate switchgear in compliance with NFPA 70E to properly notify operations and maintenance personnel of the potential hazard. This may require creating a complete and thorough arc flash model using the existing switchgear to determine the energy levels present. This information would appear on the appropriate arc flash labeling as required.
Recommendation:	Perform a load study to identify any issues related to the system power quality, quantity, and capacity. The load study would help identify deficiencies in the system such as the issues related to the blowers unable to properly operate when energized by the generators. This study can support the efforts made by the County to identify reserve capacities and potential anomalies that may affect long-term maintenance and serviceability of the equipment.

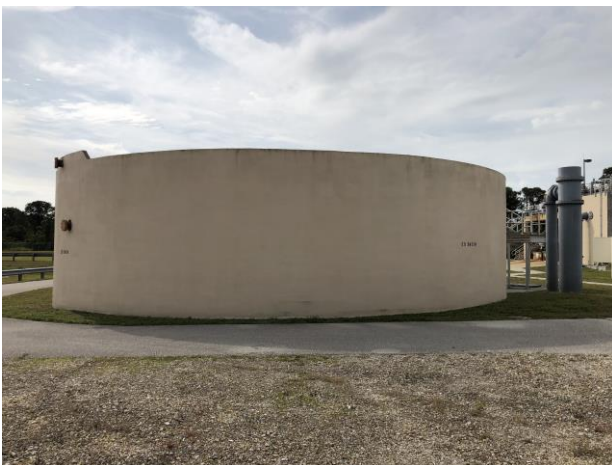
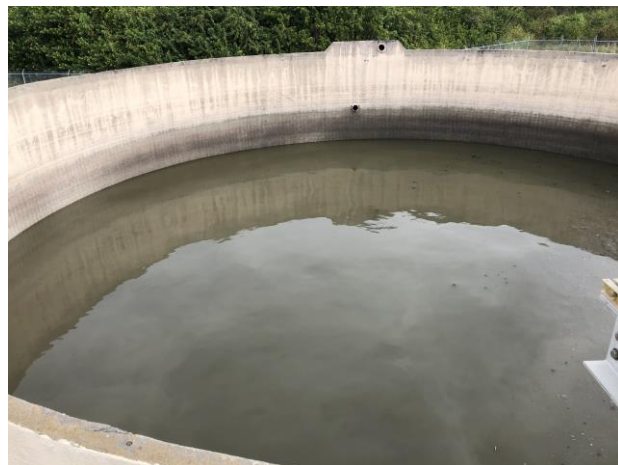
The overall condition of the 0.3-MG EQ tank is good. The EQ tank, which attenuates high hourly flows, is filled through a gravity system initiated by an overflow weir at the headworks structure. The EQ tank contents are returned to the headworks for treatment at a steady flow over 24 hours using variable-speed pumps. This has proven to be a valuable asset to the operation of the facility. The Chief Operator noted that Lift Station No. 801 sends 1,500 gpm to the Rotonda WRF for about 20 minutes and then turns off for 20 to 30 minutes. The operation of the EQ tank has been adjusted to respond to the intermittent discharge from Lift Station No. 801. Dry pit submersible pumps are used to return EQ tank contents to the treatment stream. The EQ tank positive displacement blowers are run intermittently to save power. Oil sight glasses and fill ports were added by CCU to improve maintenance. The EQ tank was painted in FY 2019.

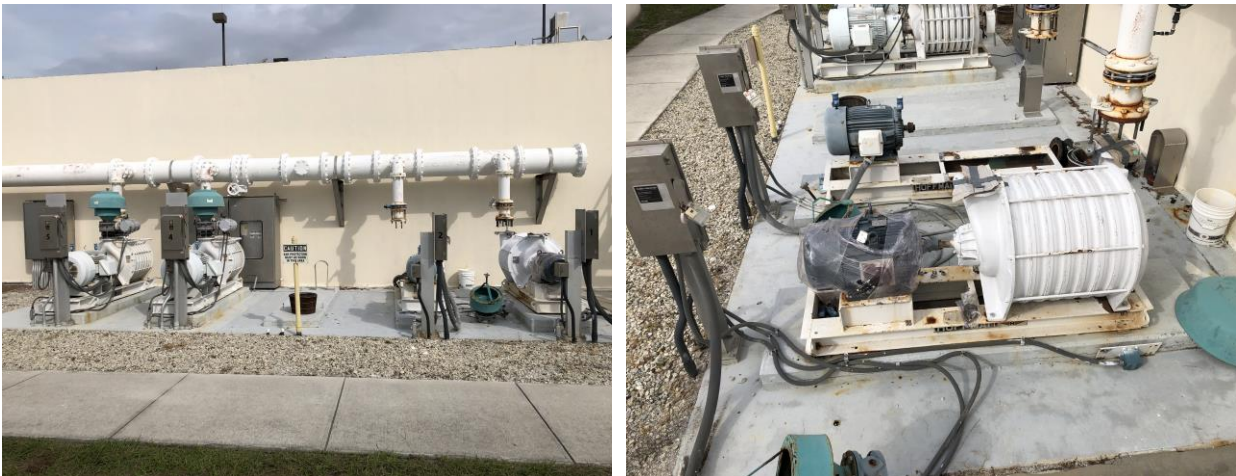
The overall condition of the activated sludge facilities is good. The aeration tanks operate in a plug flow regime with anoxic, aerobic, and swing zones. The anoxic zones and the use of automatic DO probes to control blower speeds have contributed to the high level of treatment

while conserving energy use. The aeration tanks are run at a mixed-liquor suspended-solids concentration of 3,500 to 4,000 mg/L. The two old aeration tanks were last drained for inspection in 2012. Very little grit was found in the bottom. The aeration basins were pressure-cleaned and painted in FY 2017.

The aeration system continues to supply adequate air to the aeration tanks. The facility has four multi-stage centrifugal Hoffman blowers to serve the aeration trains. Generally, one blower meets air requirements. Additional units are brought online during higher demands. Blower No. 2 has been repaired multiple times including a new motor in 2014 and new bearings in 2016; however, the blower motor was again repaired in 2017. During the site visit, we observed that Blower No. 1 was installed after it was repaired but not connected. Blower No. 2 was completely removed. Only Blower No. 4 and Blower No. 5 were in service. Blower No. 5 will be replaced after Blower No. 1 is put back in service. The blowers are well painted, and piping is marked.

One of the DO probes in the aeration basin was replaced in 2017. All four probes are functioning properly.

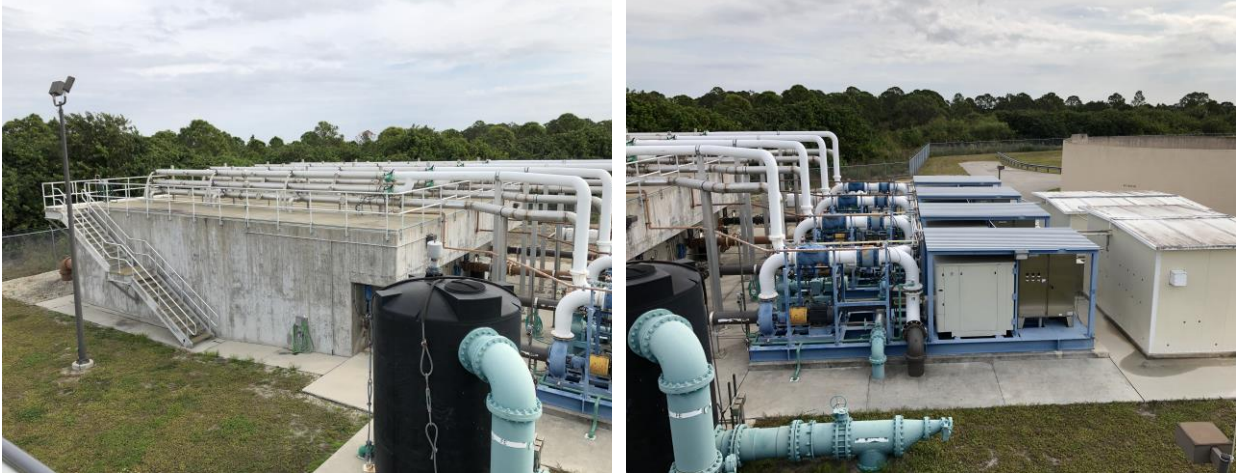
The MBR system's overall condition is good, and it is well maintained. The MBR system continues to produce a high-quality effluent with minimal problems.

Four trains contain three cassettes each. The MBRs are cleaned once per week with a weak solution of bleach to maintain their treatment efficiency. The cassettes are cleaned in place with concentrated chlorine bleach twice a year and are removed once a year for deep cleaning.

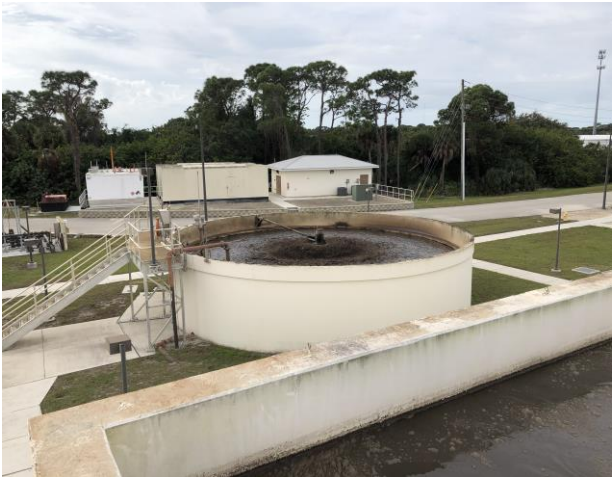
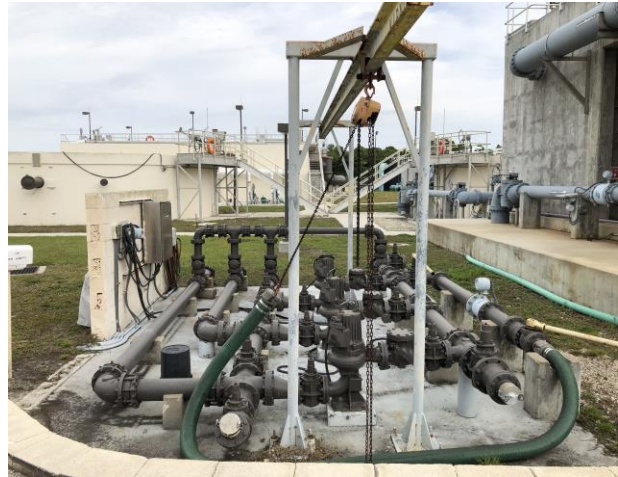
The overall condition of the solids handling facilities is good.

The decant mechanism for the sludge-holding tanks was designed as telescoping valves, but the telescoping valves can only be lowered to one-half the depth of the tank. The operators have replaced the designed method of decanting by using bottom-feed submersible pumps suspended on ropes. A small winch should be added to each pump site for better control of the pump level. The Chief Operator does not see this as a high priority because decanting is done only two or three times per month.

Sludge load-out pumps were operating properly. They were repainted in FY 2019.

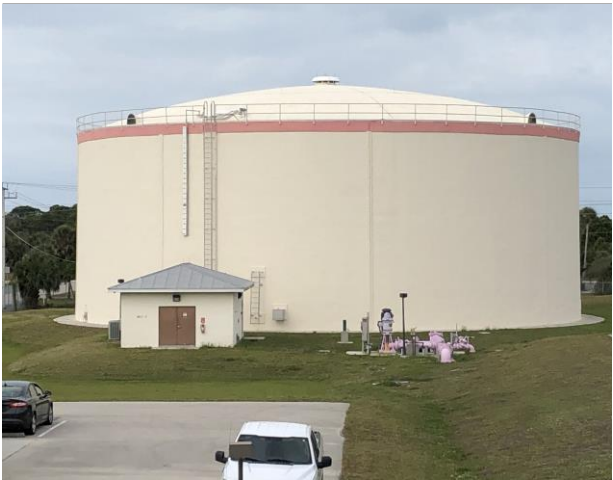
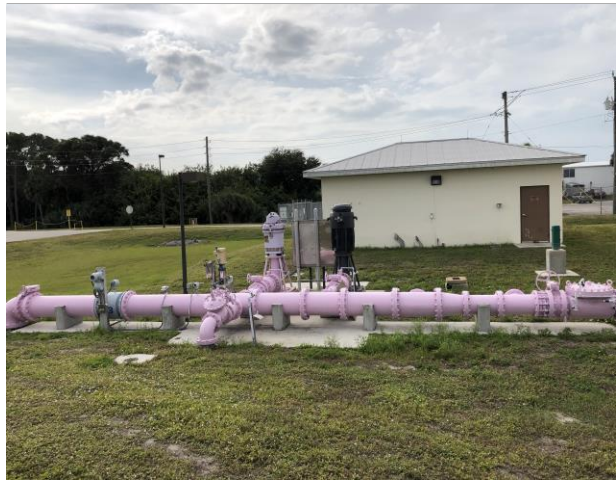
RCW-quality effluent can also be stored in the Rotonda WRF on-site RCW storage pond and the 3.0-MG GST. The GST was drained and cleaned in 2017. RCW from the GST can be pumped to pressurized reuse customers using two HSPs and one jockey pump. One of the two HSPs was replaced in FY 2019. The jockey pump was replaced in FY 2018.

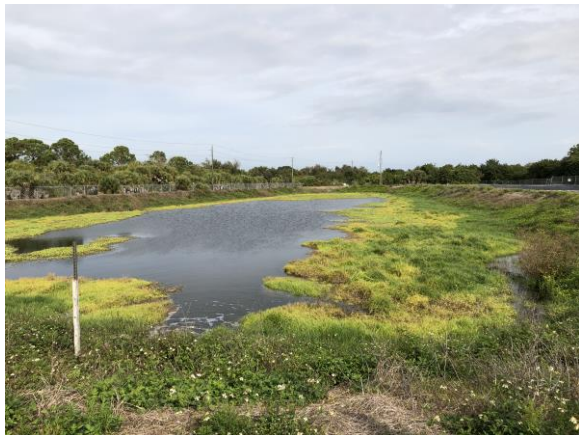
The RCW storage pond is overgrown with vegetation, reducing the capacity of the pond. The storage pond is scheduled to be dug out and cleaned, the berm reinforced, and the pond lined in 2022.

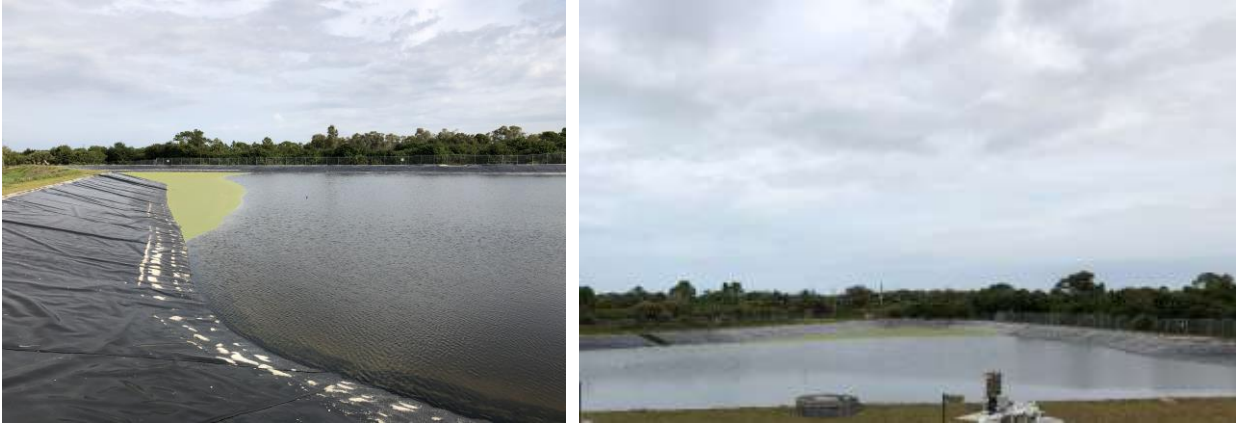
The on-site lined reject pond has a storage capacity of 5.182 MG. Water diverted to this pond does not meet RCW standards and must be retreated through the plant. A small pumping station pumps reject water back to the headworks. The pond is scheduled to be cleaned of algae in FY 2022.

Recommendation:	Clean the reject storage pond.
Progress:	Ongoing.
Recommendation:	Replace motherboard and refrigerator unit in the effluent sampler.
Progress:	Completed.
Recommendation:	Improve the operation of the generators, primarily Generator No. 2.
Progress:	Ongoing.
Recommendation:	Perform a load study to identify any issues related to power quality, quantity, and capacity of the system. The load study would help identify deficiencies in the system, identify reserve capacities and assess potential anomalies that may affect long-term operation.
Progress:	Not yet implemented.

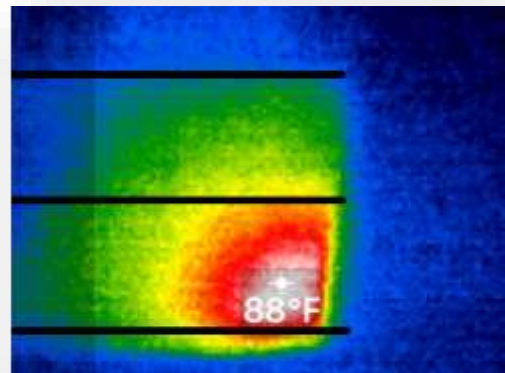
- A two-pole circuit breaker in an unlabeled 480-V panel (breaker#28/30) showed during the thermal inspection that one of the two poles was reading a much higher temperature than the other. This is extremely uncharacteristic of a two-pole breaker system since the expected current between both sides of the breaker should be the same (see photograph). The imbalance in temperature between the two contact points may indicate that one of the sides of the breakers is failing or that the connection is loose or impaired. A loose or impaired connection may increase the potential for an arc flash failure.

Recommendation:	Investigate the temperature imbalance in the poles of 480 V panel, breaker#28/30 as soon as possible. Either repair the connection or replace the defective breaker.
Recommendation:	Adjust the membranes slack within the new few months
Recommendation:	Purchase a few module blanks for top and bottom headers and wait to observe membrane effluent turbidity spikes, which would indicate that one of the cracked potting headers has breached the membrane integrity. Remove the compromised membrane module and installed module blanks in its place until new purchased membrane module is received. Once the new membrane module is received, install the new membrane in the middle of the cassette and move an existing module where the compromised module was. This could prolong the new membrane module potting header life.
Recommendation:	Continue monitoring and trending membrane permeability data and add temperature to the data collected weekly so permeability can be corrected with temperature to account for seasonal changes in water viscosity.
