# Charlotte County Utilities Department

**2019 Annual Report**  
**March 2020**

## **2019 ANNUAL REPORT**

Jones Edmunds Project No.: 03405-029-03

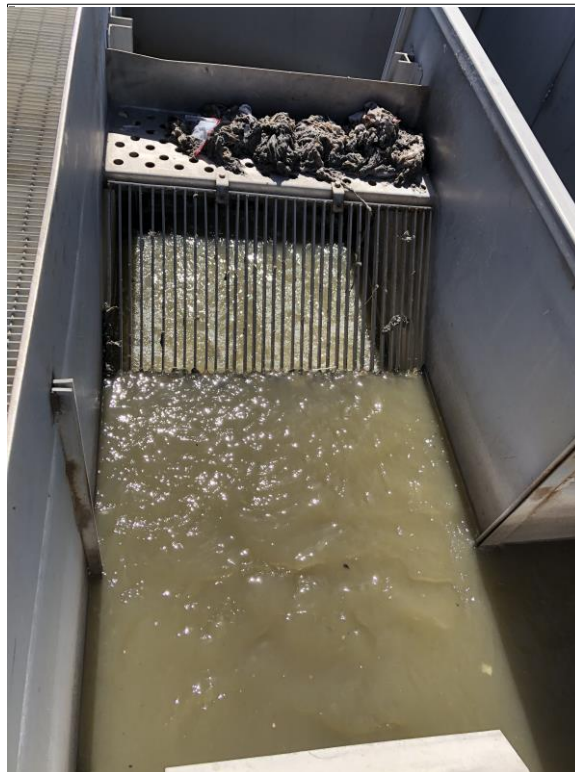
The headworks overall condition is fair. It consists of one manually cleaned bar rack. The headworks does not include grit removal and the influent manual screening system cannot prevent moderate-sized debris from entering the facility's EQ tank, pumping systems, and process tanks. Issues with the headworks include inadequate screening, lack of floatables removal, and no grit removal facilities. Currently, the only way to remove floatables that pass through the manual bar screen is by using a bucket to remove them from the EQ tank.

A mechanical fine screen and scum or floatables removal and grit removal systems are highly recommended. This issue is expected to be resolved as part of a future facility upgrade.

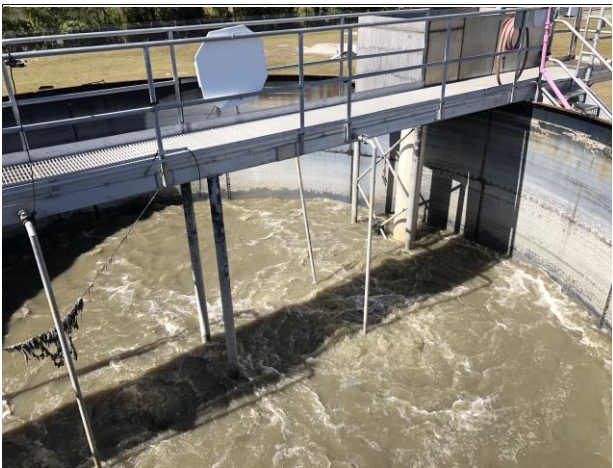
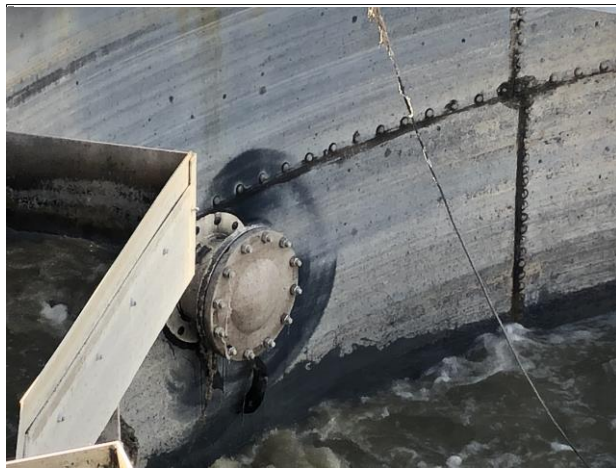
The EQ tank has signs of rust around the upper steel rim. Removing rust and painting rusted areas was not done in 2019 as scheduled and is rescheduled for 2020. Internal piping is in poor condition with leaks at flanged fittings. The leaks do not pose an environmental hazard because they are inside the tank. The piping should be replaced as part of a plant upgrade.

A leak in the aeration header of the EQ tank blower was repaired in 2017. One of the drop diffusers inside the EQ tank is damaged.

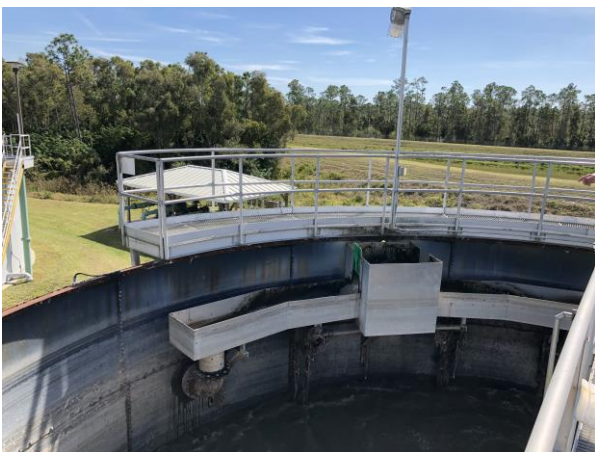
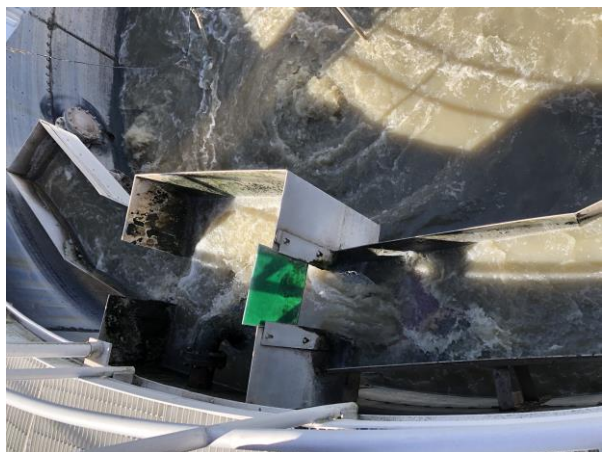
The lack of fine screening and grit removal creates operational and mechanical problems for the EQ tank and pumps. Staff clears the EQ transfer pumps weekly during the peak season and biweekly during the off-peak season. The staff also clears the pipelines of debris annually to remove clogs in the system. To help make this cleaning process safer, a permanent pump motor hoist system is installed over the EQ pumps to allow access to the pump volute.

Future plant upgrades should simplify the operation of the EQ tank to allow modes for flow and/or plant load equalization and to provide proper headworks treatment to reduce grit and screenings accumulation and wear in EQ tank and pumps.

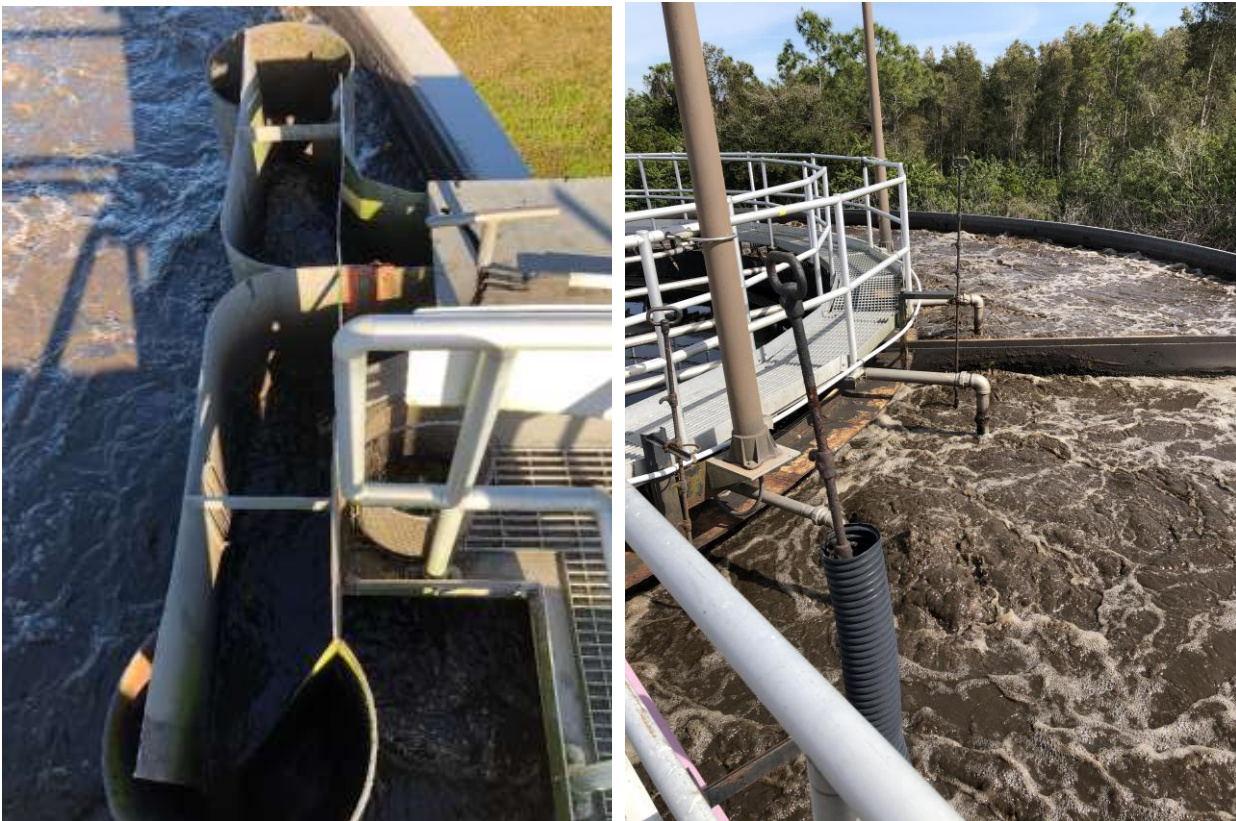
The activated sludge facilities are steel-ring package plants consisting of two aeration tanks and two secondary clarifiers. The overall condition is good. The hinged sluice gates separating the two aeration tanks are not functioning as intended, allowing wastewater to flow to the adjacent tank during maintenance.

At the time of the site visit, the aeration basins appeared to have adequate air distribution throughout the tank. The tanks have minimum free-board (<1 foot), creating concerns of overflowing during high-flow conditions or if a downstream flow obstruction occurs. Rust was removed from the metal tanks and the tanks were painted in 2018.

All blowers were rebuilt in 2017. The operation of the blowers is based on timers. There are no DO sensors to adjust blower operation.

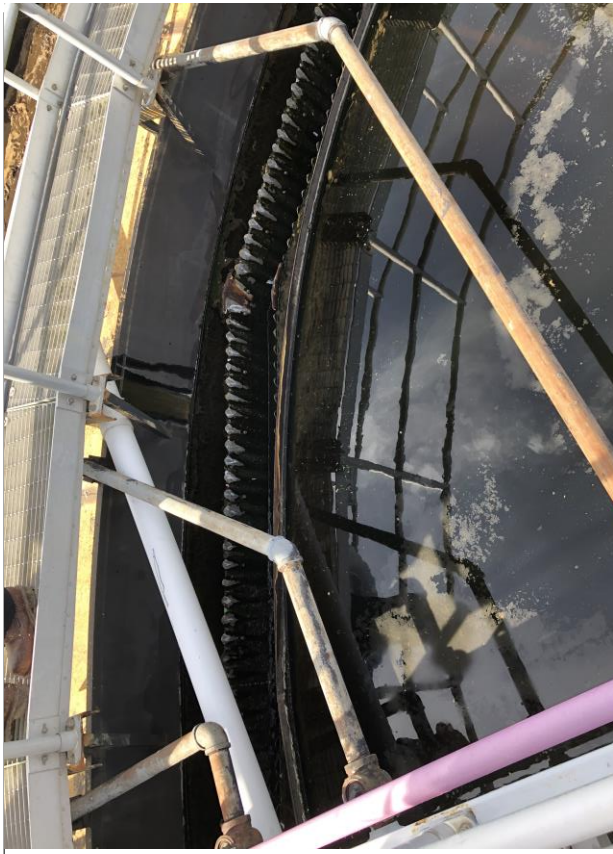
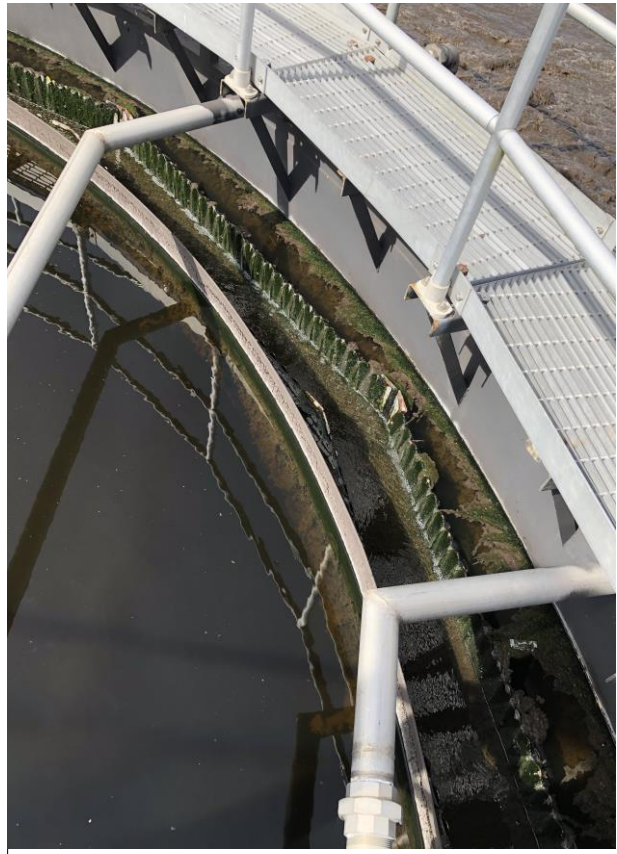
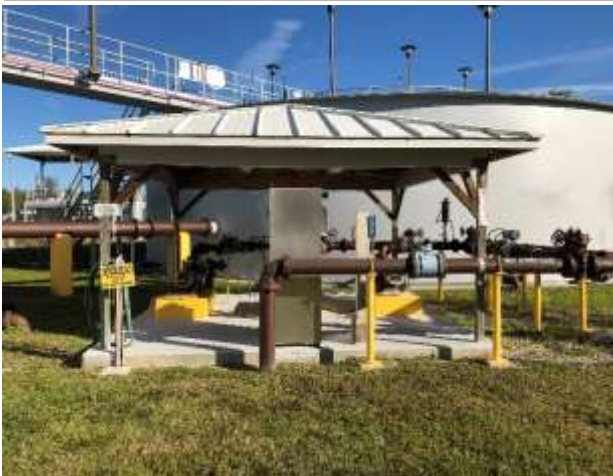
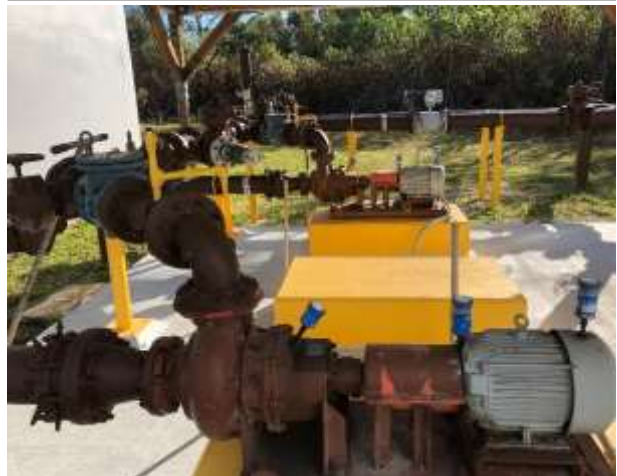
Clarifiers are in good working order. Clarifier No. 1 is cleaned of excessive algae growth on the weirs with a hose daily and brushed weekly. Clarifier No. 2 is cleaned less frequently and showed signs of algae growth during the site visit.

The two RAS/WAS pumps are in poor condition and operating at their end of lifetime. One of the pumps has an oil leak. Hence, the County ordered a pump replacement in FY 2019. A control valve is used to control RAS and WAS flows.

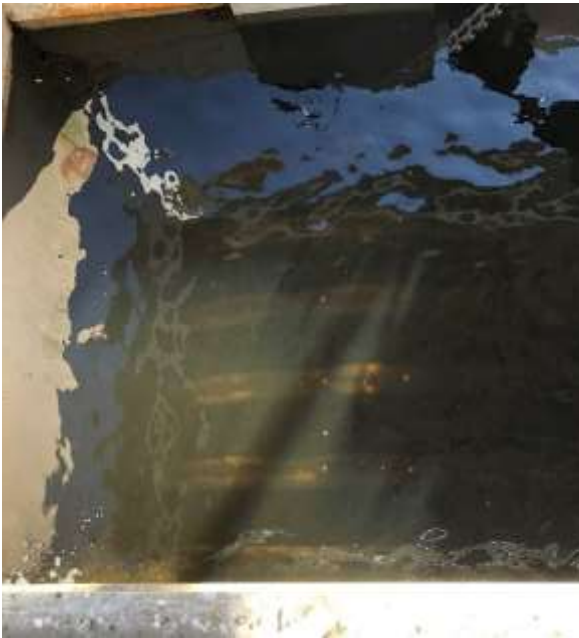
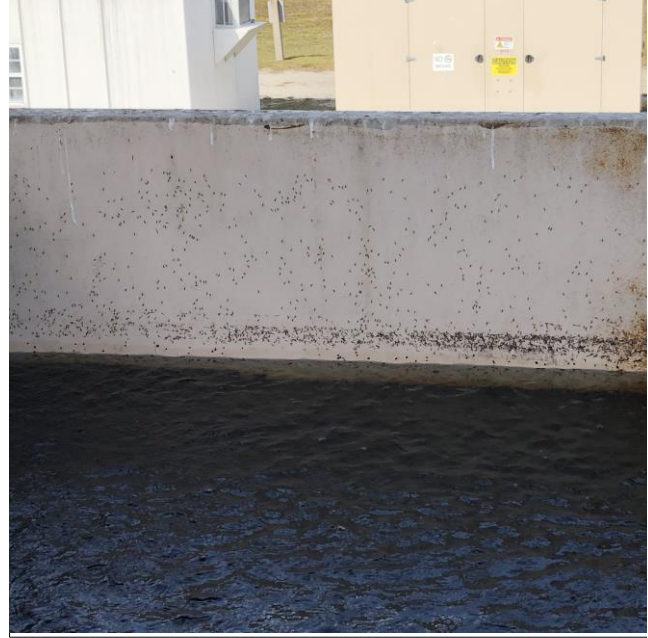
Two additional 5-micron cloth discs were installed in the two spare slots in 2017. The Chief Operator indicated that the filter is producing a good quality effluent; however, it backwashes frequently during periods of high flow. This may be because the backwash pumps are set for 10-micron cloth, but the filter has 5-micron cloth. The Chief Operator also indicated that the overflow line flows to the CCC instead of flowing back to the headworks. During the site visit, numerous mosquitoes were noticed attached to the steel tank.

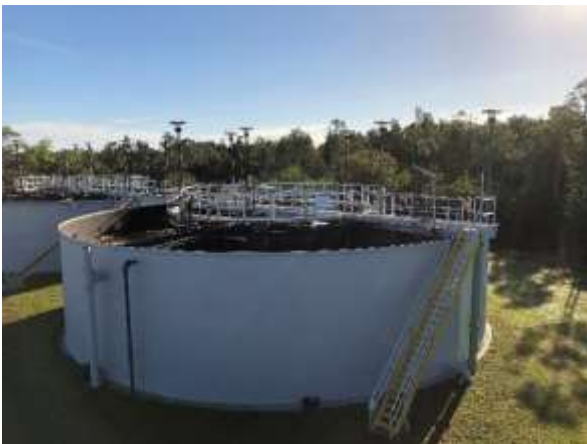
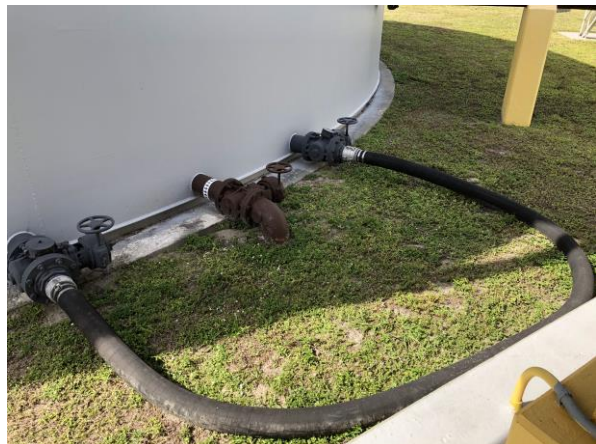
The overall condition of the solids handling facilities is good. Two tanks are aerated to provide partial sludge stabilization and the third tank is normally used for thickening and decanting. Hook-up connections are provided for trucks to transport thickened sludge to East Port WRF for further processing. A bottom feed submersible pump suspended on a winch is used to decant supernatant back to the front end of the facility for treatment. The top ring of the sludge holding tank has minor rust.

During the site visit, Aerobic Digester No. 1 and Aerobic Digester No. 2 were connected using a temporary hose. The Chief Operator indicated the internal gate connecting the digesters is inoperable.

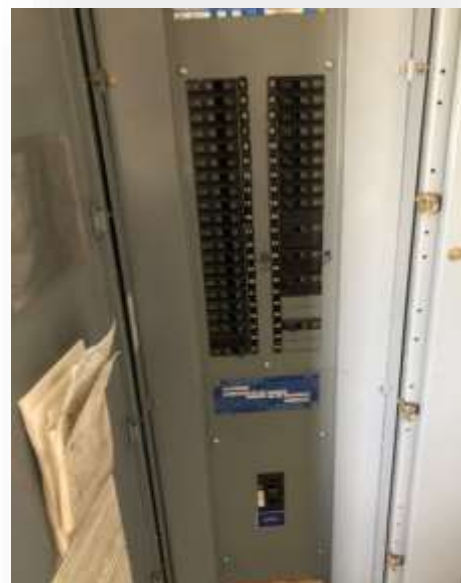
The incoming switchgear and distribution transformer appear in fair-to-good condition. The incoming power company service transformer exhibits an extensive amount of surface rust, which may soon be impacting the transformer function. The existing primary distribution switchboard outside the MCC room is also exhibiting signs of degradation from the weather. The plant is served from a single generator of an undetermined size. The generator was in good condition but exhibited signs of residual diesel fuel on top of the diesel fuel tank. This may be indicative of additional issues. Overall, the electrical equipment in Building MCC-1 is in good functioning condition based on information from the Operations staff, except for the deficiencies listed below.

- The switchgear contains warning labels identifying parts and components as being energized. However, none of the equipment includes the appropriate arc flash labeling required by NFPA 70E.
- The fiberglass MCC building should be replaced with a concrete structure.
- The main breaker trips when two blowers are started simultaneously.

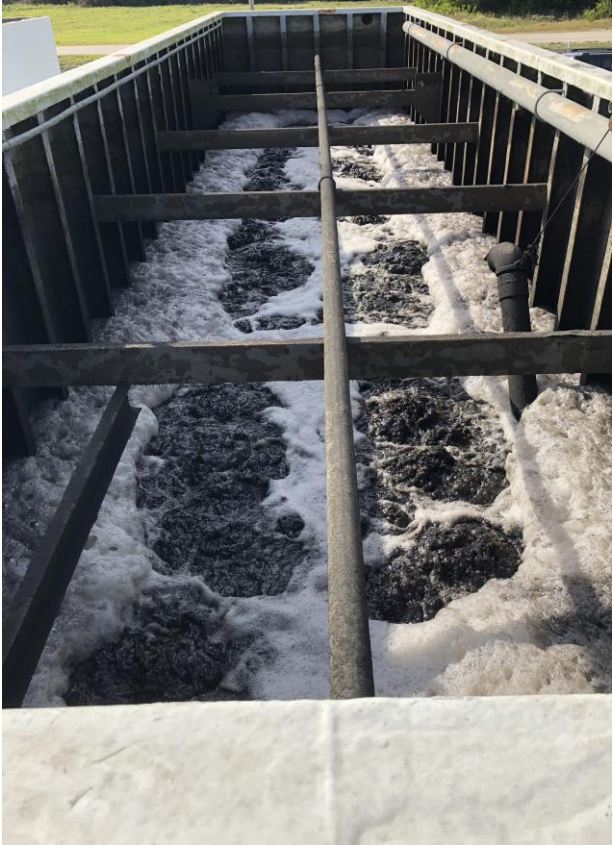
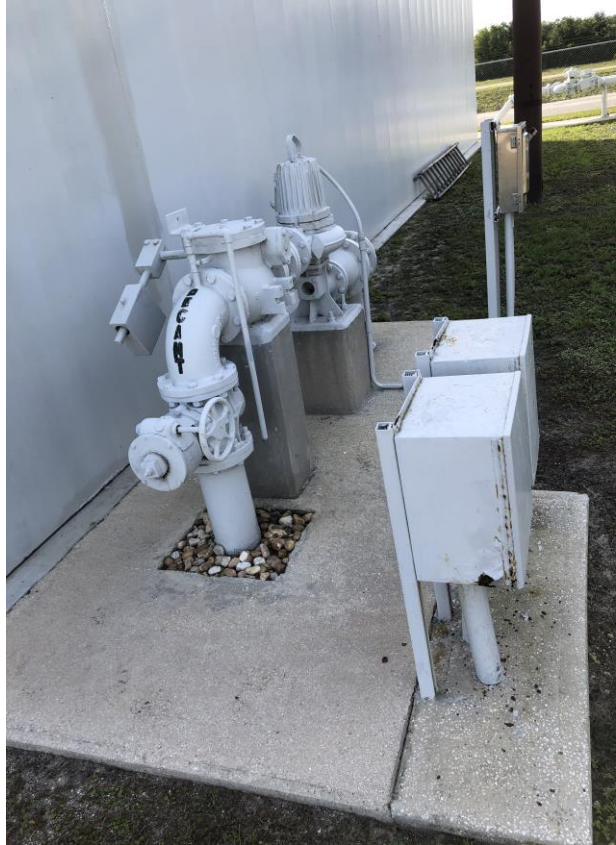
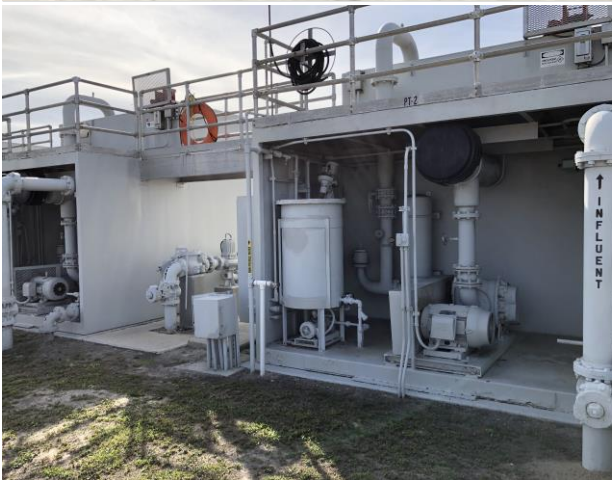
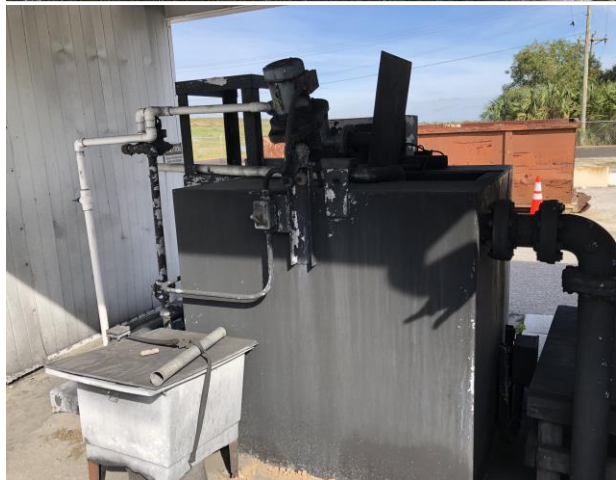
The overall condition of the three PACT treatment units is good, and the facility is operating without any treatment or capacity issues. The tanks' exteriors and interior were partially painted in FY 2017 and completed in FY 2018. Surfaces were pressure washed and rust and lost paint were removed and primed before painting was completed.

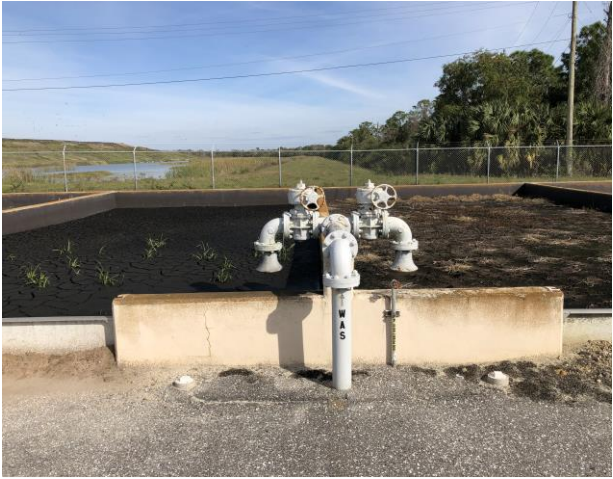
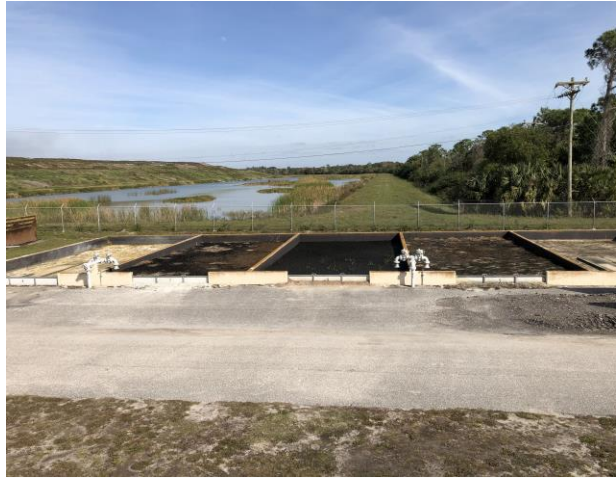
The sludge-drying beds are well maintained and sufficient drying bed area for dewatering of solids.

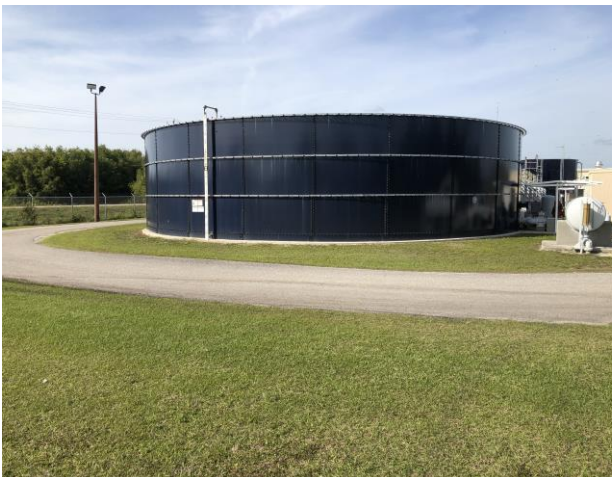
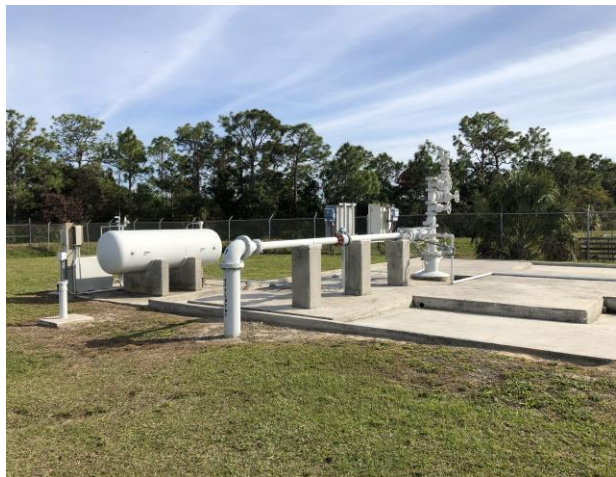
The effluent disposal system is in fair condition, since the Aquastore storage tank has a hole that needs to be repaired. The effluent storage and disposal areas are properly maintained and meet the facility needs.

Recommendation:	Evaluate adding one additional maintenance staff member to meet increasing demands and minimize overtime.
Recommendation:	Repair the hole in the Aquastore storage tank.
Recommendation:	Add a generator to the treatment facility to keep the plant operational during power outages.
Recommendation:	Replace the sand filter compressor.

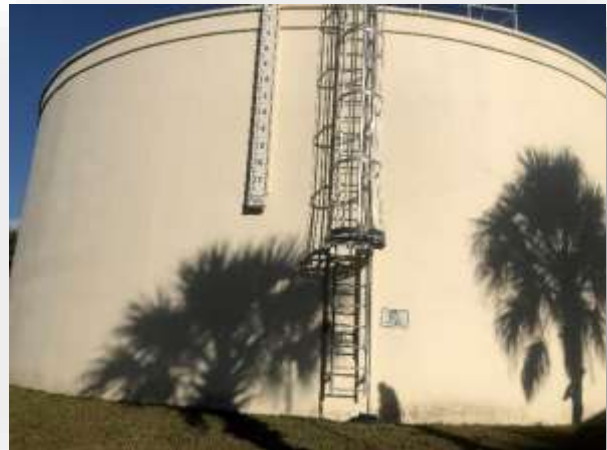
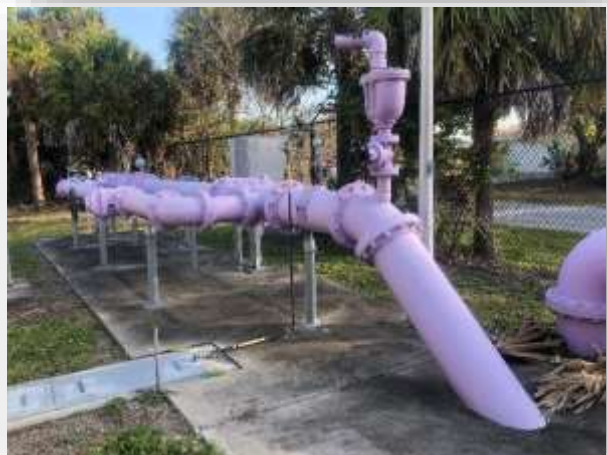
The electrical room equipment, pump room equipment, and tank were found in good condition. The piping was painted purple and clearly marked. The outside paint on some brick surfaces of the electrical building was deteriorated. Removal of the on-site chlorine injection system is being evaluated. The grounds require constant maintenance, which is provided by a private contract.

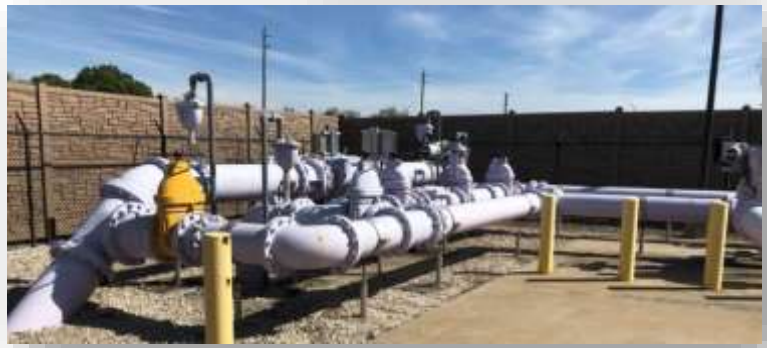
The physical condition of the Westport RCW Booster Station is excellent.

- This station remains unused due to complications during pump operations. This is a complex pump station with multiple operational configurations. The County is currently operating the station in manual mode to supply water from East Port to West county.
- The station's hydraulics must be evaluated to update the operating protocol and improve the usefulness of the station to operators.

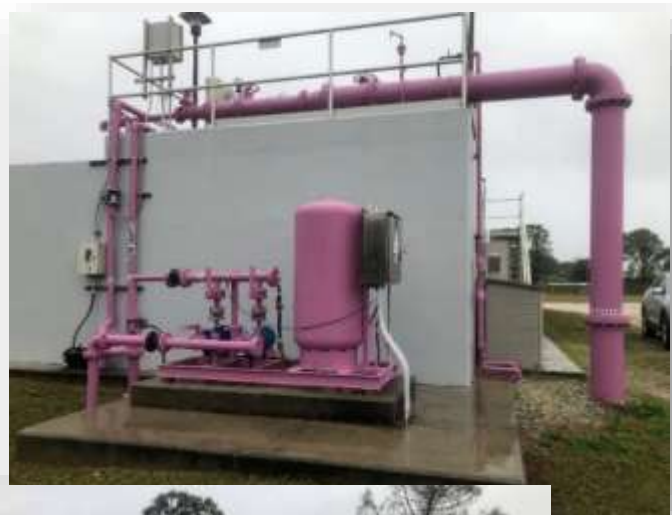
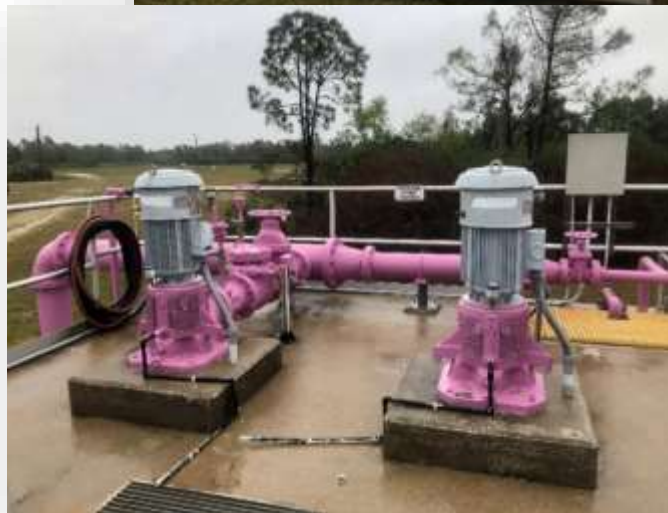
Overall, the system is in good condition.

- A new flow meter on the RCW discharge line is required to measure flow leaving the site.
- The Burnt Store WRF has no RCW storage, and the pumps are not capable of matching demand with flow. New customer development would require customer storage in the same manner as that proposed by the original golf course customer.
- New transmission mains are needed to serve the increasing population within the WRF service area.
