Charlotte County Utilities Department

2022 Annual Report
March 2023

Prepared by
JonesEdmunds

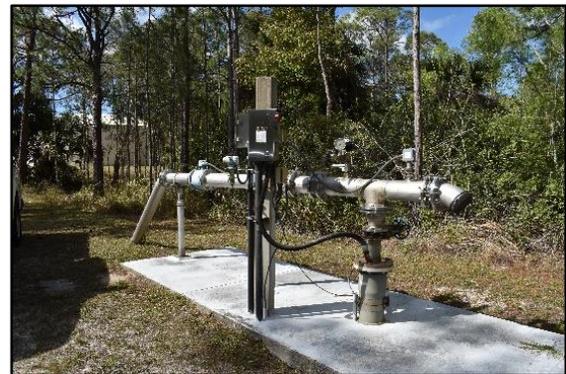
- Well No. 15 is at the rear of the site. The well pump and piping are in excellent condition. However, Well No. 15 is currently not in service due to suspected intrusion of lower-quality water from this well’s terminal strata. The 2013-issued WUP required this well be abandoned and capped. A study was completed in 2017 to evaluate an alternative way to bring this well back into service.

- Well No. 16 is a 12-inch-diameter well on the east side of the site. The well pump is in excellent condition.

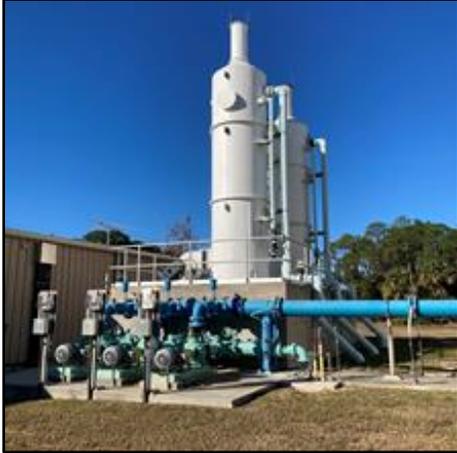
Hydrogen sulfide is removed from the RO permeate via packed-tower degasification. Three packed-tower degasification units are on top of the concrete clearwell and can be operated automatically or manually. One of the degasifier blowers was repaired in February 2017. The degasifier media was inspected in FY 2022 and will be replaced in FY 2023. In 2014, the clearwell was temporarily taken out of service for inspection. The clearwell inspection report noted for staff to paint the clearwell and exercise the isolation valve between the two tanks.

The clearwell valve was exercised by staff and found to be operational in 2019. The outside of the clearwell should be painted.

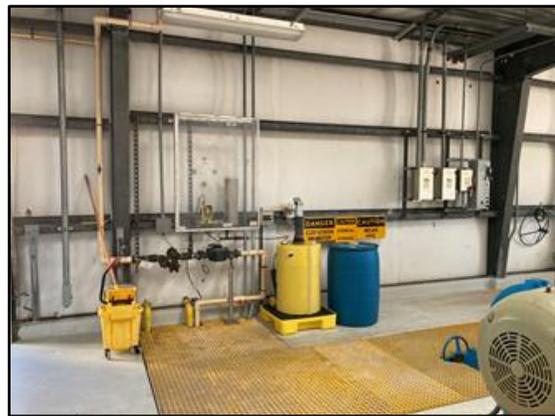
Sodium hydroxide is used to adjust the pH of the finished water before pumping it into the distribution system. The sodium hydroxide system consists of a 1,100-gallon bulk storage tank, a chemical feed skid with two metering pumps, and a 90-gallon chemical feed tank. The skid and smaller storage tank are in the RO process room and are in good condition. One pump is scheduled to be replaced in FY 2023. The bulk storage tank is outside near the other bulk chemical storage tanks, which poses operational issues during cold weather. When temperatures are less than 45 degrees Fahrenheit (°F), operators install heat lamps to prevent the sodium hydroxide viscosity from increasing. The glass sight gauge on the bottom of the 1,100-gallon bulk storage tank and the ball valve on the transfer line from the bulk tank were replaced in 2018 and are functioning properly.

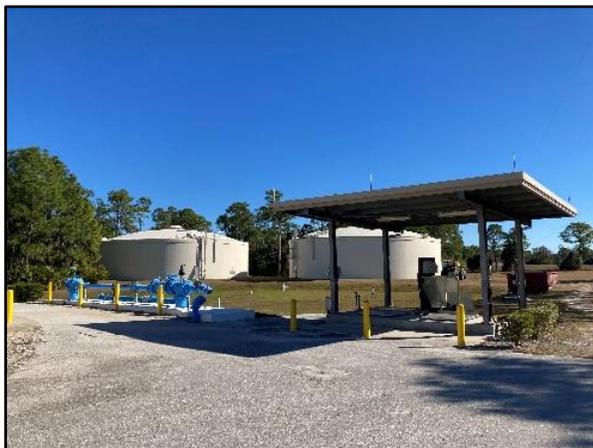
The Burnt Store RO WTP contains three 0.5-MG concrete GSTs housing a total of 1.5 MG of finished water. GSTs A and B were cleaned, inspected, and received new interior coating in FY 2022; GST C was inspected in FY 2019. No sedimentation or defects were found in any tank. The outside of GST B was painted in 2019. The outside of GST A was cleaned and painted in 2020.

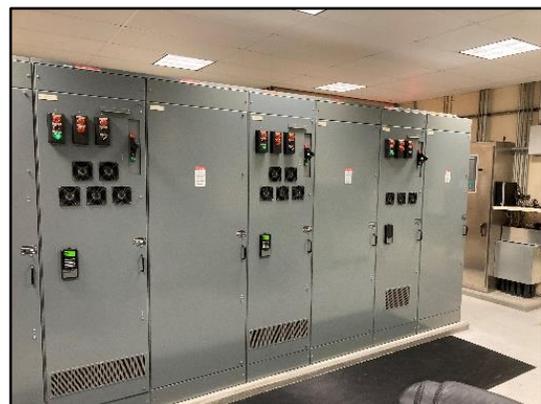
The incoming switchgear is in good condition with minor issues. The switchgear contains warning labels identifying parts and components behind blank cabinets as being energized. The floor near the electrical equipment is marked with hazard tape, but none of the equipment includes the appropriate arc flash labeling as required by National Fire Protection Association (NFPA) 70E. In FY 2021, the building exterior was pressure washed.

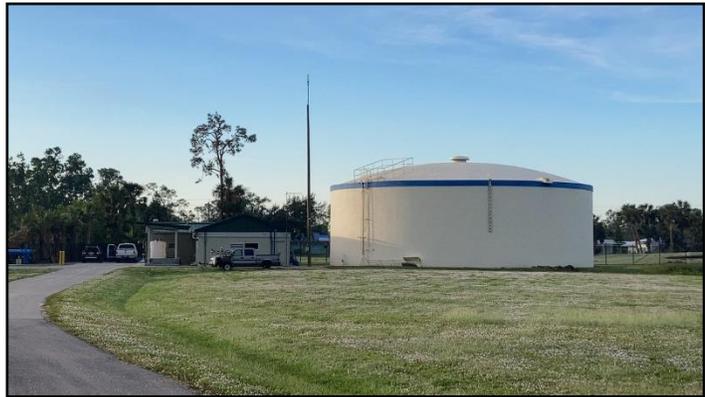
- The roof cap is damaged from hurricane winds and is currently being repaired.
- Some portions of the site fence are broken and leaning with loose barb wire.
- Fallen trees are around the fence perimeter at the site.
- The computer inside the building is damaged from a water leak through the roof of the building.
- The lower portion of the ladder cage on the side of the aboveground storage tank is torn off and laying on the ground.

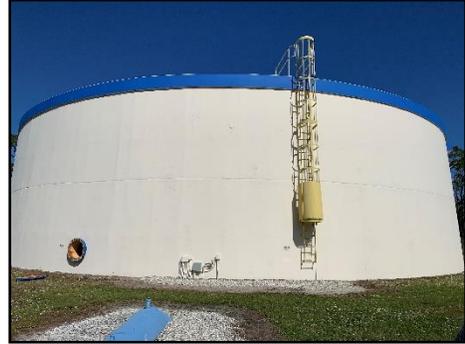
The station is generally in good condition. Roads and landscaping are well maintained. Graveled areas around the facility infrastructure are weeded and the grass is cut. The fence surrounding the perimeter is being replaced in response to damage done by Hurricane Ian. The indoor buildings are kept clean, and tools and equipment are organized and stored properly. Three of the four HSPs are well maintained and functioning properly with Pump #2 out of service and is scheduled to be repaired in FY 2023. In 2016, the County began planning to install a new water feed pipe across the Myakka River. The project is ongoing and in the permitting phase. The GST tank was down for maintenance due to a leak in the floorstop.

The incoming switchgear and distribution transformer appear in good condition with no obvious signs of significant concern. The incoming power company transformer shows signs of superficial rust. The standby generator reportedly functions properly and has no issues. The fuel system on the generator is a separate fuel tank, not a sub-base fuel tank as in many other installations throughout the County. The fuel tank is undersized and is insufficient to provide the County’s minimum required 72 hours of operation during a storm event; it should be increased to hold additional fuel. The fuel piping and transfer system appears in good condition with no apparent signs of leakage. Overall, the electrical equipment is in good functioning condition based on information from the Operations staff.

- The pipe connecting the GST to the pump station is constructed of formed concrete, which is not industry standard.
- The Pump Building requires repainting.
- HSP No. 2 is out of service and undergoing replacement.
- The ammonia chemical feed room exhaust fan is severely corroded and will not function.
- The pressure transducer at the back of the GST is not properly anchored or supported and is being supported by the conduits.
- The conduit wires from the newly installed cameras are not enclosed.
- The copper chemical injection quill connections are rusted and should be replaced with Schedule 80 quill connections.

According to Operations staff, a generator replacement project is budgeted for FY 2023, including a new generator and fuel tank sized to support five 150-HP pumps. A security upgrade began in FY 2022 and is pending completion of camera upgrades in FY 2023. Additionally, the corroded exhaust fans in the ammonia chemical room will be replaced in FY 2023.

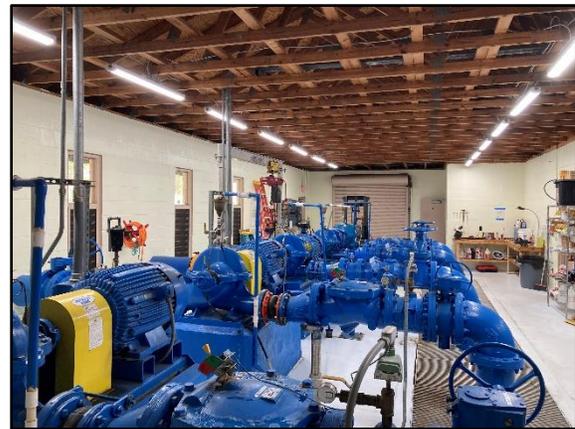
Jones Edmunds last completed an on-site review of the plant on November 15, 2022, as part of CCU's Hurricane Ian Damage Assessments; the information gathered at that time was used to update this section, in accordance with the project scope. CCU staff is aware of the following damages, as recorded during the hurricane assessment, and have been working diligently to address them accordingly. The general condition of the station is good. The access roads outside the facility are aging and need to be repaved but are in fair condition inside the property. Graveled areas around the station infrastructure are weeded, and landscaping is well maintained. The site perimeter requires some maintenance including filling holes under the fence caused by burrowing animals and clearing debris off the fence. Fallen trees around the site will require complete removal. The portion of the site fence near the entrance is damaged, causing the gate to be inoperable. The indoor buildings are kept clean, and tools and equipment are organized and stored properly. The soffit and shingles on the external of the main building are damaged or missing due to hurricane winds and need to be replaced. The HSPs are well maintained and functioning properly.

The incoming switchgear and distribution transformer appear in good condition with no obvious signs of significant concern. CCU staff reported that the existing on-site standby generating system is slightly undersized for a full load of the facility. The generator is inside the building that also contains the electrical switchgear. The security camera needs to be reinstalled, and the internet antenna needs to be repaired. Overall, the electrical equipment is in good functioning condition based on information from the Operations staff.

- The tank inspection found an issue in the tank bonding that will require multi-layer stripping before the tank can be repainted.
- CCU Operations staff confirmed that the generator is unable to accommodate the existing loads of the facility, which is a significant concern and relates to the operational security of the facility. Additionally, since the generator is inside the building that also contains the electrical switchgear, it raises concerns regarding maintenance personnel being properly notified of hazardous conditions that may exist during maintenance operations including fuels present, elevated noise level, and potentially excessive heat. This heat may also prove detrimental to the VFDs in the building since these devices are typically temperature sensitive. Staff has also indicated that the fuel system for the generator is sufficiently sized and functioning properly to handle the current loading.

- The access roads outside the facility are washed out and need to be repaved.
- The external soffit on the external of the main building are damaged or missing.

- The security camera needs to be reinstalled.
- The internet antenna is broken and needs to be repaired.

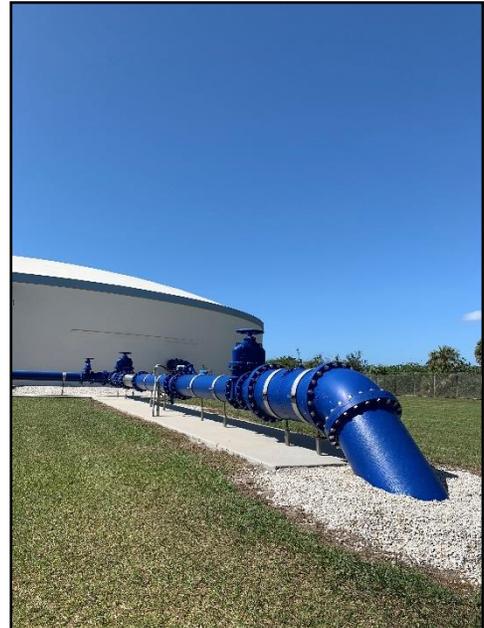
The station is in fair condition. Roads and landscaping are in good condition. Graveled areas around the facility infrastructure are weeded. The indoor buildings are kept clean, and tools and equipment are organized and stored properly. Hurricane Ian damaged the plumbing, waterlogged the roof of the building, and blew away the awning over the chemical storage tanks.

The incoming switchgear and distribution transformer appear in fair to poor condition. Components were identified as possibly being at the end of their service life because of their age. The standby generator and incoming power appear in fair condition as well. Interviews with County staff reported an unresolved issue in FY 2021 that continued into FY 2022. During the last maintenance cycle, the incoming main breaker for the facility would not re-close. After several attempts, maintenance personnel were able to get the breaker to close and maintain position. However, this indicates that the breaker has an issue and may likely fail soon. A electrical engineer's review of the site found an unresolved issue from the last annual report. Several drives have been updated to Yaskawa VFDs and were retrofitted into the existing MCC cabinets. However, the spaces provided did not match the drives, and foam is now filling the gap between the drive and the enclosure, which may be problematic. Although no live parts appear to be exposed, this does raise a maintenance concern and the possibility of exposed parts. Staff has indicated that the CIP includes a project to replace all main switchgear in this facility this fiscal year or next. Additionally, MCC/pump upgrades are budgeted for FY 2022/2023.

- Much of the switchgear appears to be in fair-poor condition and is possibly reaching the end of its service life. Many components may no longer be manufactured, making long-term maintenance an issue.
- An exterior-mounted ATS appears to be in fair condition and degraded due to exposure to weather.
- The switchgear contains no warning labels identifying parts and components as being energized.
- Foam spacers are between the updated VFD drives and the enclosure.
- Several large paint chips in the GST influent pipe.
- A VFD exhaust fan was blown away, leaving potential for the room equipment to overheat.
- The chemical storage tanks are not clearly labeled.
- The check valve at Pump No. 4 was leaky.
- The building roof is damaged and waterlogged.

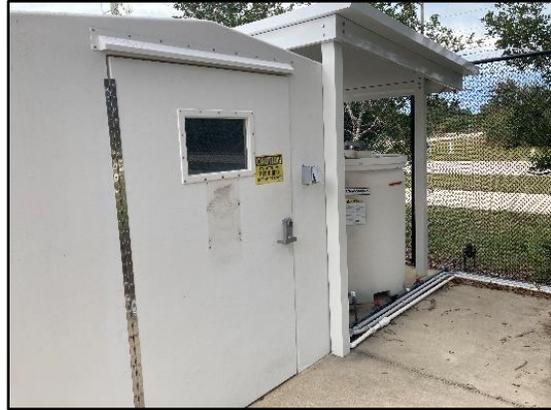
The general condition of the station is fair. The buildings are weathered but in operational condition. The landscaping is maintained. The electrical components at the Ingraham Disinfection Station are in good condition. A new flow meter will be installed in FY 2023.

The station is powered from the nearby lift station and does not have access to backup power in the event of power loss.

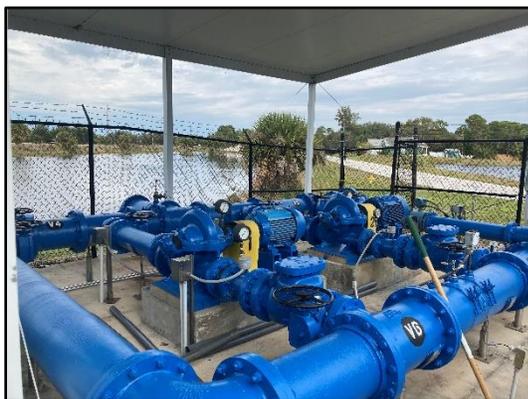
Due to damage done by Hurricane Ian, the interconnect was not in operation since the storm. The control panel was flooded, and evidence of a small electrical fire is present. The small office building used as an operator laboratory was blown away. The canopy installed in FY 2021 was damaged and must be re-anchored. The light pole adjacent to the canopy is cracked and should be replaced or repaired. Additionally, the electrical engineer visited on February 21, 2023, to meet with staff and observe the station.

- The operator laboratory/office building is completely gone.
- The control panel is powered but shows signs of water damage and previous fire.
- Conduit to the control panel is rusted.
- The canopy is leaning to one side and is not secure.
- The light pole is cracked and ineffective as the light is directly above the canopy.
- Debris should be cleared from around the station.

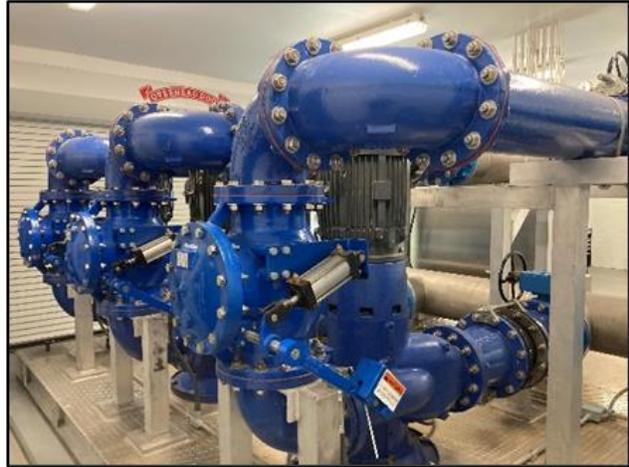
Jones Edmunds last completed an on-site review of the plant on November 15, 2022, as part of CCU's Hurricane Ian Damage Assessments; the information gathered at that time was used to update this section, in accordance with the project scope. CCU staff is aware of the following damages, as recorded during the hurricane assessment, and have been working diligently to address them accordingly. The station is in great condition overall.

- The roof was damaged; it is missing shingles and is wrapped with plastic.

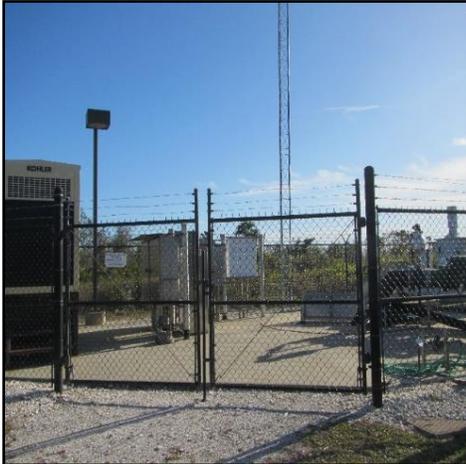
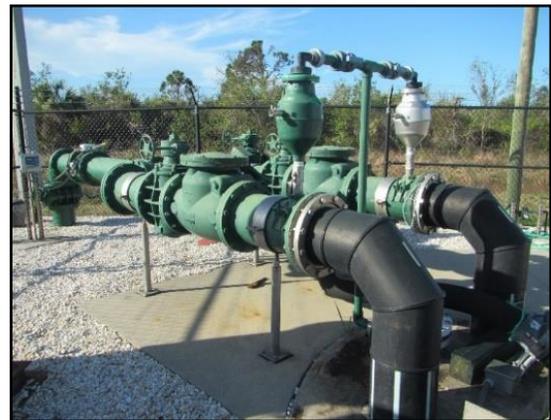
The wetwell hatches are in good condition and provide adequate access to remove the pumps on the 2-inch cylindrical-rail retrieval system. The wetwell interior is in great condition. The 12-inch Dezurik plug valves, 12-inch Kennedy check valves, air-release valves, and dedicated discharge connection are above ground near the wetwell. They are all in great condition and do not require repair or replacement at this time. The electromagnetic flow transmitter for the force main does not display flow through the force main and needs to be replaced.

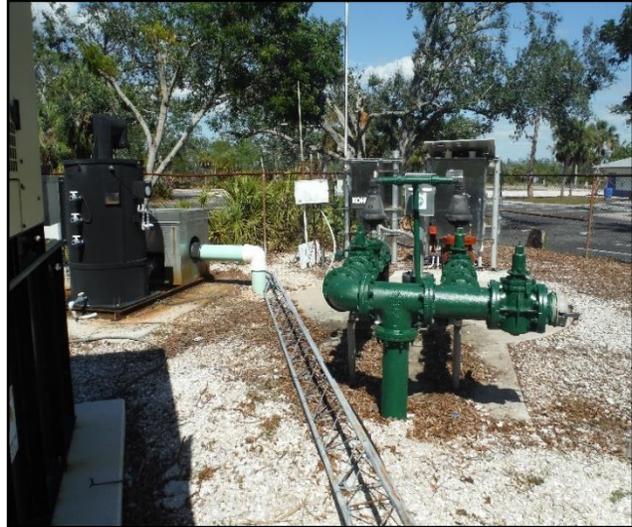
The station's wetwell interior walls are in good condition and show no signs of corrosion. Since this lift station does not receive much flow, solids build up near the bottom of the wetwell. Wastewater Operations staff spray down the solids with the water service hose once a week to break up the solids. The wetwell hatches are in good condition and provide adequate access to remove the pumps on the 2-inch cylindrical-rail retrieval system. The 6-inch Dezurik plug valves, 6-inch Kennedy check valves, air-release valves, and dedicated discharge are above ground near the wetwell. One of the check valves was replaced in February 2022 and has not been painted yet.

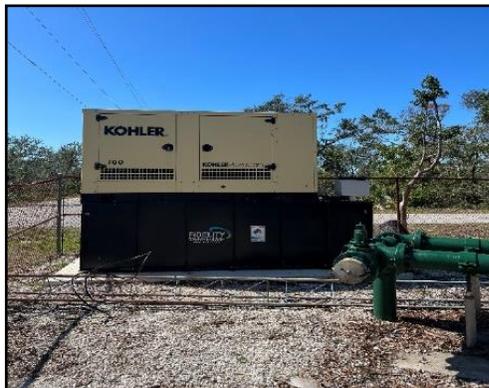
The wetwell is vented and contains an odor-control unit. The biological odor-control unit contains a blower that draws air from the wetwell and reduces the hydrogen sulfide odor generated. The skid for the odor-control unit is heavily corroded but is still intact with the concrete pad.

Power is provided by a 480-volt, three-phase power service. The station contains a telemetry transmitter that allows monitoring to occur from the CCU central office and treatment plants. The antenna mast, damaged by Hurricane Ian, is down and has not been removed from the site. The master lift station contains a 100-kW Kohler generator with a 683-gallon fuel tank. The control panel has a sunshield, seal-offs, and a mechanical interlock between the main breaker and

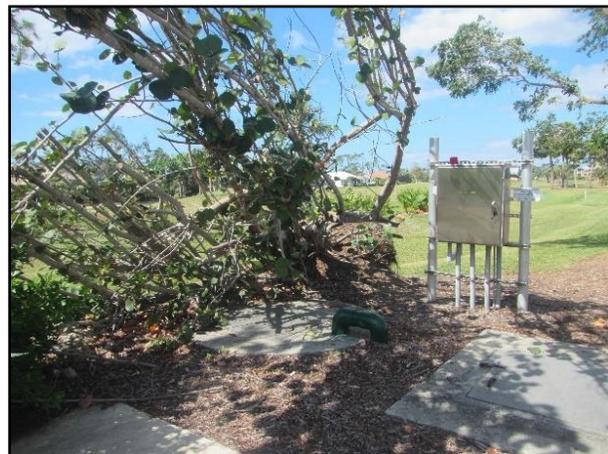
The 4-inch discharge Dezurik plug valves and 4-inch Kennedy check valves are in an underground vault southeast of the station. The valve vault interior has corrosion from standing water. The plug valves, check valves, dedicated discharge connection, and discharge piping are in fair condition with signs of heavy rust and need to be replaced.

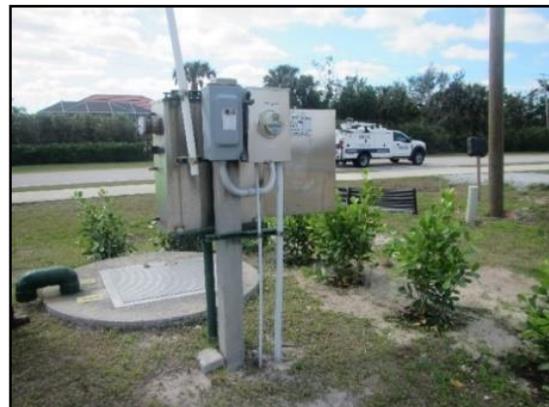
The concrete wetwell interior is in great condition and is vented. The wetwell hatch is in good condition and provides adequate access to remove the pumps on the 2-inch cylindrical-rail retrieval system. The 4-inch Dezurik plug valves, 4-inch Kennedy check valves, and dedicated discharge connections are in an underground vault, east of the wetwell. The plug valves, check valves, and discharge piping show minimal signs of rust. The valve vault has standing water and sediment at the bottom, indicating inflow of stormwater and a clogged drain.

- Missing seal-offs from the control panel conduit.
- The portable generator receptacle is covered in rust on the outside.
- Standing water and sediment were observed at the site under the valves and flanges, indicating rain is entering through the valve vault hatch.
- The valve vault drain is partially clogged.

- Install seal-offs on any electrical equipment within 10 feet of the wetwell to conform with current codes.
- Replace the generator receptacle.
- Replace the valve vault hatch and associated lock.
- Remove sediment from the valve vault drain opening.

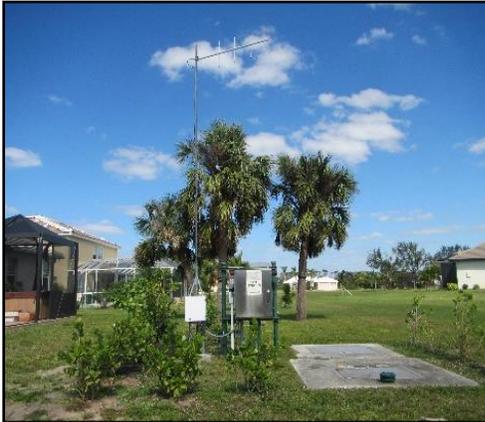
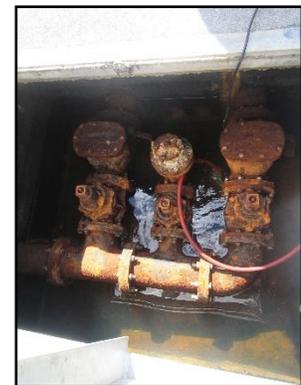
5.2.4.3 Lift Station 408 – Cabana

The wetwell is vented and has no odor control. The liner on the concrete interior wetwell is faded with some corrosion due to hydrogen sulfide exposure. The wetwell hatch is heavily rusted on the inside and provides adequate access to remove the pumps on the 2-inch cylindrical-rail retrieval system. The 4-inch Dezurik plug valves, 4-inch Kennedy check valves, and dedicated discharge connection are in an underground vault north of the wetwell. The plug valves, check valves, dedicated discharge connection, and discharge piping are in fair condition with signs of heavy rust and need to be replaced. The vault currently has standing water present inside that needs to be pumped out.

- Missing seal-offs from the control panel conduit.
- The portable generator receptacle is rusted on the outside.
- The pump discharge piping, plug valves, check valves, and dedicated discharge connection in the valve vault are heavily rusted.
- The wetwell hatch is heavily rusted on the inside.
- Standing water and sediment were observed at the site under the valves and flanges, indicating rain is entering through the valve vault hatch.
- The valve vault drain is clogged.

- Install seal-offs on any electrical equipment within 10 feet of the wetwell to conform with current codes.
- Replace the generator receptacle.
- Evaluate replacing the submersible pump discharge piping, plug valves, check valves, and dedicated discharge connection.
- Replace the wetwell hatch.
- Replace the valve vault hatch and associated lock.
- Remove sediment from the valve vault drain opening.

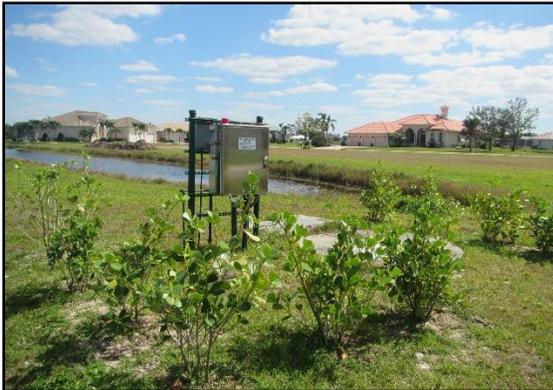
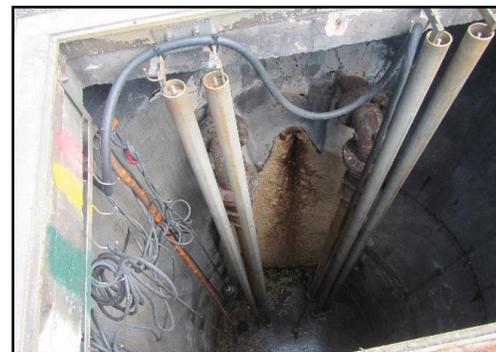
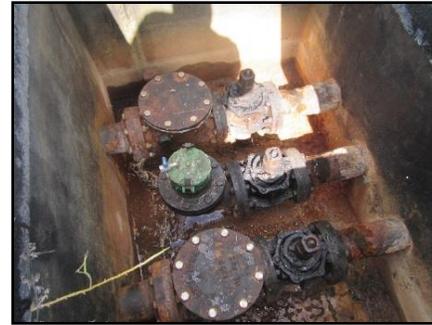
5.2.4.4 Lift Station 409 – Santa Inez

The wetwell is vented and does not have odor control. The wetwell hatch is showing heavy signs of corrosion on the inside and provides adequate access to remove the pumps along the 2-inch cylindrical-rail retrieval system. The 4-inch Dezurik plug valves, 4-inch Eddy-Iowa check valves, and dedicated discharge connection are in an underground vault east of the wetwell.

- Missing seal-offs from the control panel conduit.
- Moderate rust on the pump discharge piping, plug valves, check valves, and dedicated discharge connection in the valve vault.

- The wetwell hatch is heavily rusted on the inside.
- Rust and sediment were observed at the site under the valves and flanges, indicating rain is entering through the valve vault hatch.
- The valve vault drain is partially clogged.

- Install seal-offs on any electrical equipment within 10 feet of the wetwell to conform with current codes.
- Evaluate replacing the submersible pump discharge piping, plug valves, check valves, and dedicated discharge connection.
- Replace the wetwell hatch.
- Evaluate replacing the valve vault hatch and associated lock.
- Remove sediment from valve vault drain opening.

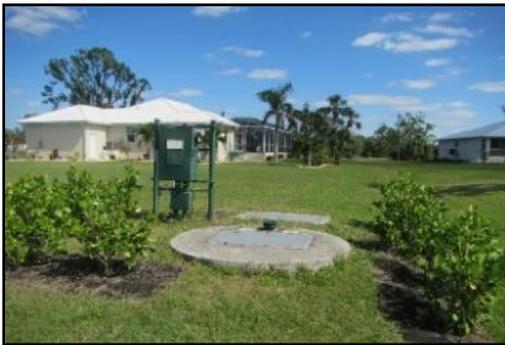
5.2.4.5 Lift Station 410 – Monza

The wetwell is vented and does not have odor control. No odors were present at the time of the site visit. The wetwell hatch is heavily rusted on the inside and provides adequate access to remove the pumps along the 2-inch cylindrical-rail retrieval system. Its exterior is in relatively good condition, but the interior concrete wall is showing signs of corrosion and the discharge piping from the pumps is rusted. The station has a valve vault east of the wetwell that contains 4-inch Dezurik plug valves, 4-inch Kennedy check valves, and a dedicated discharge connection. The floor of the vault has rust and sediment beneath the valves and piping.

- The wetwell hatch is heavily rusted on the inside.
- The pump discharge piping, plug valves, check valves, and dedicated discharge connection in the valve vault are heavily rusted.
- Rust and sediment were observed at the site under the valves and flanges, indicating rain is entering through the valve vault hatch.

- Replace the wetwell hatch.
- Evaluate replacing the submersible pump discharge piping, plug valves, and check valves, and dedicated discharge connection.
- Evaluate replacing the valve vault hatch and associated lock.

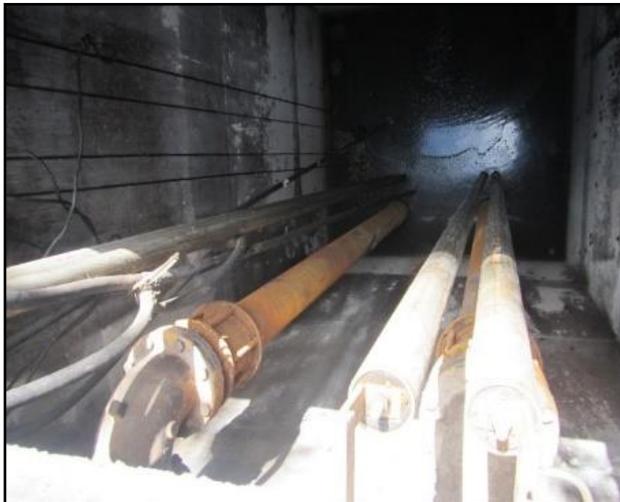
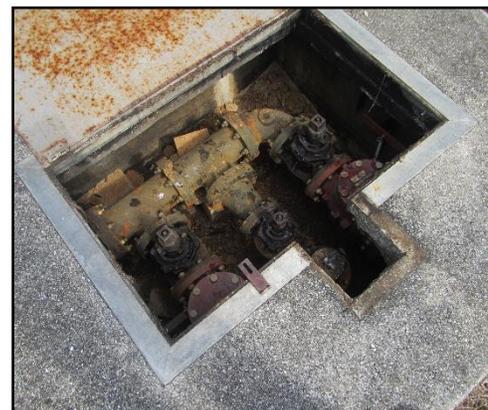
5.2.4.6 Lift Station 411 – San Ciprian

access to remove the pumps along the 2-inch cylindrical-rail retrieval system. The wetwell exterior is in relatively good condition, but the interior is showing major signs of rust on the discharge piping from the pumps. The station has a valve vault northeast of the wetwell that contains 6-inch Dezurik plug valves, 6-inch Mueller check valves, and a dedicated discharge. The plug valves and dedicated discharge piping have minimal rust. The floor of the valve vault has debris and sediment beneath the valves and piping.

generator receptacle and a mechanical interlock between the generator and the main breaker. The portable generator receptacle is rusted on the outside and should be replaced. The station has no dedicated lighting. The station has a potable water hose bibb for washdown.

- The wetwell hatch is heavily rusted on the inside.
- The pump discharge piping, plug valves, check valves, and discharge piping in the valve vault are heavily rusted.
- Rust was observed at the site under the valves and flanges, indicating rain is entering through the valve vault hatch.
- Missing seal-offs from the control panel conduit.
- The portable generator receptacle is corroded on the outside.

- Replace the wetwell hatch.
- Evaluate replacing the submersible pump discharge piping, plug valves, and check valves.
- Evaluate replacing the valve vault hatch and associated lock.
- Install seal-offs on any electrical equipment within 10 feet of the wetwell to conform with current codes.
- Replace the portable generator receptacle.

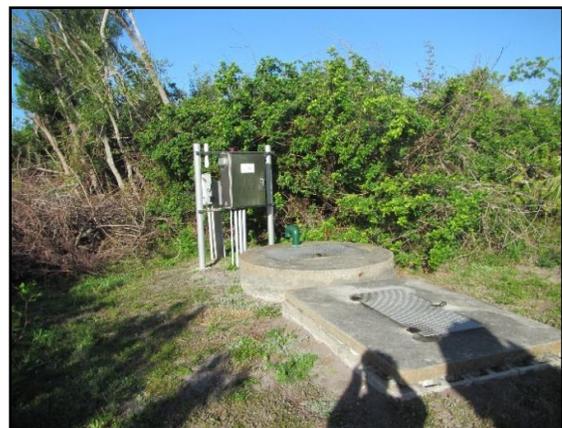
The wetwell interior has a crack in the wall that is leaking fluid. The wetwell hatch is in good condition and provides adequate access to remove the pumps along the 2-inch cylindrical-rail retrieval system. The wetwell is vented and no odor was present.

The 4-inch discharge Dezurik plug valves and 4-inch Kennedy check valves are in a valve vault with a dedicated discharge connection. The pump discharge piping is heavily rusted. The floor of the valve vault has moderate sediment.

- The wetwell wall has a crack that is leaking fluid onto the liner.
- The pump discharge piping is heavily rusted.
- Missing seal-offs from the control panel conduit.

- Perform thorough rehabilitation including some form of structural improvement and lining repair.
- Evaluate replacing the submersible pump discharge piping.
- Install seal-offs on any electrical equipment within 10 feet of the wetwell to conform with current codes.

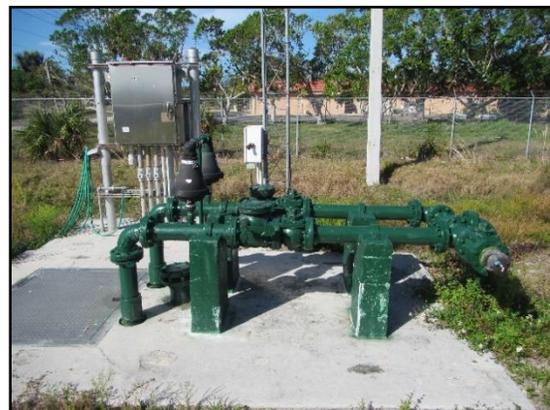
The wetwell is vented and no odor was present. The wetwell exterior and electrical equipment are in relatively great condition. The wetwell interior is in great condition with no signs of deterioration. The wetwell hatch is in great condition and provides adequate access to remove the pumps along the 2-inch cylindrical-rail retrieval system. The discharge 4-inch Dezurik plug valves, 4-inch Kennedy check valves, air-release valves, and dedicated discharge connection are above ground near the wetwell. They are all in great condition and do not require repair or replacement at this time.

No deficiencies were noted at this station.

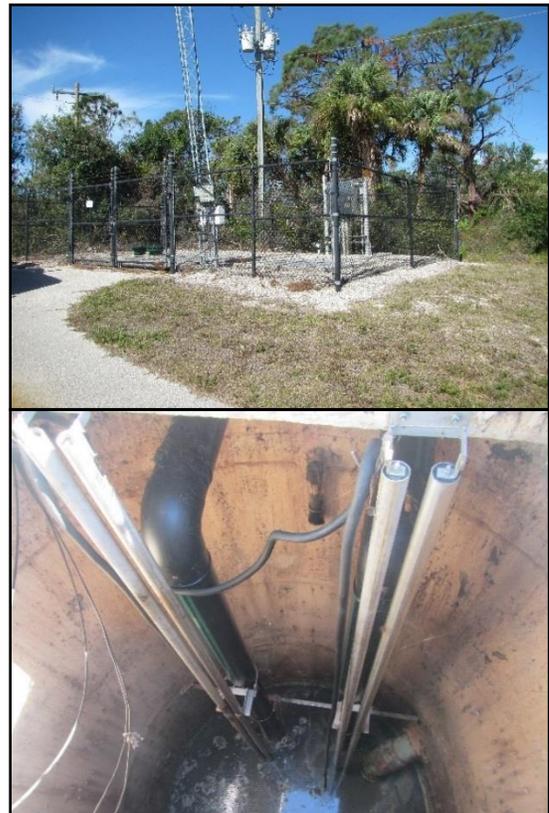
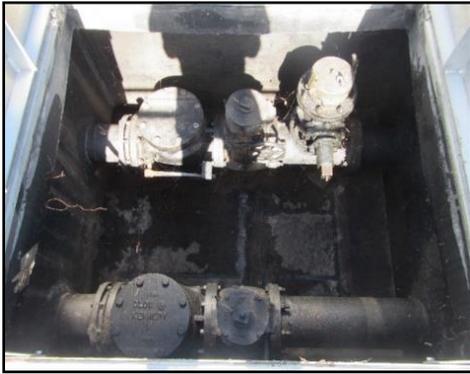
The wetwell interior liner is cracked in a few areas and fading due to the presence of hydrogen sulfide. The wetwell hatch is in good condition and provides adequate access to remove the pumps along the 2-inch cylindrical-rail retrieval system. The discharge 8-inch Dezurik plug valves, 8-inch Kennedy check valves, and dedicated discharge connection are in a valve vault near the wetwell.

- The wetwell interior liner is cracking.
- The antenna mast is leaning.

- Perform thorough rehabilitation including some form of structural improvement and lining repair.
- Evaluate replacing the antenna mast.

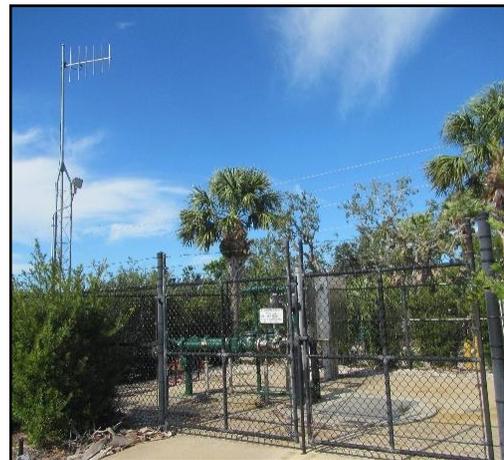
The wetwell hatch is in good condition and provides adequate access to remove the pumps on the 2-inch cylindrical-rail retrieval system. The wetwell interior has solids built up at the bottom near the submersible pumps. The wastewater technicians break down the solids once a week with potable water from a hose bibb. The discharge 4-inch Dezurik plug valves, 4-inch Kennedy check valves, air-release valves, and dedicated discharge connection are above ground southwest of the wetwell. They are all in great condition and do not require repair or replacement at this time. A Bay Products Inc. biological odor-control unit with a fan draws air from the wetwell and reduces the hydrogen sulfide odor generated. The air

No deficiencies were noted at this station.

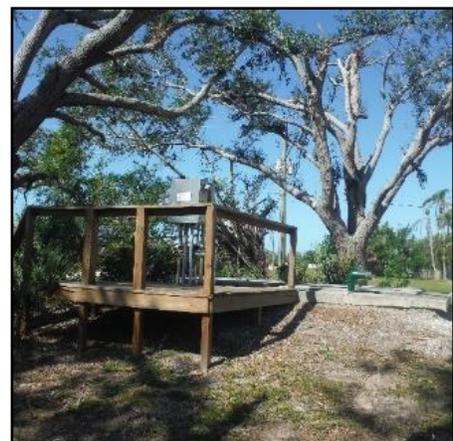
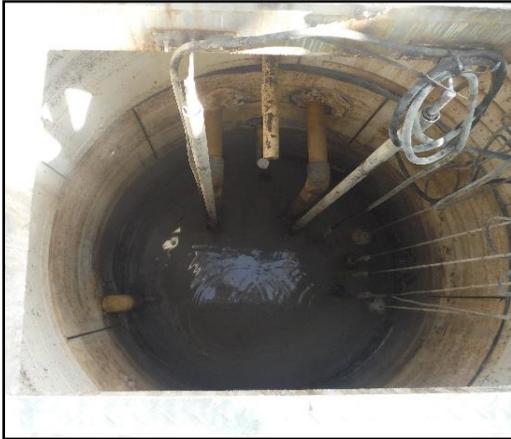
The wetwell hatch is in good condition and provides adequate access to remove the pumps on the single-cylindrical-rail retrieval system. The wetwell interior liner is faded from hydrogen sulfide exposure. The discharge 4-inch Dezurik plug valves and 4-inch Kennedy check valves are in a valve vault near the wetwell. The dedicated discharge connection is above grade near the valve vault opening. The valve vault interior is in good condition. The pump discharge piping, check valves, and plug valves are showing moderate signs of rust and should be replaced.

- The wetwell interior liner is faded from hydrogen sulfide exposure.
- Moderate rust on the pump discharge piping, plug valves, and check valves in the valve vault.

- Perform thorough rehabilitation including some form of structural improvement and lining repair.
- Evaluate replacing the submersible pump discharge piping, plug valves, and check valves.

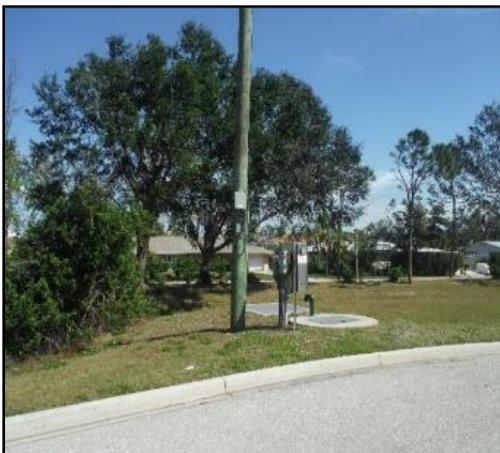
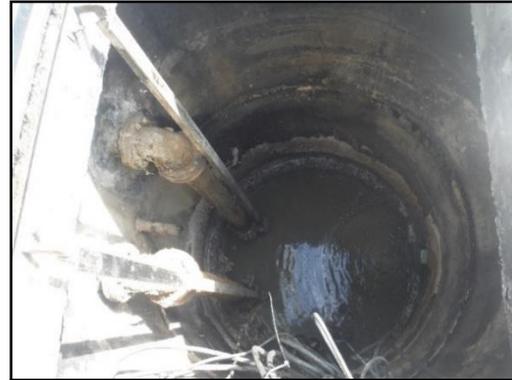
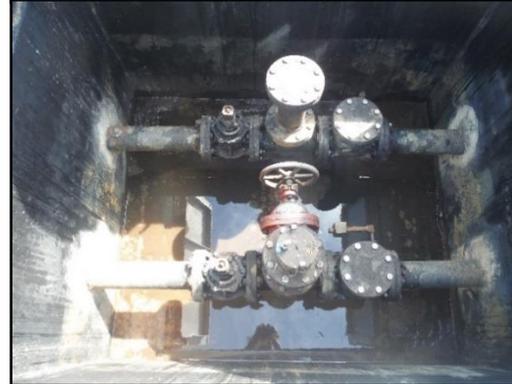
5.2.4.12 Lift Station 808 – Publix

The wetwell is vented, and no odor was present on site. The wetwell hatch is in good condition and provides adequate access to remove the pumps on the single-cylindrical-rail retrieval system. The wetwell interior liner is faded from hydrogen sulfide exposure. The discharge 4-inch Dezurik plug valves, 4-inch Kennedy check valves, and dedicated discharge connection are in a valve vault near the wetwell. The pump discharge piping is showing heavy signs of corrosion and should be replaced. The valve vault has standing water and sediment at the bottom, indicating inflow of stormwater and a clogged drain.

- The wetwell interior liner is faded from hydrogen sulfide exposure.
- The pump discharge piping has heavy corrosion.
- Standing water and sediment were observed at the site under the valves and flanges, indicating rain is entering through the valve vault hatch.

- Perform thorough rehabilitation including some form of structural improvement and lining repair.
- Evaluate replacing the submersible pump discharge piping.
- Replace the valve vault hatch and associated lock.
- Remove sediment from the valve vault drain opening.

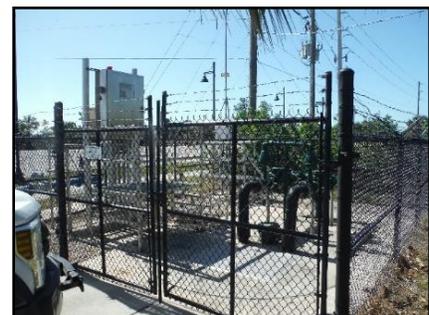
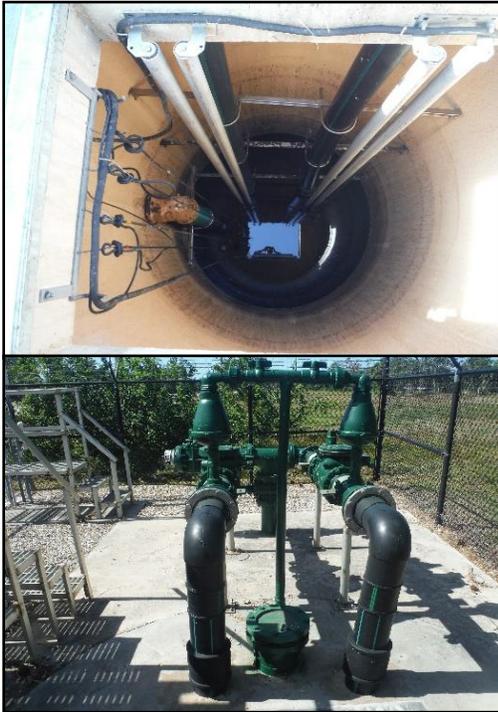
5.2.4.13 Lift Station 811 – Fishery

The wetwell is vented, and no odor was present on site. The wetwell exterior and electrical equipment are in great condition. The wetwell interior shows no signs of corrosion and odor. The wetwell hatch is in great condition and provides adequate access to remove the pumps along the 2-inch cylindrical-rail retrieval system. The discharge 8-inch Dezurik plug valves, 8-inch Kennedy check valves, air-release valves, and dedicated discharge are above ground near the wetwell. They are all in great condition and do not require any repair or replacement at this time.

No deficiencies were noted at this station.

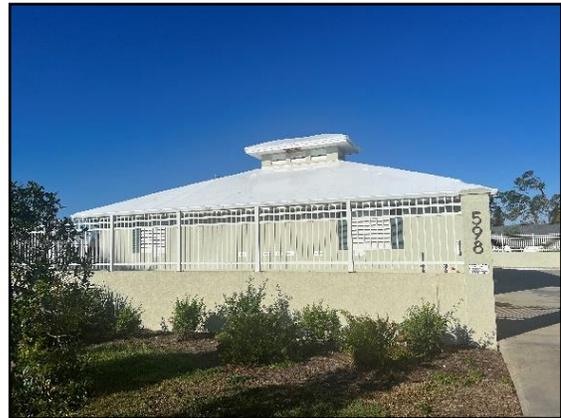
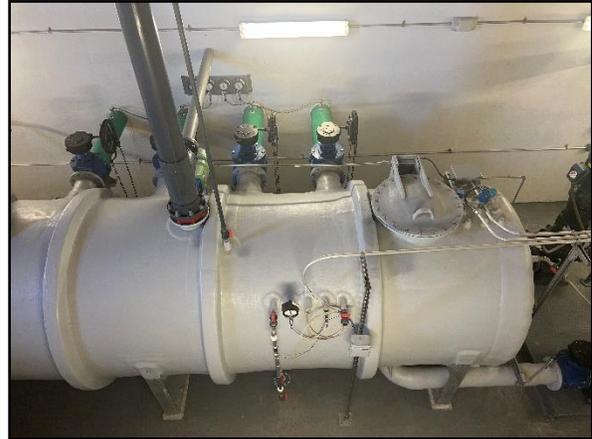
5.3.1 VS 1 – SKYLARK (FORMERLY LS 59)

The station contains two 50-HP Cornell centrifugal Model 4514T-VC18DB pumps inside the building. Each pump has a design capacity of 725 gpm at 137.5 feet of head, but the pumps recently had their impellers trimmed to 34-foot TDH @725 gpm and their VFDs modified to account for the improvements made to the system curve after the RTS and GMLS construction. The plastic covers for both pump motor components are missing or broken and need to be replaced. The 8-inch check valve after the discharge of the Cornell pumps is sticking and needs to be replaced.

- The crane pump on site is not aligned with the valves. Some of the valves are vertically below the common discharge line and meter, making them difficult to access with the crane.
- The access for tank maintenance is at the top of the tank without a dedicated access point. CCU staff noted an access platform for this was being designed.
- The check valve after the discharge of the sewage pumps is sticking in the open position.
- Plastic covers for the pump motor components are missing or broken.
- A fire extinguisher is not inside of the building.

- The Cummings 352 KW Generator Set was rebuilt after being damaged by a lightning strike four months ago.
- Generator set remote display is almost impossible to read because of its location and provides little to no clearance.
- Staff noted significant voltage issues at this station causing problems with controls and VFDs; FPL to monitor and verify, and County to also monitor and verify.
- Sump pump motor flex conduit has insufficient support.
- Conduit strut stand is missing anchor bolts.

- Evaluate modifying the overhead crane with a trolley for lateral movement.
- Evaluate a catwalk or dedicated ladder for accessing the top of the tank for maintenance.
- Evaluate replacing the check valve.
- Replace the plastic covers for the pump motor components.
- Add a fire extinguisher inside the building.

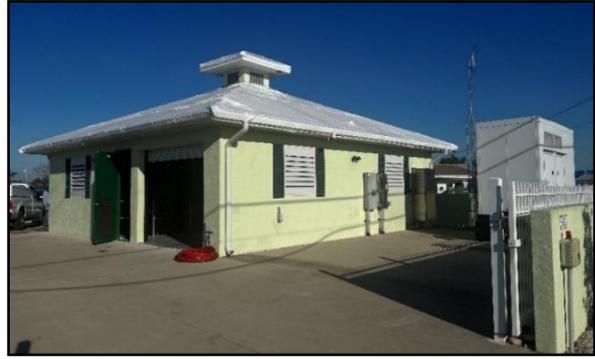
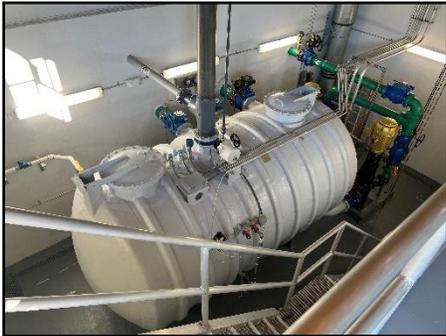
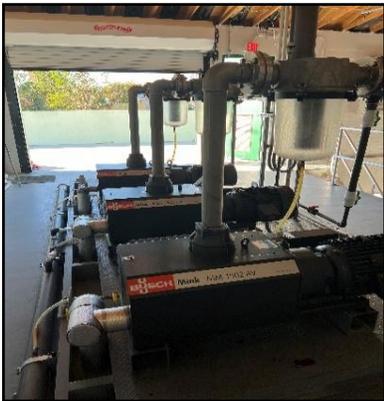
5.3.2 VS 3 – HARBOR VAC (FORMERLY LS 143)

The building contains a dedicated pump crane for removal of pumps and valves from the lower level; however, the crane is not aligned with the pumps or the valves. The discharge isolation valves are overhead and accessible by the dedicated overhead crane in the building.

The vacuum tank was approaching its scheduled maintenance at the time of the site visit; however, a feasible way to access the equipment on top of the tank to maintain and clean the equipment was not apparent.

- Staff reports uninterruptible power supply failure on the control panel, but the cause is unknown.

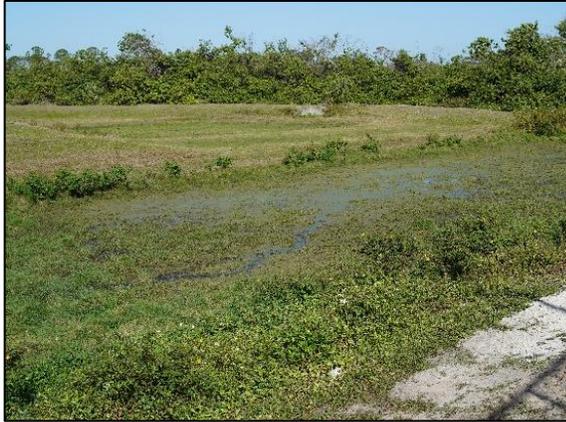
In general, the plant site is well kept and maintained. Staff has done a good job in groundskeeping and facility appearance. The area of mowed grass outside the reclaimed water storage pond is an aesthetic welcome to plant visitors. The Operations Building and shop area are clean and organized. The stormwater pond near the headworks requires clearing and reconditioning.

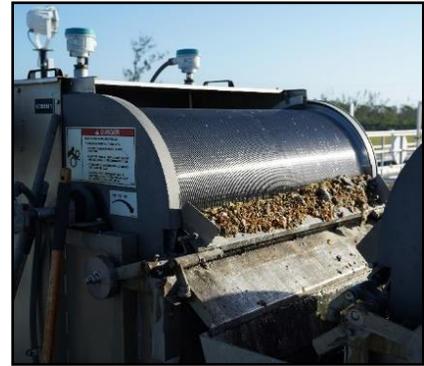
The overall condition of the headworks structure was considered good at the time of the site visit. In 2021, the County completed a headworks rehabilitation project where the headworks structure, pumps, and piping were re-coated; all four drum screens were replaced; and four new chain-operated influent valves were installed. The drum screens and rotating equipment continue to corrode due to hydrogen sulfide. Adding odor control through chemical addition will extend the service life of the drum screens. The bottom of the headworks structure and dumpster appeared to be clean and orderly.

A fiberglass grating over the influent flow splitter area had been supported by two carbon-steel beams. These beams were replaced with aluminum beams in FY 2015. The fiberglass grating is showing minor signs of fraying.

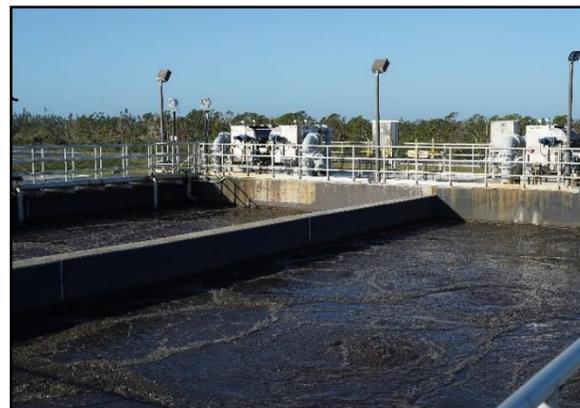
The overall condition of the activated-sludge facilities is good. The mixed liquor suspended solids (MLSS) are sampled every morning by the Operations staff. The WRF has four aeration basins – all basins were in service at the time of the site review. New fine-bubble diffusers were installed in all basins in 2013 and 2014. This has had a positive effect on the treatment process by providing a more even air flow distribution. However, the lack of grit removal continues to

present a maintenance challenge since deposited grit levels rise to block the diffusers. Basin No. 3 was cleaned of grit, and damaged aerators were repaired in FY 2016.

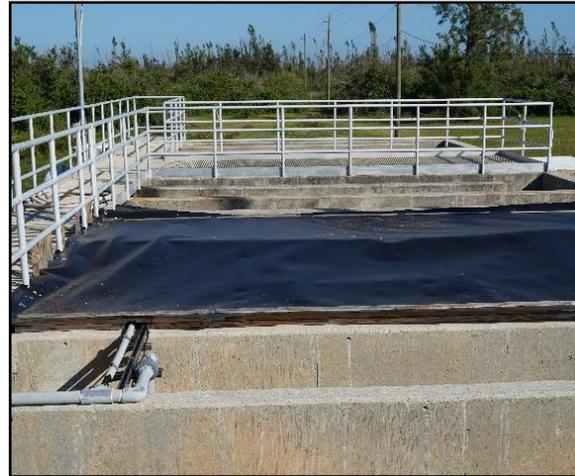
The overall condition of the chlorination system is excellent with the exception of the permanent roof structure. The roof was blown off due to wind damage when Hurricane Ian made landfall in September 2022. Only CCC No. 1 was in operation at the time of the site visit. CCC No. 2 was reported to be in good working condition. Each CCC has two trains. Good turbulent flow in the inlet boxes to the CCCs creates effective mixing. The pH and chlorine analyzers are in good working order. Plant operators clean the analyzer assemblies at regular intervals to remove any algae buildup. They also periodically alternate the CCCs to clean them.

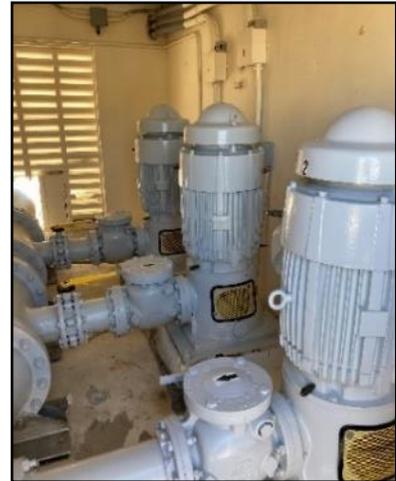
Effluent that does not meet public-access reclaimed water standards is conveyed to a clearwell for disposal via a deep injection well. Three new deep-well pumps are used to convey effluent through a 16-inch manifold pipe into the deep well. All compliance monitoring equipment and pumps were fully functioning and in good condition at the time of the inspection. The building housing the pumps suffered wind damage when Hurricane Ian made landfall in September 2022.

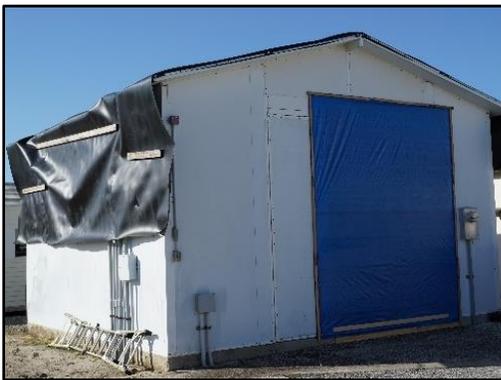
The incoming switchgear and distribution transformer appear in good condition with no obvious signs of significant concern. The incoming power via overhead aerial was installed a few years ago. The WRF is served from two 400-kVA generators connected in parallel that are fed from a subbase tank and an auxiliary tank adjacent to them. A 6,000-gallon fuel tank and pad for the generators was installed in 2020; however, the Chief Operator reported issues with the tank's functionality and expects the tank to be removed and/or replaced in the future. Overall, the

electrical equipment is in good functioning condition based on information from the Operations staff, except for the generator MCC building's roof and side panels due to wind damage when Hurricane Ian made landfall in September 2022. Additionally, the hurricane caused some water damage to computer equipment. Generators were used during the entirety of the storm; however, Generator Set No. 2 was damaged and is currently pending repairs.

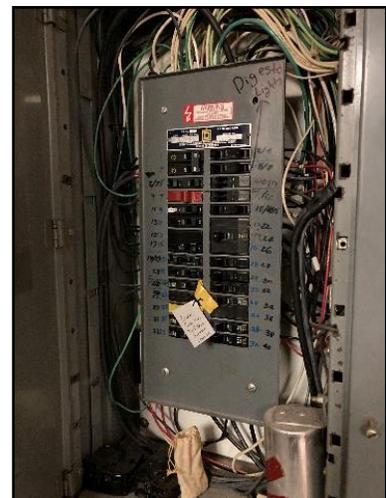
Overall, the following deficiencies were noted:

- Generator Set No. 2 was out of service due to Hurricane Ian. The generator vendor states a new generator is required.

- Staff indicated issues with incoming power where imbalance occurs and trips the blower breakers; staff indicated they plan to monitor and record power to verify this.
- The lighting panel in MCC No. 1 is missing a cover.
- Electrical room adjacent to the generator set was damaged due to Hurricane Ian; the facility is currently missing the roof and CCU has installed a temporary cover.
- Sludge bed sump pump conduit broken.
- Blower MCC building outside conduit cover open.
- MCC Building No. 2 outside conduit cover open.
- Digester No. 2 area light conduit support missing.
- Clarifier No. 1, 2, 3, and 4 missing conduit clamps on area lights.
- Clarifier No. 1 and 2 have broken conduit and are missing an line-box-style fitting cover.
- The conduit supports on the north wall of the headworks/ aeration basin have broken, leaving the conduit unsupported.

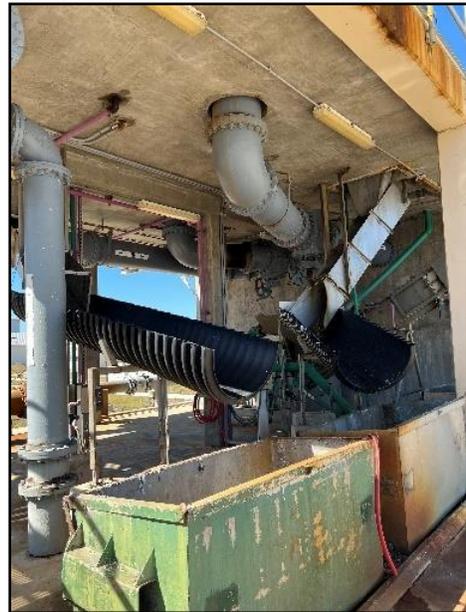
The overall condition of the headworks is fair to poor. The headworks is undergoing an improvement and rehabilitation/replacement project that will include new piping and fine screens as well other improvements to the headworks.

In 2020, the screening handlers (conveyors, compactors, etc.) were replaced with stainless steel and half-pipe corrugated HDPE chutes. The replacement system is operating as intended. The grit removal process operates as intended. The organic wastewater component of the pumped mixture is returned to the wet wells. Separated grit slurry is pumped to two cyclone units where the grit is further concentrated. The separated grit passes to a grit "snail" washer before being deposited into a dumpster. The grit "snail" washer includes a conveyor system that allows the grit to shed water as it proceeds to the dumpster. In 2017, Grit Pump No. 2 was replaced, and the cyclones are scheduled for replacement in FY 2023 as part of the headworks improvement project.

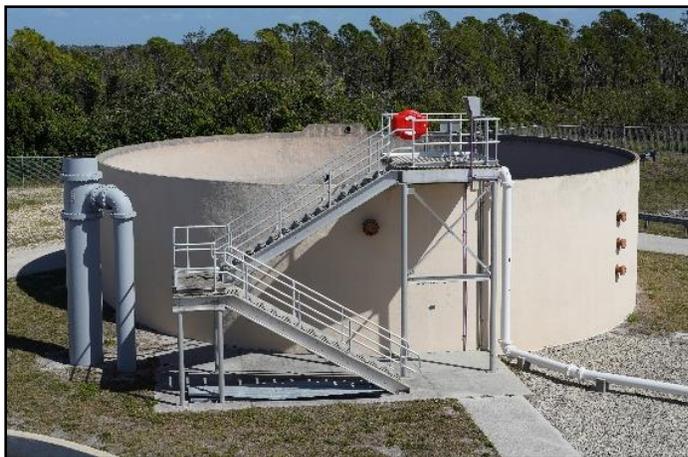
The overall condition of the 0.3-MG EQ tank is good. The EQ tank, which attenuates high hourly flows, is filled through a gravity system initiated by an overflow weir at the headworks structure. The EQ tank contents are returned to the headworks for treatment at a steady flow over 24 hours using VFD pumps. This has proven to be a valuable asset to the operation of the facility. The Chief Operator noted that Lift Station No. 801 sends 1,500 gpm to the Rotonda WRF
