Charlotte County Utilities Department

2022 Annual Report
March 2023

Prepared by
JonesEdmunds

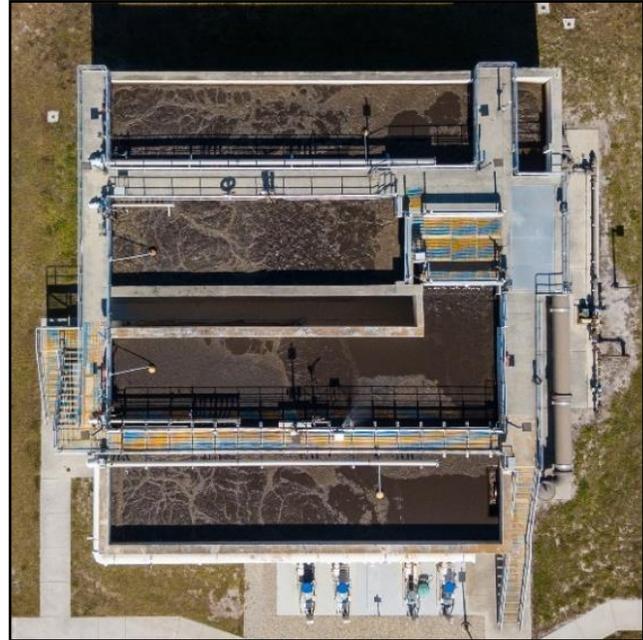
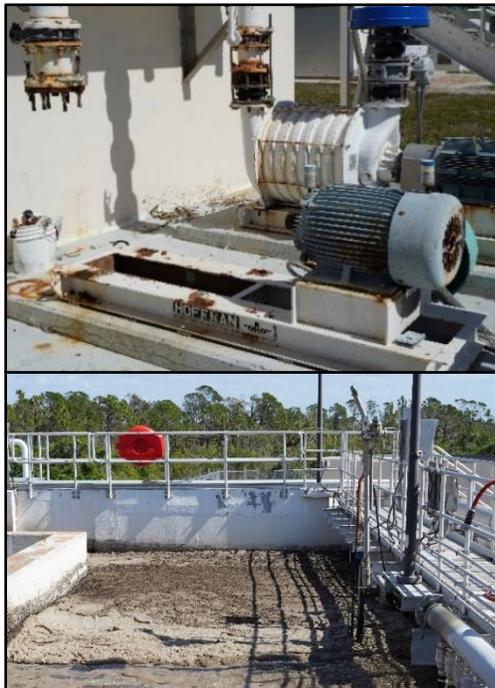
The overall condition of the activated sludge facilities is good. The aeration tanks operate in a plug flow regime with anoxic, aerobic, and swing zones. The anoxic zones and the use of automatic DO probes to control blower speeds have contributed to the high level of treatment while conserving energy use. The aeration tanks are run at a MLSS concentration of 4,500 to 5,000 mg/L. The aeration tanks were last drained for inspection in FY 2012. The aeration basins were pressure-cleaned and painted in FY 2017. A layer of foam was on the water surface in the anoxic zone at the time of inspection. The Chief Operator recommended that additional tank volume is necessary to increase denitrification capacity.

The aeration system continues to supply air to the aeration tanks. The facility has four multi-stage centrifugal Hoffman blowers to serve the aeration trains with room for an additional blower. Generally, one blower meets air requirements. Additional units are brought online during higher demands. Blower No. 2 has been repaired multiple times including a new motor in FY 2014 and new bearings in FY 2016; however, the blower motor was again repaired in FY 2017. During the site visit, we observed that Blower No. 2 was removed from service; staff reported replacement of Blower No. 2 hardware will occur in 2023. Blower Nos. 1 and 4 were replaced in FY 2020 and FY 2019, respectively. The installed blower and motors were in good condition. Blower No. 5 was replaced in FY 2021, but requires replacing with a lower standard cubic foot per minute (scfm)-capacity blower to maintain oxygen levels.

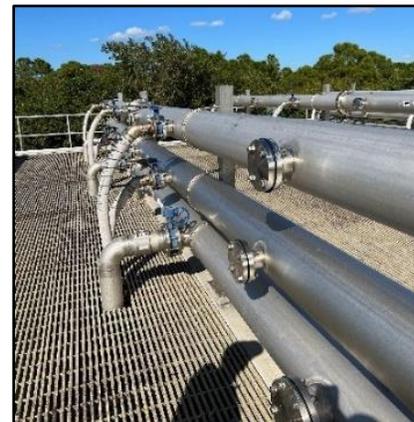
One of the DO probes in the aeration basin was replaced in FY 2017. All four probes are functioning properly. One DO probe controller screen was severely faded and degraded by UV from the sunlight, and other screens showed similar signs of UV damage. The controller with the damaged screen likely transmits data to plant operations staff via SCADA; however, the damaged controllers should be replaced for field operational purposes. We also recommended installing sun shields on the front of all the controller three-sided enclosures to extend the life of existing equipment.

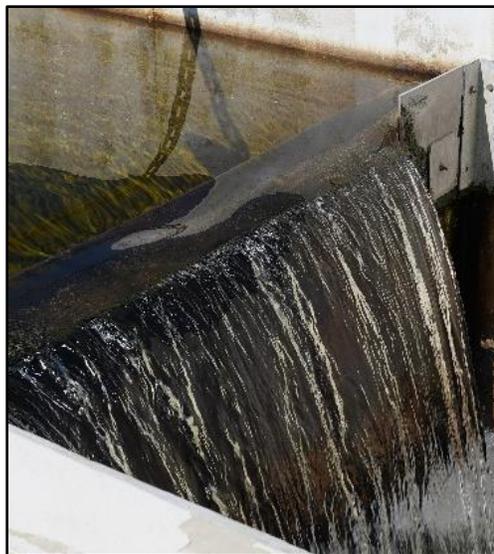
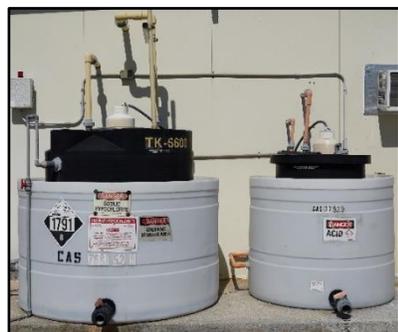
The overall condition of the chlorination system is good. The two concrete CCCs are in good condition. The CCCs are used alternately, but only one is required to meet the required contact time under current flows. Wind from Hurricane Ian in September 2022 caused the UV filter cloth and metal roof to be blown off the CCC, and it was still missing at the time of our site visit. During the site visit, neither CCC had a UV filter cloth.

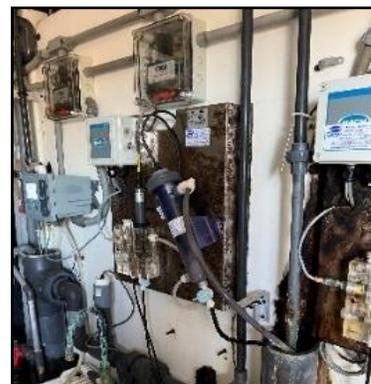
Prominent Feed Pump No. 3 was replaced in FY 2018. Prominent Feed Pump No. 2 was replaced in FY 2019. Prominent Feed Pump No. 1 was replaced in FY 2021. The two total chlorine analyzers were replaced in FY 2019. The metal backplates for the chlorine analyzers have experienced substantial corrosion and staining and should be replaced. The chlorine feed line from the in-plant road was replaced in FY 2018.

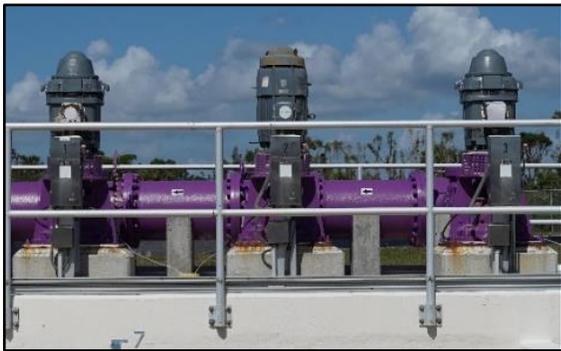
Reclaimed water meeting public-access water quality is sent to the Master Reuse System using the HSPs at HSPS No. 1 and HSPS No. 2. HSPS No. 1 uses three vertical turbine pumps with VFDs to provide reclaimed water to golf course storage ponds north of the Rotonda WRF. The golf course's high-pressure pumps then increase pressure for irrigation system use. The motors for Pumps No. 1 and No. 3 failed and were replaced in FY 2022. These motors are only for temporary

use since they are not rated for outdoor use. These indoor motors will continue to be used until outdoor motors can be acquired.

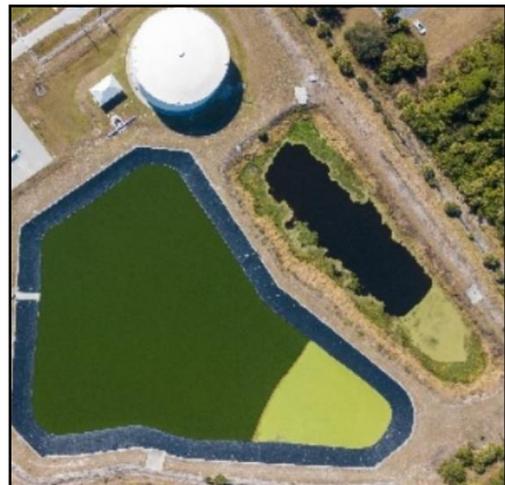
Reclaimed water quality effluent can also be stored in the Rotonda WRF on-site 3.0-MG GST and unlined reclaimed water storage pond. The GST was drained and cleaned in FY 2017. Reclaimed water from the GST can be pumped to pressurized reuse customers using HSPS No. 2. The unlined reclaimed water storage pond has a reduced capacity due to groundwater percolation into the pond. The Chief Operator expressed that the unlined storage pond is not being used at this time or in the foreseeable future. Jones Edmunds recommends this pond be removed from the permit. It can then be filled with compacted suitable soil and replaced with a 3.0-MG GST.

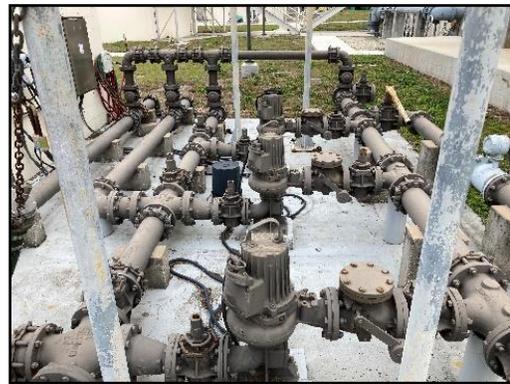
Pump out station pumps for truck loading were not operating during the site visit and are scheduled to be replaced in FY 2023. The Chief Operator indicated that the plant is experiencing limited sludge-hauling capabilities, and excess sludge stored in the biosolids handling facilities has not exceeded system capacity. The situation is being closely monitored by Operations staff. Expanding the storage and dewatering at the biosolids handling facilities at East Port WRF is currently part of the ongoing 9.0-MGD expansion project to increase the receiving capacity from Rotunda WRF.

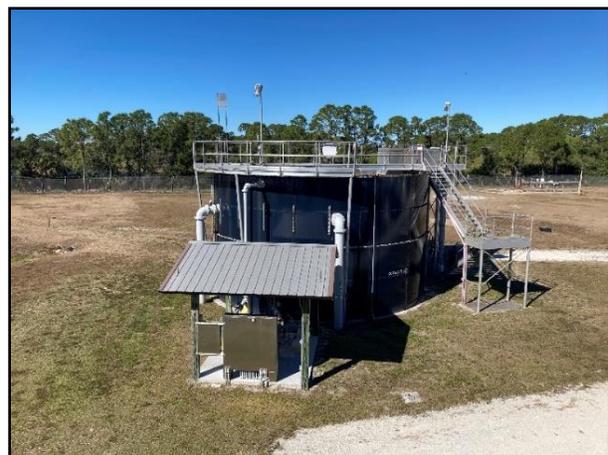
The Aquastore EQ tank is in poor condition. The EQ tank has signs of rust around the upper steel rim, which likely originates from the RO WTP waste line. Internal piping is in poor condition with leaks at flanged fittings, and one of the drop diffusers inside the EQ tank has been damaged and is no longer secure. Since no grit-removal facilities are provided, grit accumulation occurs in the EQ tank and reduces treatment capacity. The grit accumulation is currently being managed by having a vendor periodically pump out the grit in the EQ tank while in operation.

Due to these operational concerns and the condition of the headworks and EQ tank, CCU is re-designing the Burnt Store headworks as part of the Burnt Store expansion project.

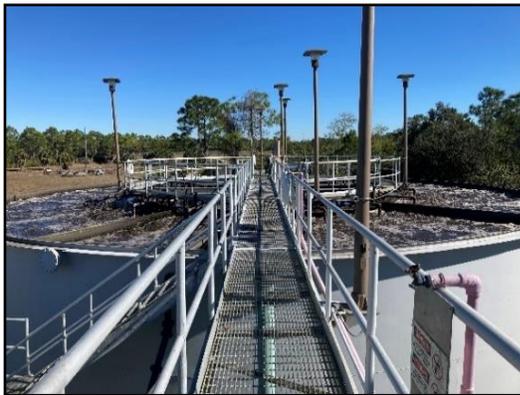
The activated-sludge facilities are steel-ring package plants consisting of two aeration tanks and two secondary clarifiers. At the time of the site visit, the aeration basins appeared to have adequate air distribution throughout the tank. All blowers were rebuilt in 2017, and new VFDs were provided for two of blowers in 2022. Blower No. 1 was undergoing motor repairs. The Chief Operator noted that the blowers are undersized for the volume of wastewater that the plant has been experiencing recently. The operation of the blowers is based on

timers, but no DO sensors are provided to adjust blower operation. The hinged sluice gates separating the two aeration tanks are not functioning as intended, allowing wastewater to flow to the adjacent tank during maintenance. The tanks have minimum free-board (<1 foot), creating concerns of overflowing during high-flow conditions or if a downstream flow obstruction occurs. At the time of site visit, minor tank overflow was noted due to valves being broken; the Chief Operator stated that CCU had already notified FDEP of the minor overflow; also, that FDEP was scheduled for an observational site visit and repairs for the tank had been scheduled. Discussions with CCU staff post-site-visit reported the tank has since been repaired by a certified diver.

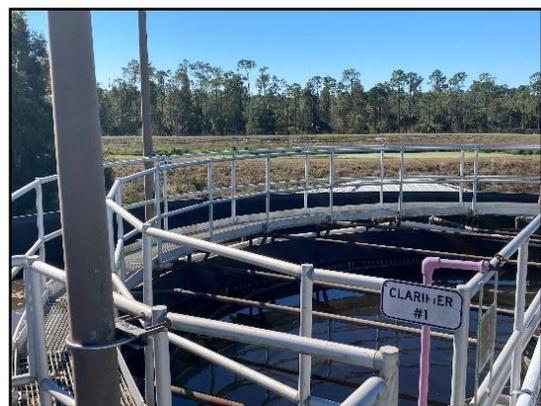
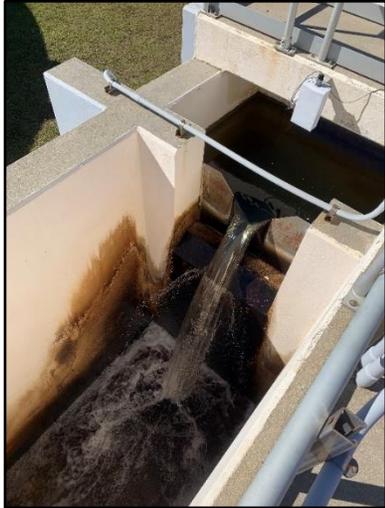
The clarifier portions of the tanks are in good working order and cleaned of excessive algae growth on the weirs as needed; a significant amount of floatables passes through the headworks and collects in the clarifiers. The floatables are returned to the headworks and accumulate in the WRF until they are manually removed. The two RAS/WAS pumps that draw solids from the bottom of the tanks are in poor condition and operating at their end of lifetime. The Chief Operator reported issues with the drives and chains being faulty. The chains were last replaced in December 2021. The pipe pumping design makes it difficult for operators to de-rag the pumps. The County continues to maintain and repair these systems until the WRF expansion is completed.

Overall, the tanks appear to be in good condition and were recently painted. The Burnt Store WRF expansion project has identified that these tanks could likely be repurposed during the preliminary design discussions.

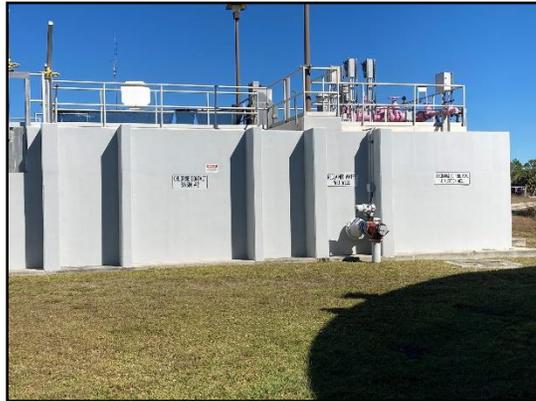
satisfy demand in the reuse system, but the two large HSPs are working properly and are tested regularly. The reclaimed water HSPs and jockey pumps are well maintained and show no signs of deterioration. Flow to the reclaimed water pump station is monitored by an ultrasonic flow meter and primary weir device, which became obsolete when the WRF began transferring flow to the deep injection well system. A new flow meter is needed to monitor the pump discharge line and measure reclaimed water flow. In addition, no on-site reclaimed water storage is available, which will

require future major reclaimed water users to be served through direct distribution to the user's reclaimed water holding facility or require storage to be added on site. These limitations will be addressed in the design of the Burnt Store WRF expansion project. Chapter 7 provides additional information about the Burnt Store Reuse System.

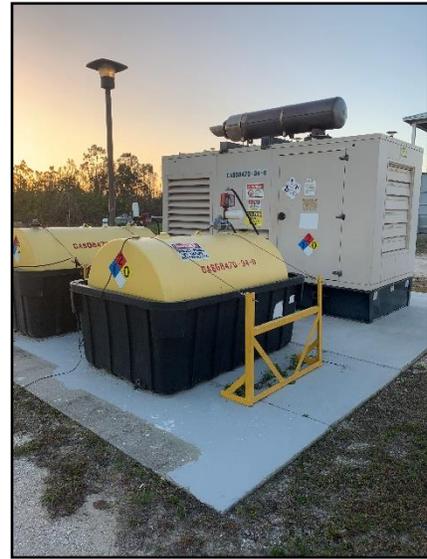
The incoming switchgear and distribution transformer appear in fair-to-good condition. The incoming power company service transformer exhibits an extensive amount of surface rust, which may soon be impacting the transformer function. The existing primary distribution switchboard outside the MCC room is also exhibiting signs of degradation from the weather. The plant is served from a single generator of an undetermined size, and its water pump was replaced in 2022. The generator was in good condition but exhibited signs of residual diesel fuel on top of the diesel fuel tank. This may be indicative of additional issues. Overall, the electrical equipment in Building MCC-1 is in good functioning condition based on information from the Operations staff, except for the deficiencies listed below.

- The switchgear contains warning labels identifying parts and components as being energized. However, none of the equipment includes the appropriate arc-flash labeling required by NFPA 70E.
- The fiberglass MCC building should be replaced with a concrete structure.
- The main breaker trips when two blowers are started simultaneously.
- The generator is undersized and is not capable of supporting all blowers at one time.

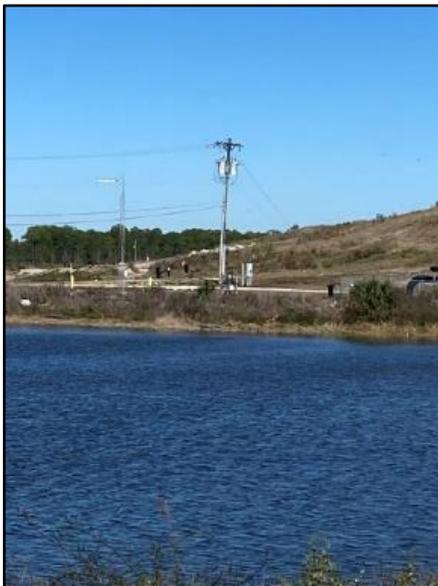
Overall, the influent pump station (PS-1) is in good condition. PS-1 is manually controlled and operated to maintain a 1-foot water level difference across the slurry wall. It has a capacity of approximately 150 gpm. Although the influent is primarily fed by the gravity-driven network, a significant amount of storage is within the landfill collection system, which provides some operational flexibility for the LTF and can be used if PS-1 is temporarily out of service.

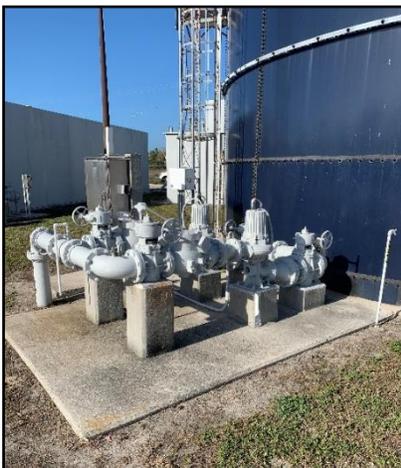
The filter EQ tank is a glass-lined steel tank with a capacity of 107,000 gallons. The filter feed stream flows by gravity through the sand filter system and is pumped from the sand filter to the effluent storage tank. The sand filter compressor was replaced in FY 2020, but the mechanical parts of the sand filter remain in poor condition and should be replaced. No back-up is provided for the treatment equipment, which makes maintenance and repair work more difficult to coordinate. The installation of a second filter or provisions to provide temporary filtration connection should be investigated as needed based on plant operating conditions.

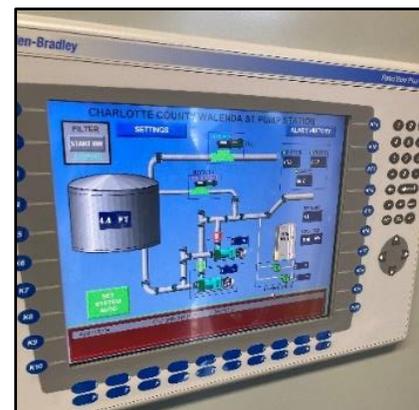
The access roads outside the facility are aging and need to be repaved but are in fair condition inside the property. The site fences are damaged and need to be repaired or replaced. Fallen trees are around the site with one leaning against the aboveground storage tank that will require complete removal. The roof over the chemical storage tanks has missing shingles from hurricane winds that need to be replaced. The HSPs are well maintained and functioning properly.

The electrical room equipment, pump room equipment, and storage tank are in good condition. The piping was painted purple but needs repainting. The grounds are well maintained. A small leak in the recirculation valve requires repair.

- The access roads outside the facility are washed out and need to be repaved.
- The site fences are damaged and need to be repaired or replaced.
- The site has fallen trees with one leaning against the aboveground storage tank.
- The roof over the chemical storage tanks has missing shingles.

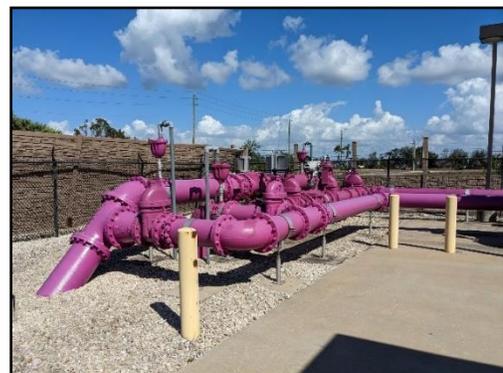
Aside from notable hurricane-related damage, such as extensive architectural fence damage, the physical condition of the RWBS was great; the aboveground piping at the RWBS was painted in 2022. However, HSP No. 2 was out of service for repairs at the time of site visit.
